Emergency Repair to the Delaware River Turnpike Bridge

Year Built: 1956
Designer: George S. Richardson
Contractor: American Bridge
Structure Type: 6,571', 31 Spans

Main Span – Continuous Arch Truss (682' Main/341' anchor)
Approach – 3/4 Span Continuous Deck Truss, girder/floorbeam
Over: PA US Route 13, Amtrak Mainline, 3 Local Roads in PA,
Delaware River, River Road in NJ

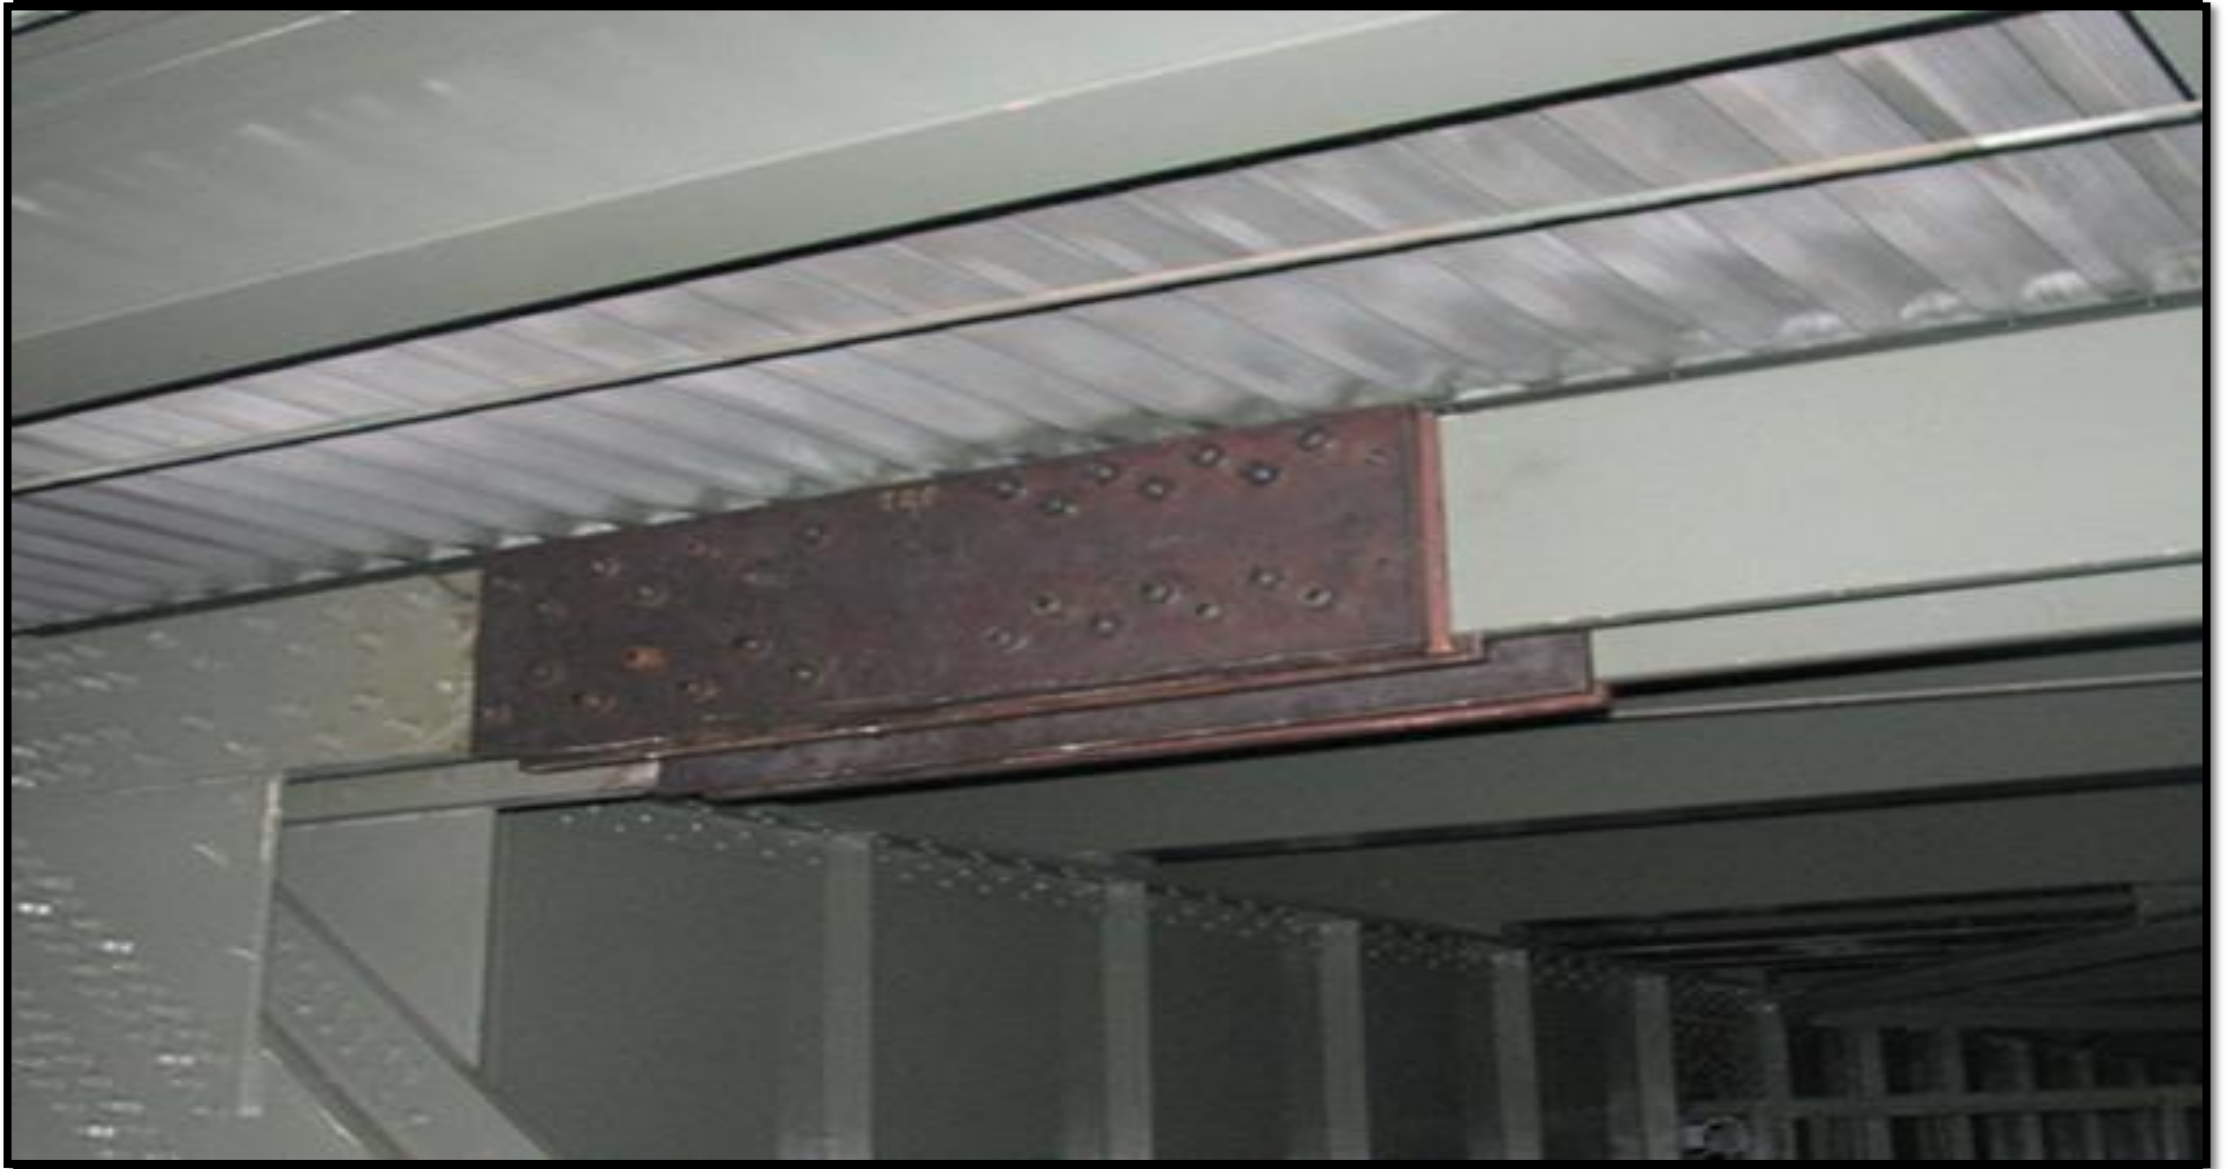
STABILIZE TRUSS

Install Temporary Support Towers

Temporary Support/Jacking Towers

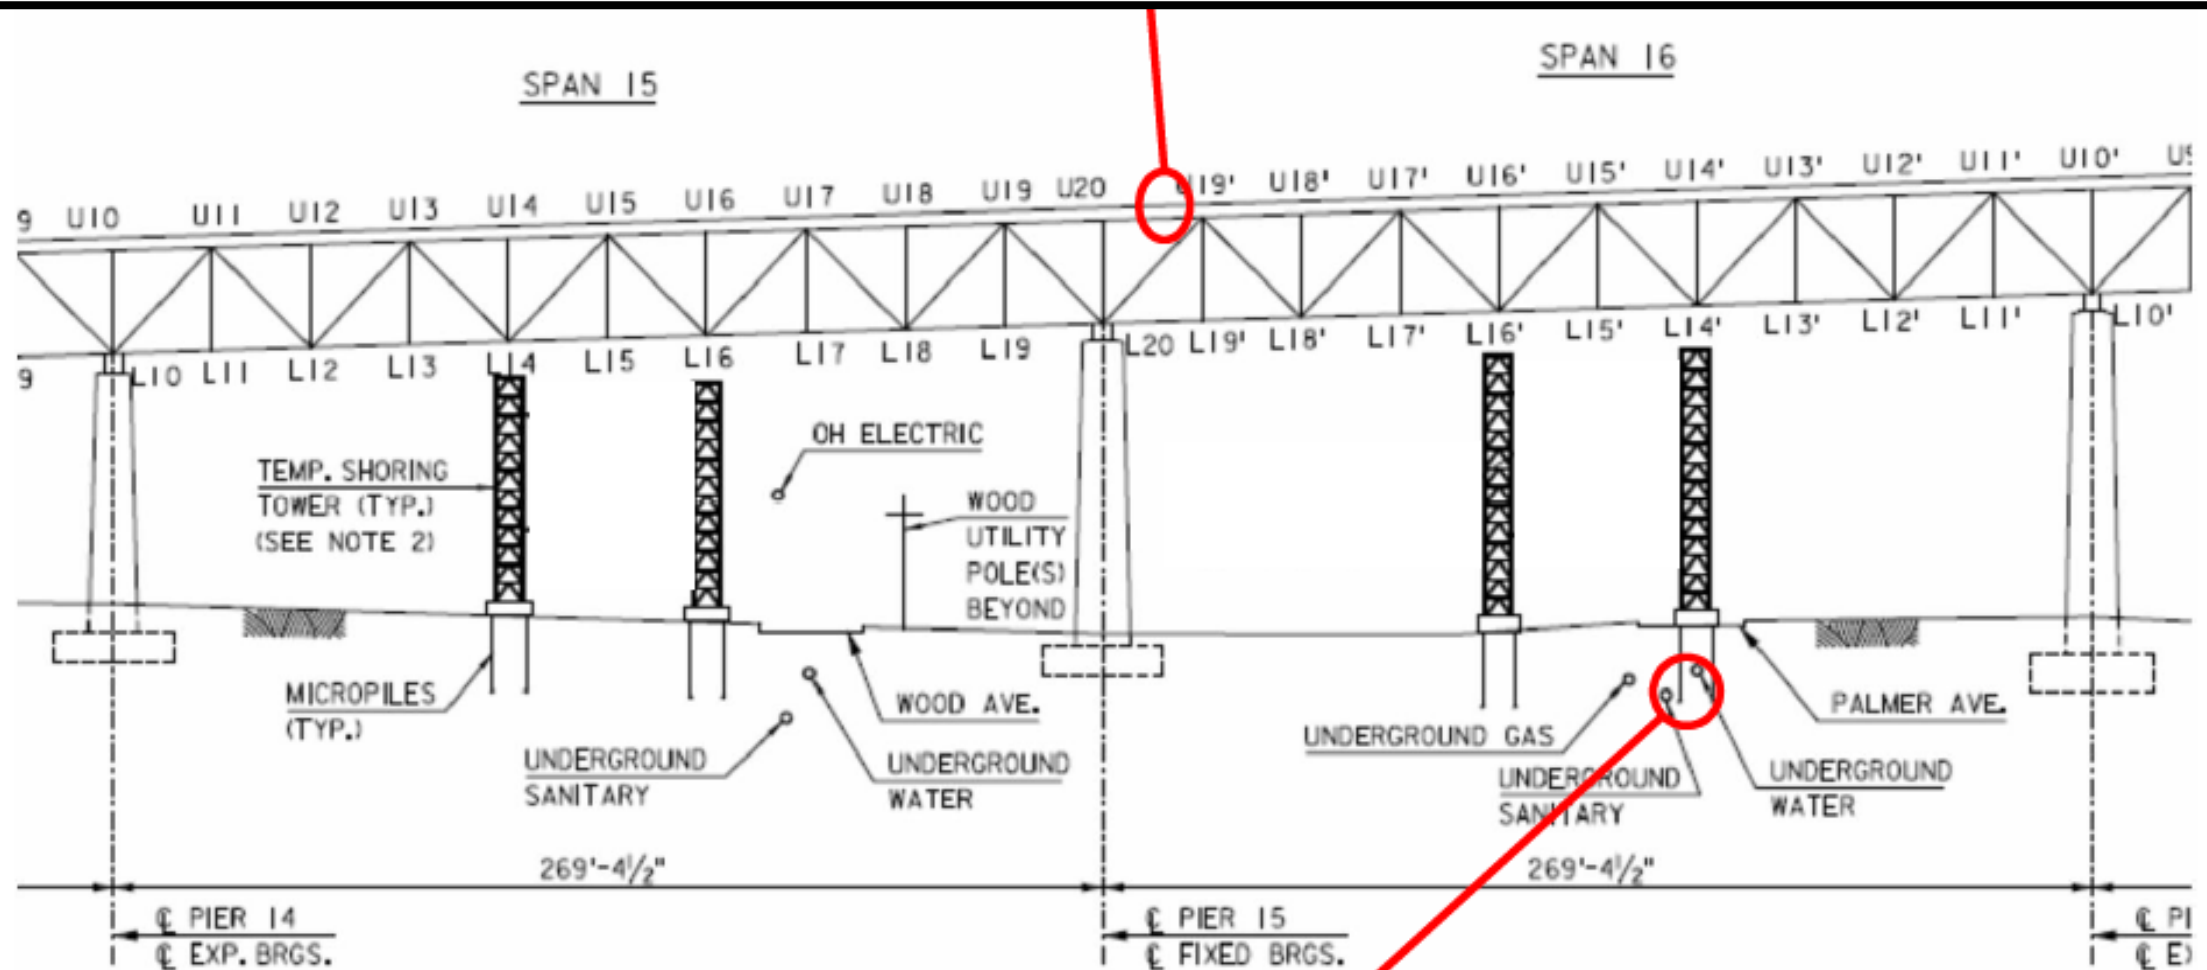
Utilities were avoided during drilling

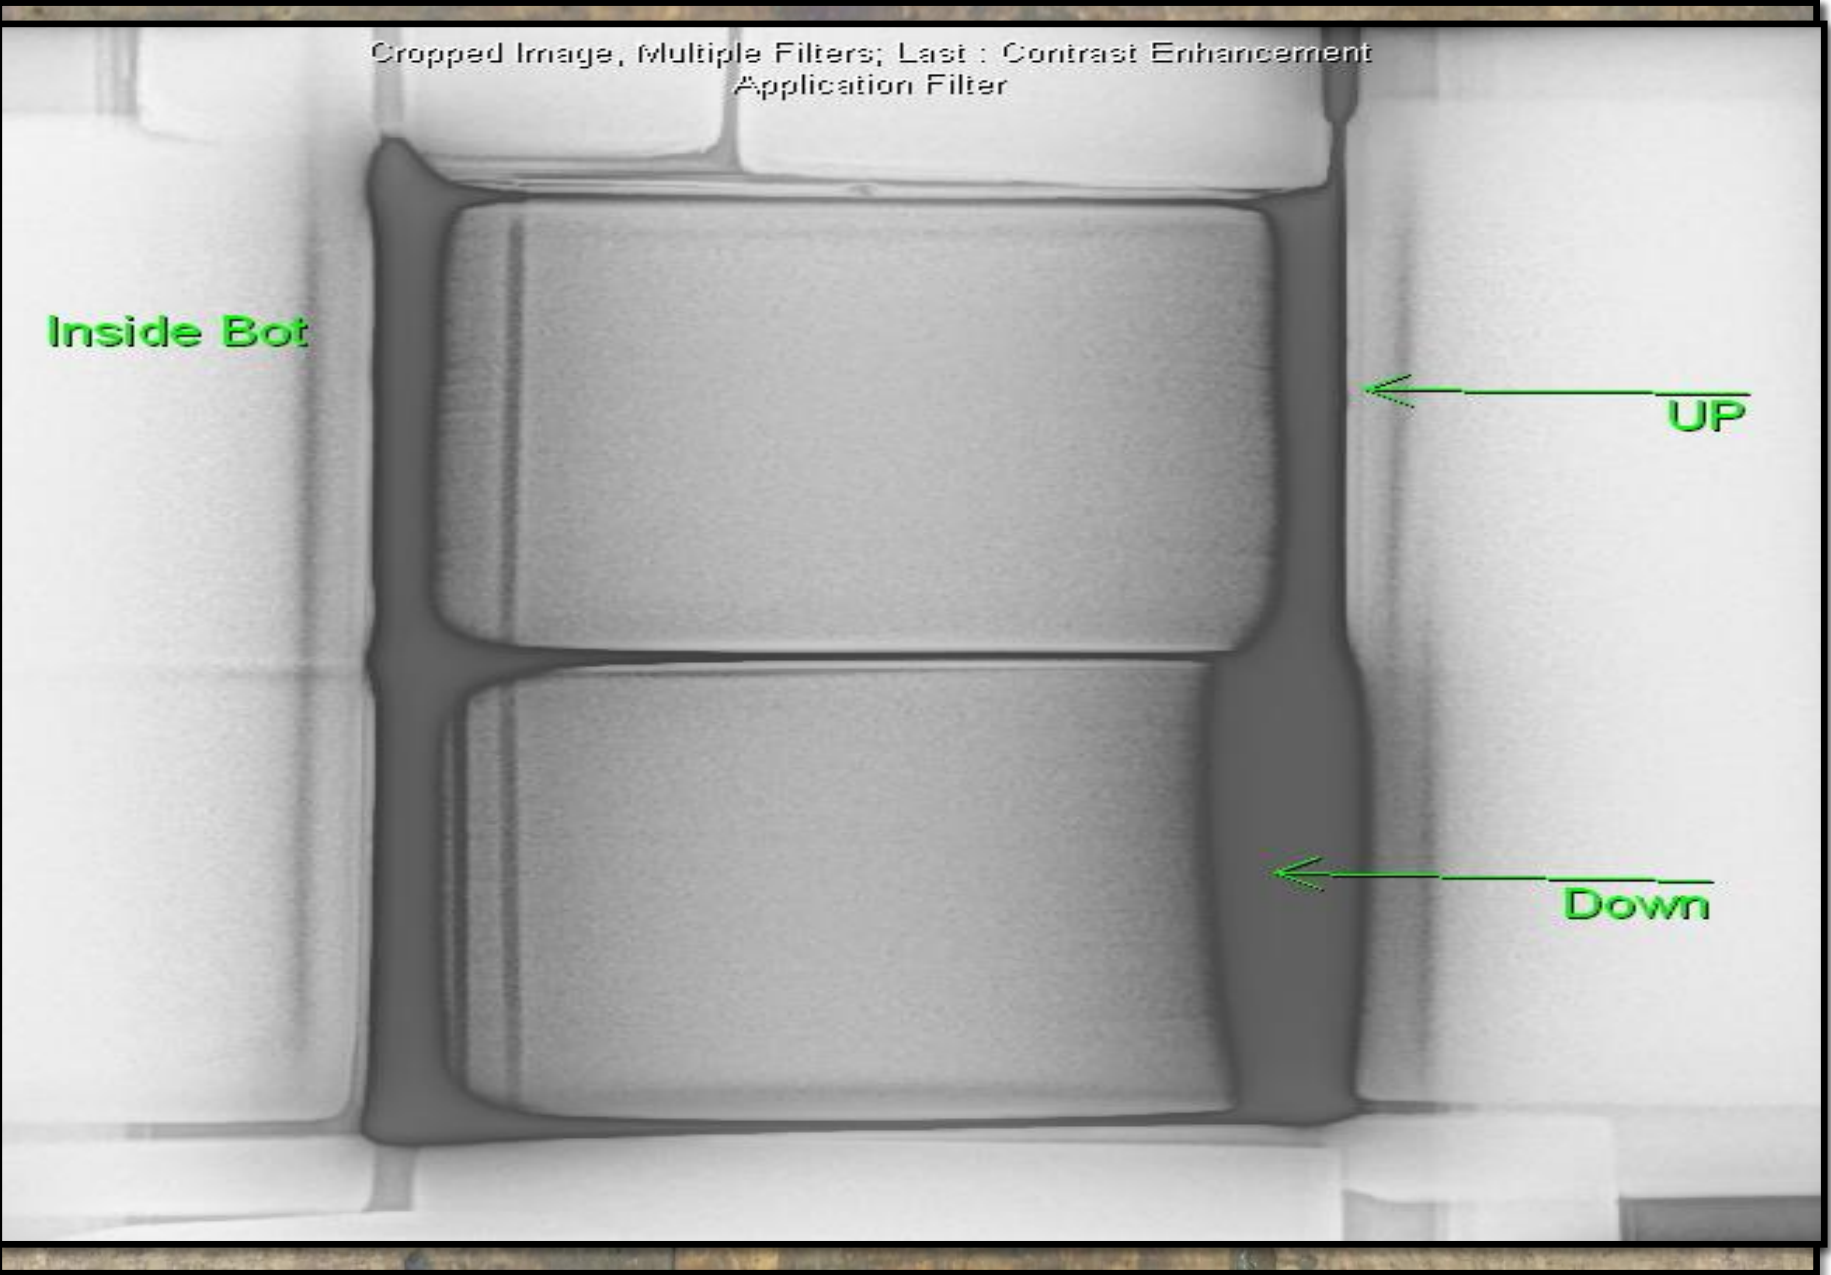
U7-U9 Finding

- 277 members tested. 3 ft. limits each end
 - Zero plug weld indications
- Removed chord scanned prior to delivery to Lehigh. No other plugs present
- 53 additional members identified for full length testing. No defects found.
- Suspected “mechanically filled holes” confirmed that “no welds” present.
- U7-U9 cores tested multiple ways. No evidence of any rejectable defects

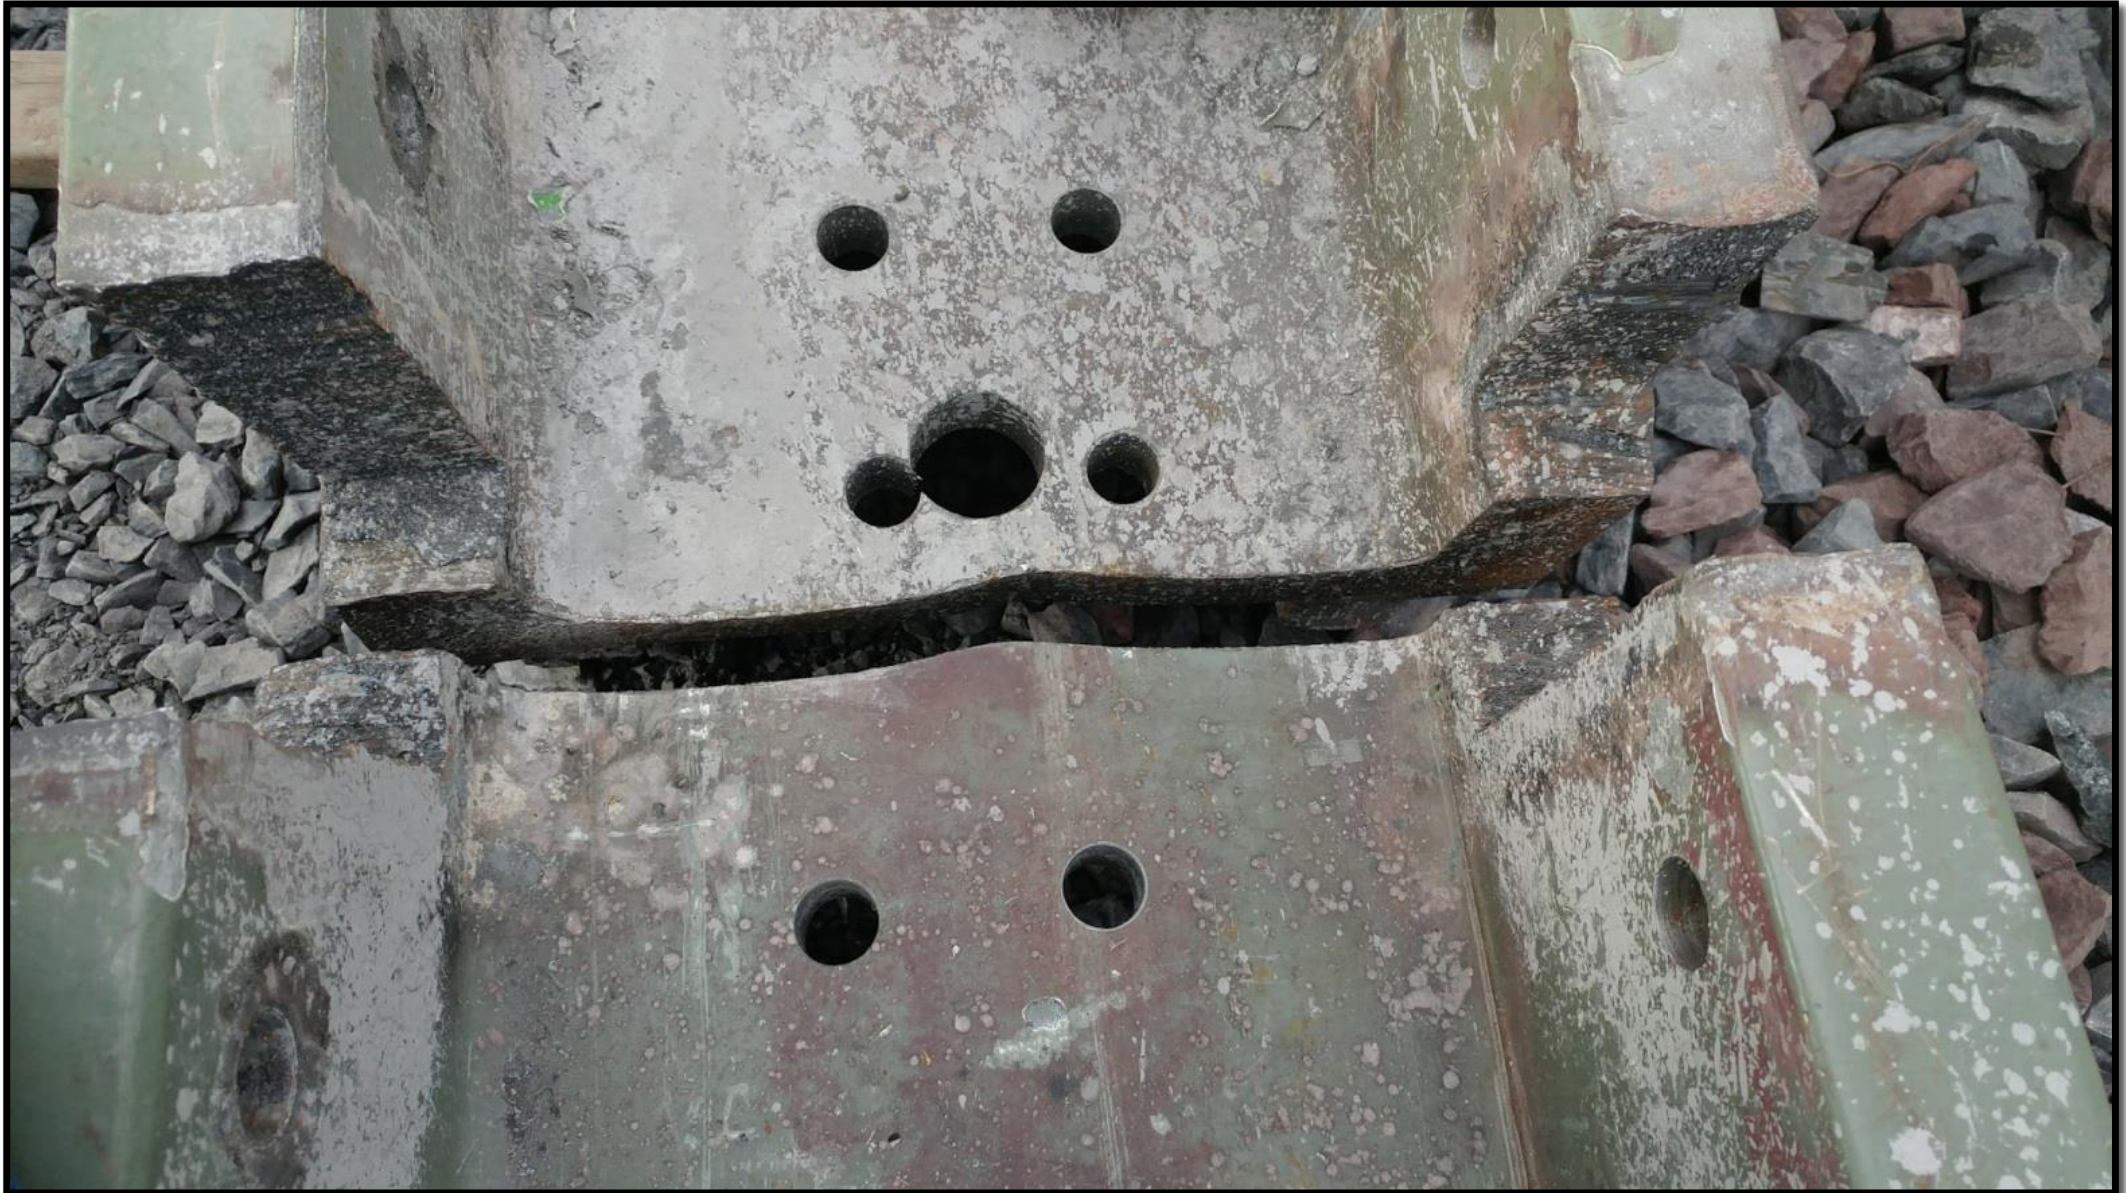
Removal of Fractured Member

- Brittle fracture initiated and propagated from holes repaired/partially filled with weld material.
- No evidence of fatigue damage observed in initiation areas.
- The weld HAZ may have increased the susceptibility to brittle crack initiation.
- Five of six samples tested met the yield and tensile strength requirements.
- Test results indicate the material is as-expected for the era of construction
- Cracking observed along inclusions near the mid-surface of the flange:
 - May have formed during welding or fracture.
 - Oriented perpendicular to the fracture.
