Liberty Bridge Fire Event: Response Evaluation for Jacking Operations and Ratings

ABCD Susquehanna Chapter

Thomas Murphy, Ph.D., P.E.
Andrew Adams, P.E.
Nohemy Galindez, Ph.D., P.E.
Christopher Smith, P.E.

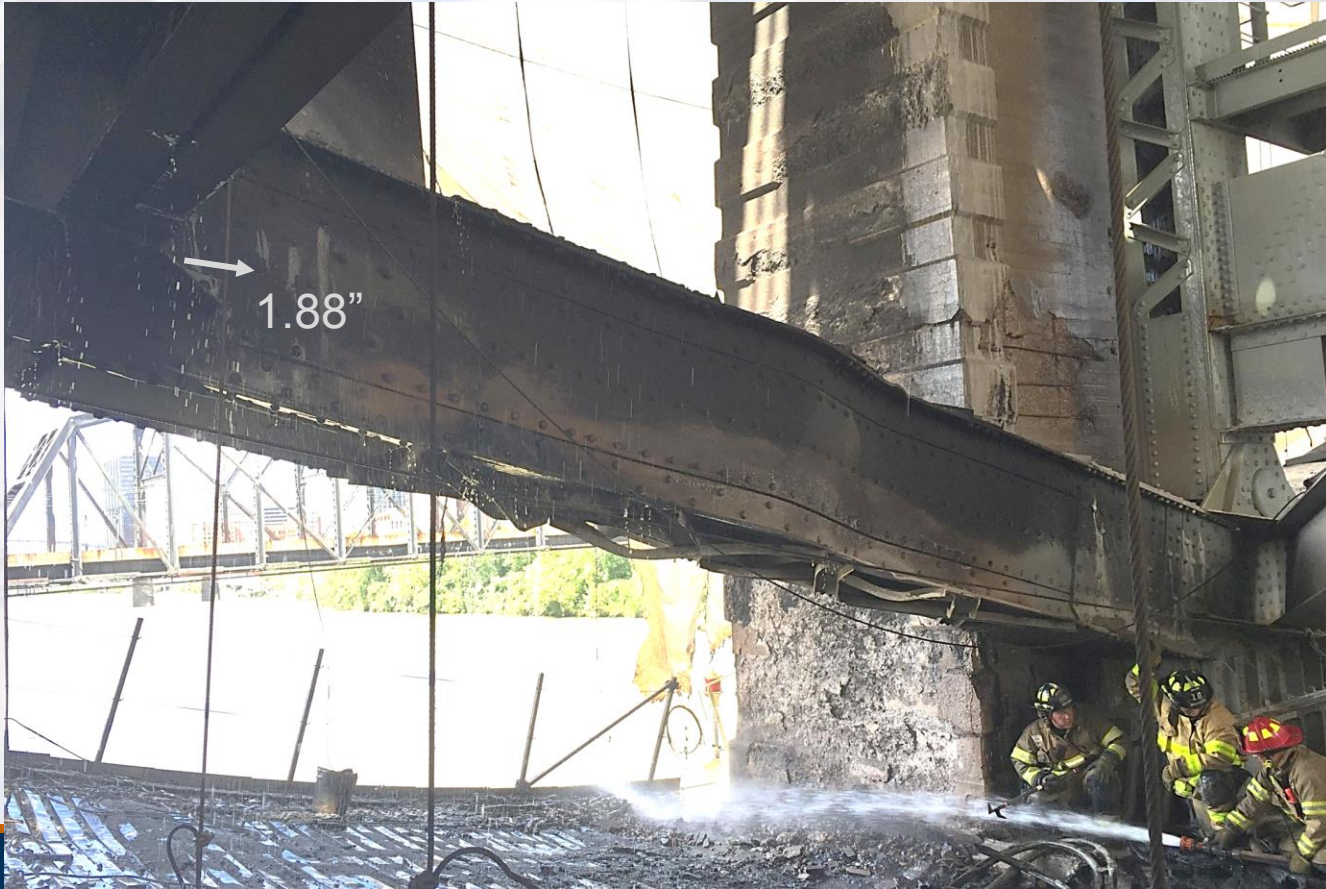
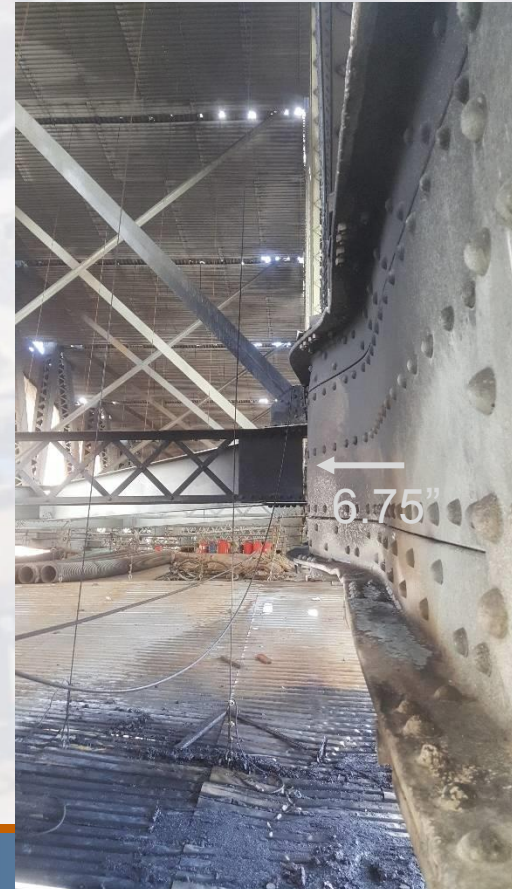
The Fire Damage

- Tasks focused on examining how the rest of the truss was affected by the fire damage to L31L32W
 - Determine ratings factors for post-fire condition
 - Evaluate effectiveness of jacking operations to restore truss to pre-fire condition
 - If truss geometry not fully restored, is the bridge ok? If not, how many repairs required?
 - Provide updated ratings after jacking
 - Post-process field data to update calculations.
 - Determine if safe to reopen the bridge immediately after jacking.

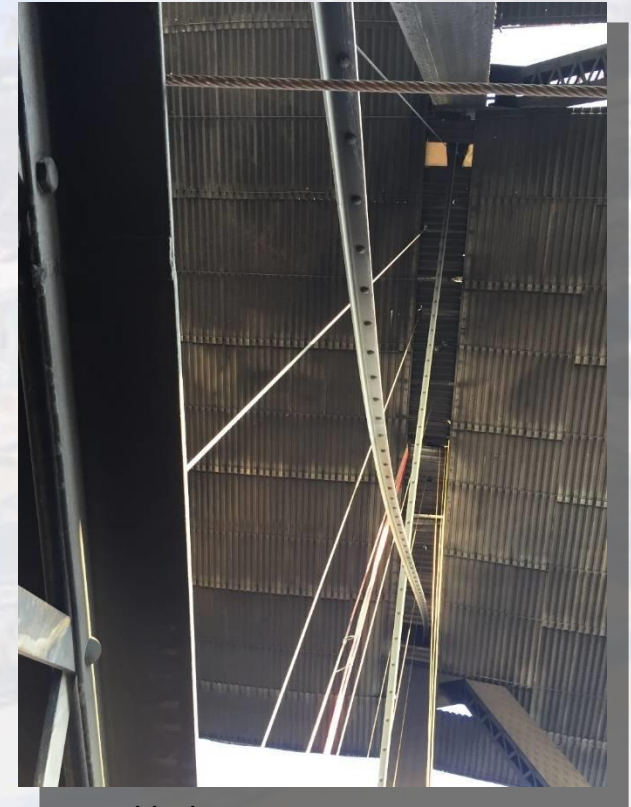
Location	Composite Deck	Non-Composite Deck	Field Observations of Buckling (Visual)
	P/P _{cr}	P/P _{cr}	
PP26	2.47	0.25	
PP27	3.19	0.31	(moderate)
PP28	4.16	0.44	(moderate)
PP29	4.58	0.61	(severe)
PP30	1.62	0.96	
PP31	3.52	0.39	(severe)
PP32	0.36	0.01	
PP33	0.35	0.05	
PP34	1.12	0.00	(minor)
PP35	1.12	0.00	
PP36	0.74	0.00	(minor)
PP37	0.85	0.00	(minor)

Buckled Sway Bracing near Pier 7

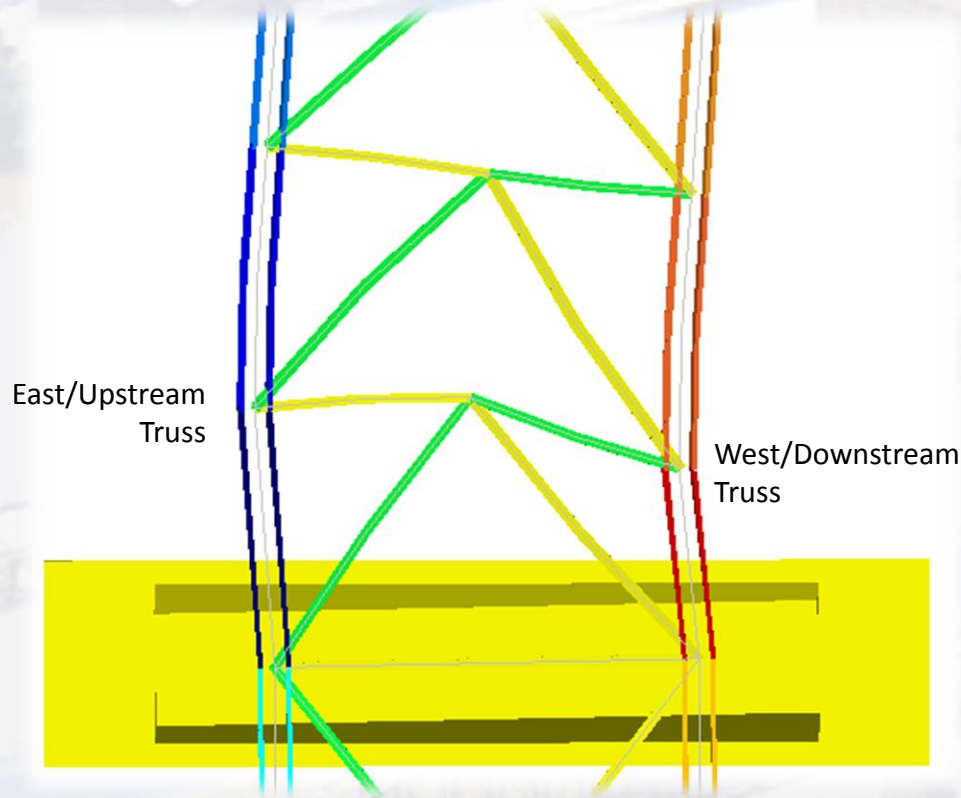
- Exaggerated deformed shape of bottom chords and lower lateral system due to shortening of L31L32W

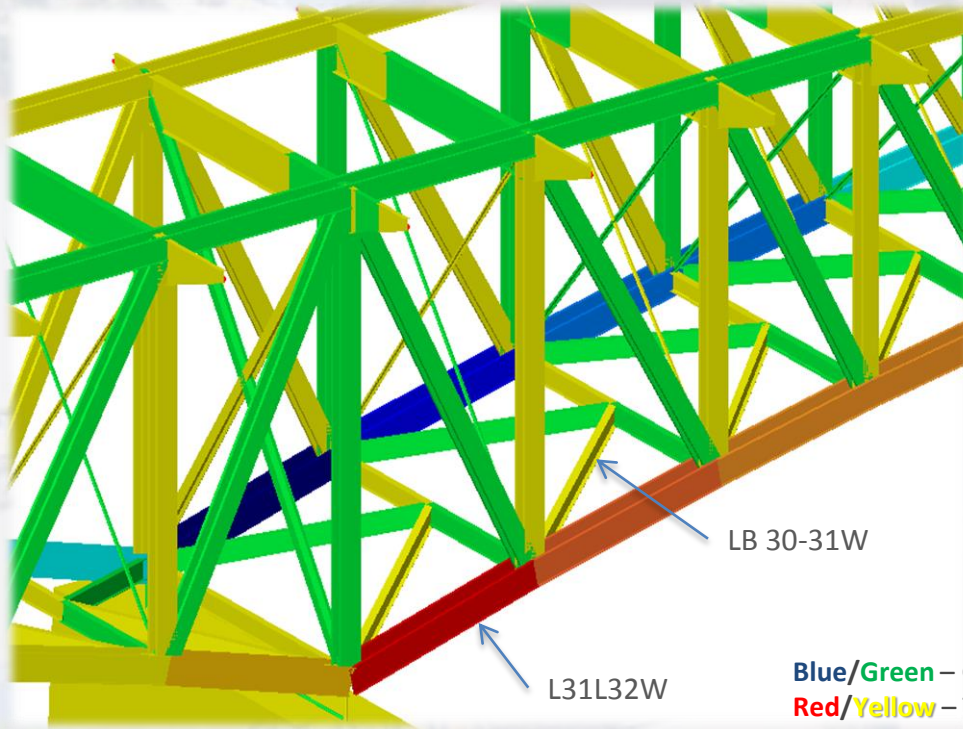
- Change in axial load due to shortening of L31L32W

Estimated Load shift of ~2000 k from West (downstream) truss to East (upstream) truss
