# Birmingham Bridge Preservation

Ahmad K. Ahmadi, PE, PhD, SAI Consulting Engineers, Pittsburgh, PA

# Birmingham Bridge – Features

# Birmingham Bridge – Scope

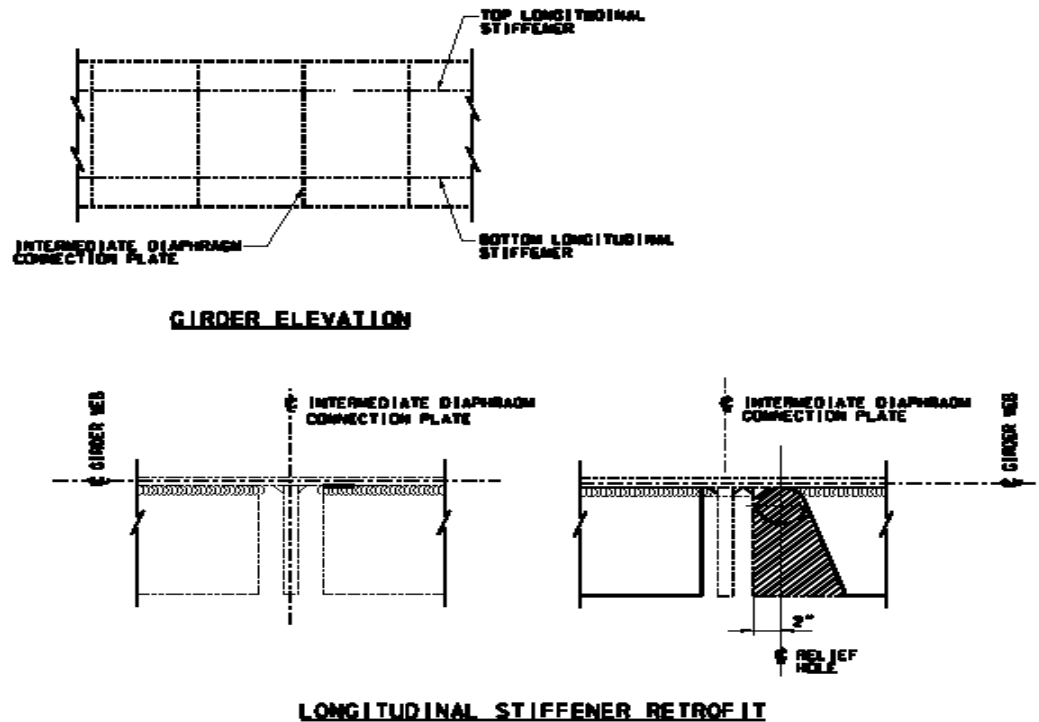
# Longitudinal Stiffener retrofit

Cracked Longitudinal Stiffener's weld  
Welds spacing  $\leq 1/4"$

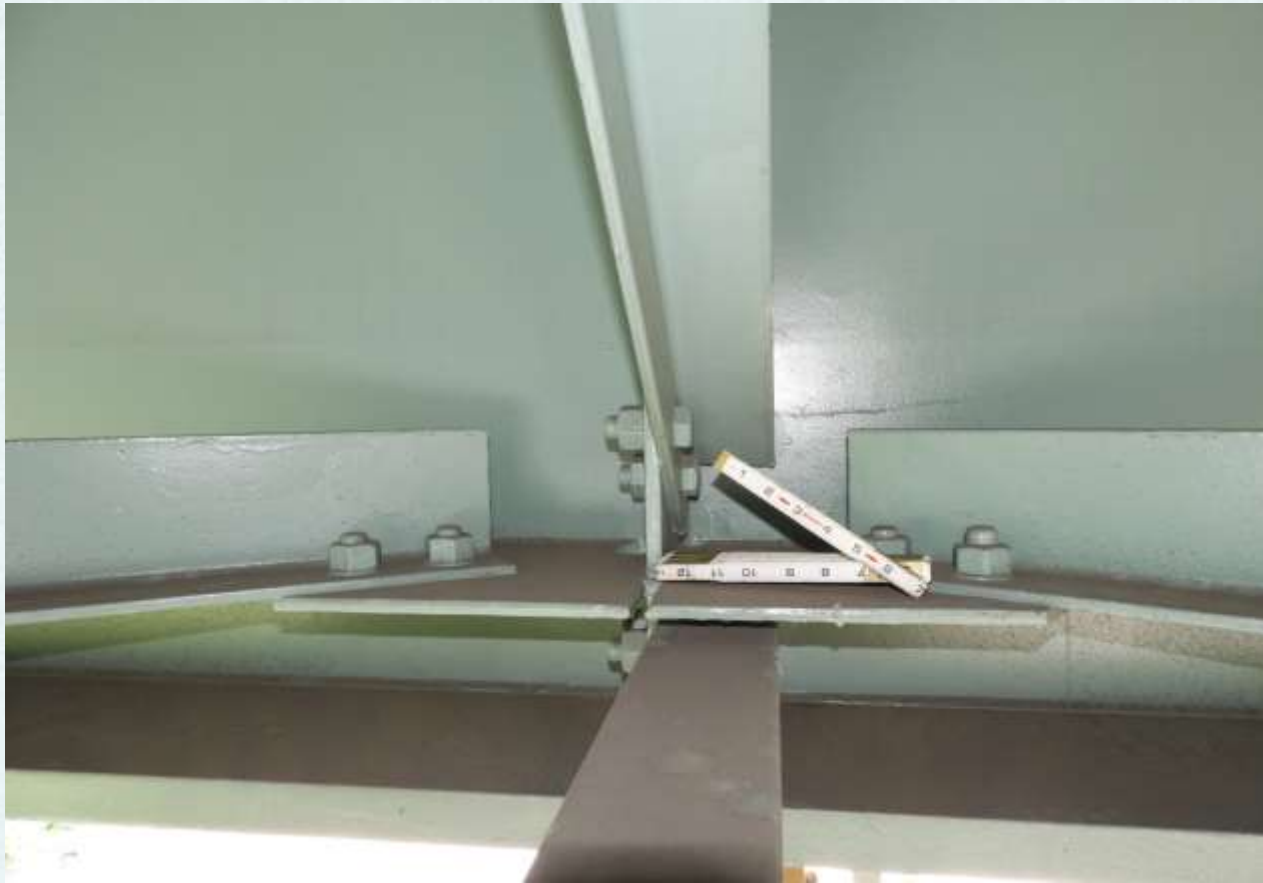
# Lateral Bracing (Hoan detail) Retrofit

Welds spacing  $\leq 1/4$ "

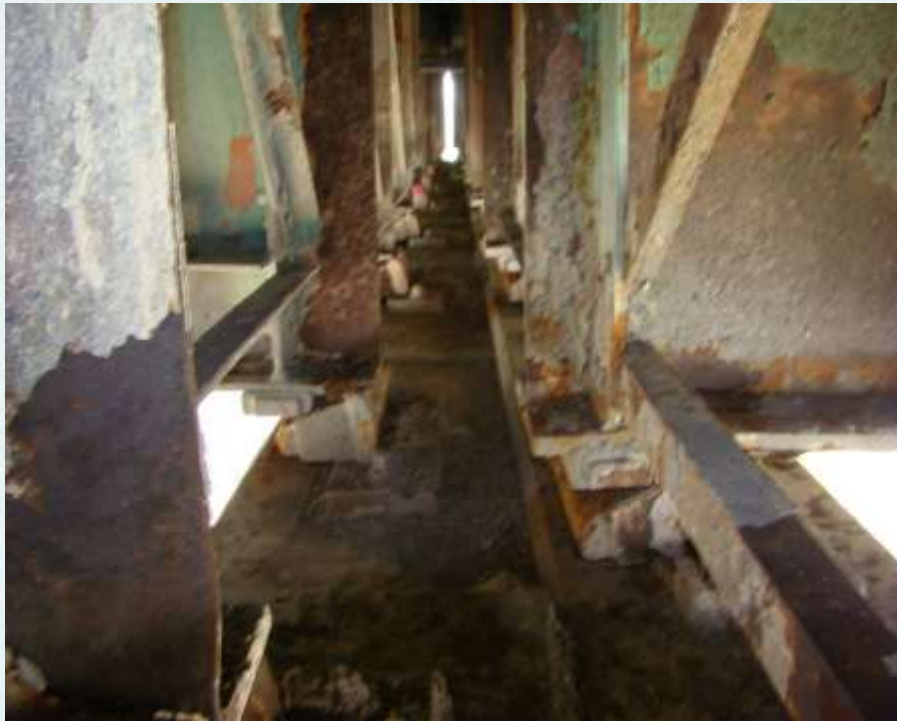
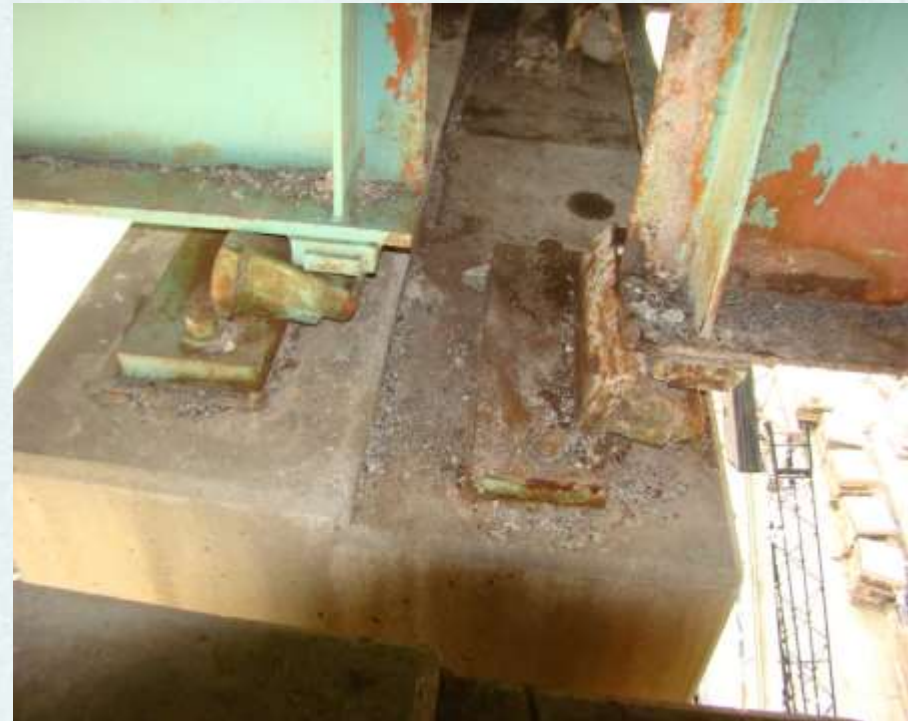
# Bearing Replacement

Total of 222 bearings including:

155 neoprene bearings, 23 pot bearings, 22 metal sliding bearings, 20 disc, and 2 spherical bearings

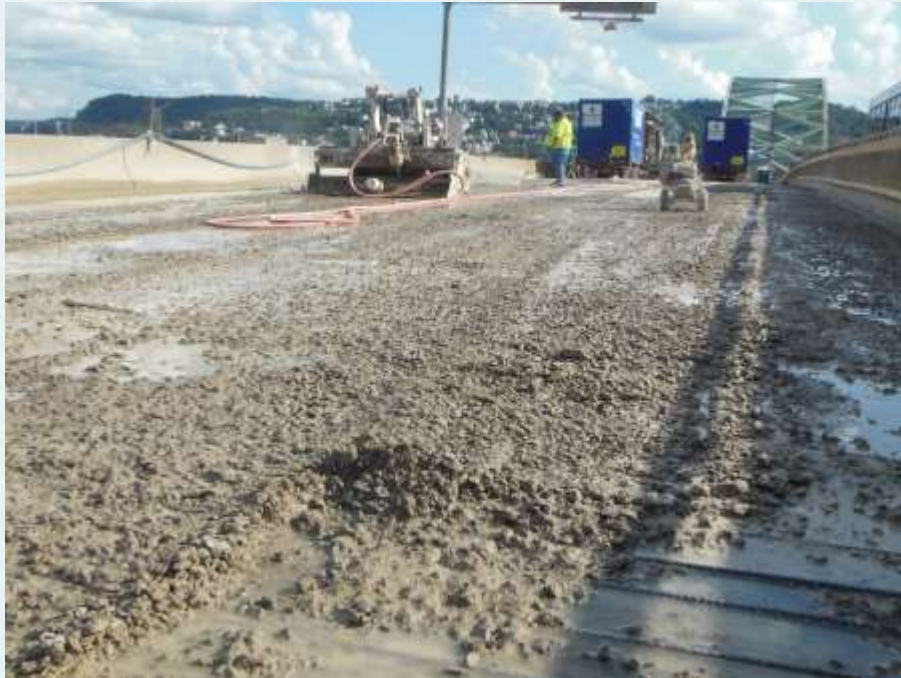
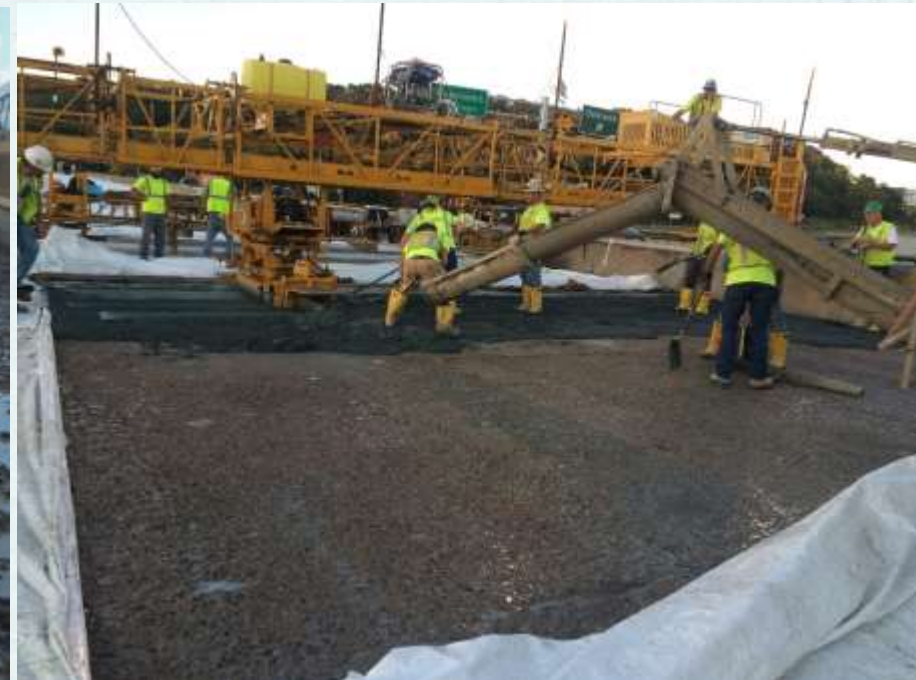
# Hydro Demolition and LMC

1" milling

Hydro demolition to prepare deck surface

1 1/4" latex modified concrete

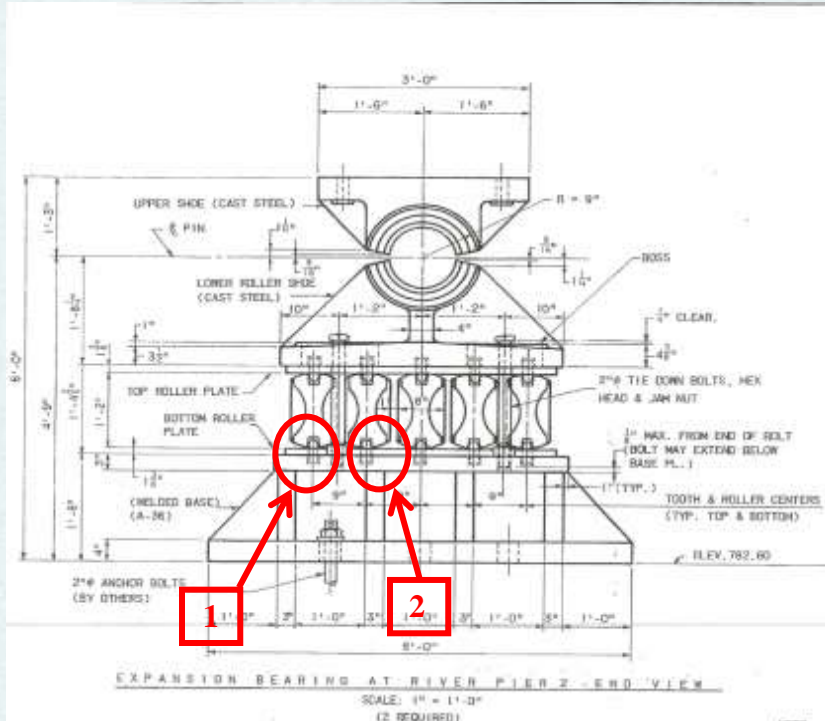
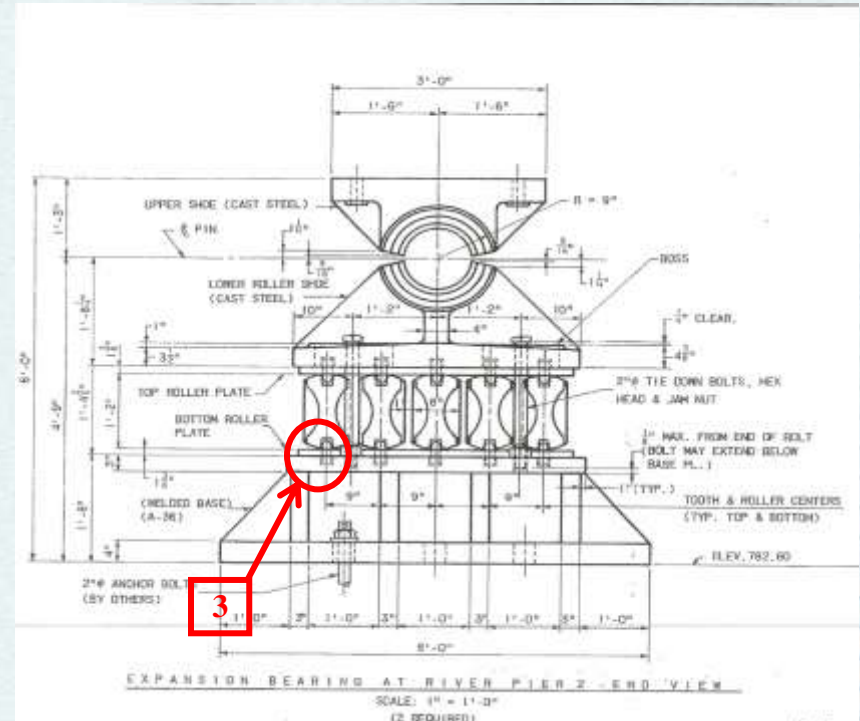
# Downstream Bearing

1. Previous inspection reports indicated tooth lifted. Cracked during construction
2. Previous inspection reports indicated tooth lifted. Cracked during construction
3. Tooth lifted during construction

Decision was to replace the existing bearings with new bearings.

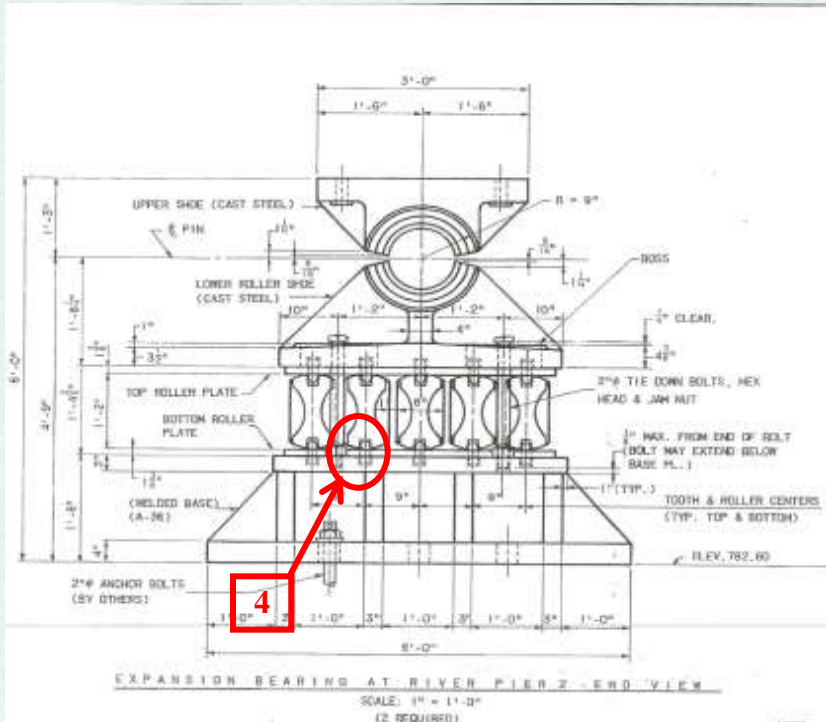
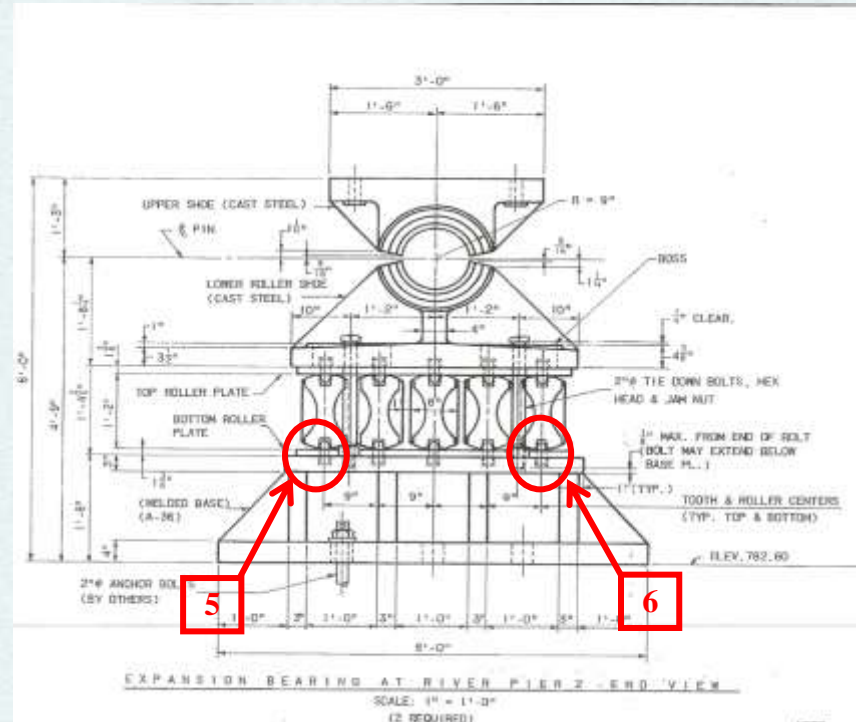
# Upstream Bearing

- 4. Tooth lifted during construction
- 5. Previous reports indicated tooth cracked
- 6. Tooth rotated during construction

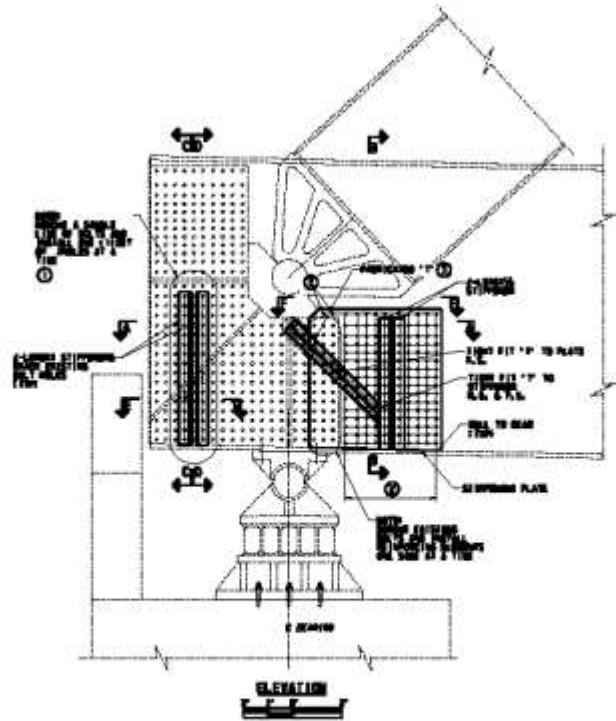
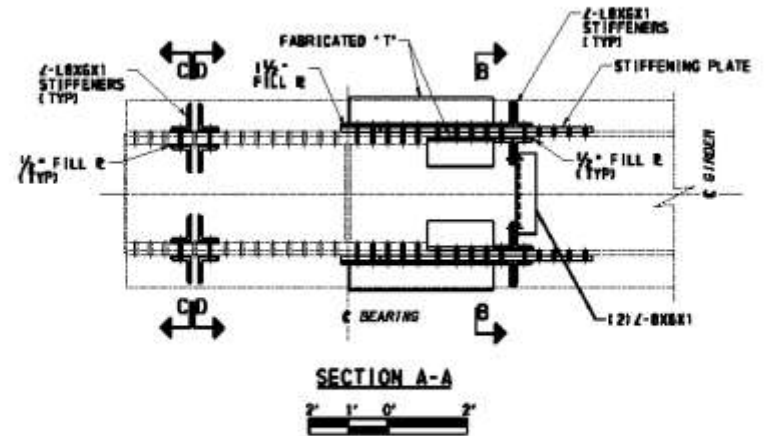
# Strengthening Plan

Elevation

Plan

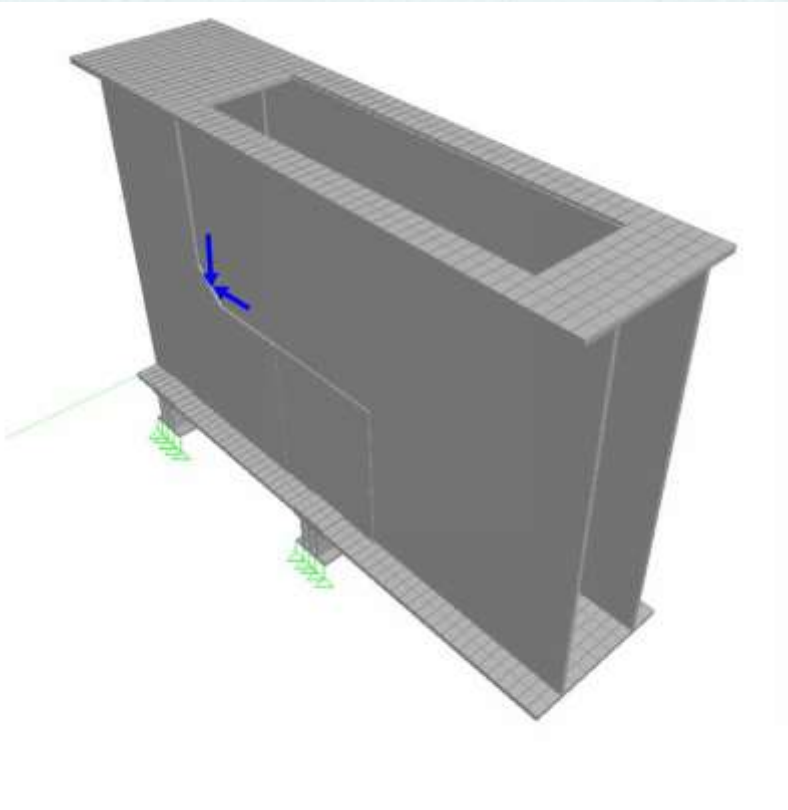
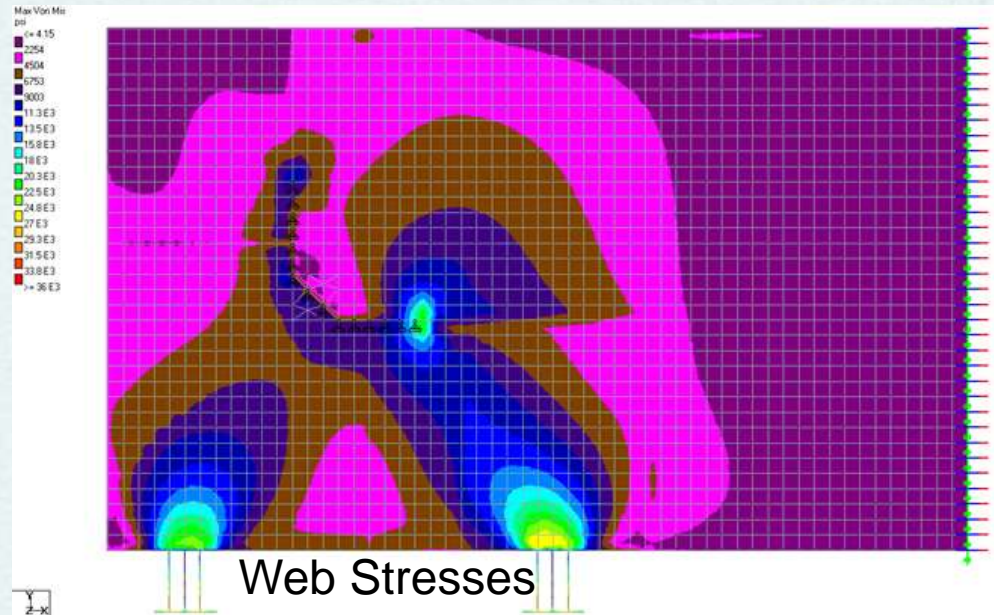
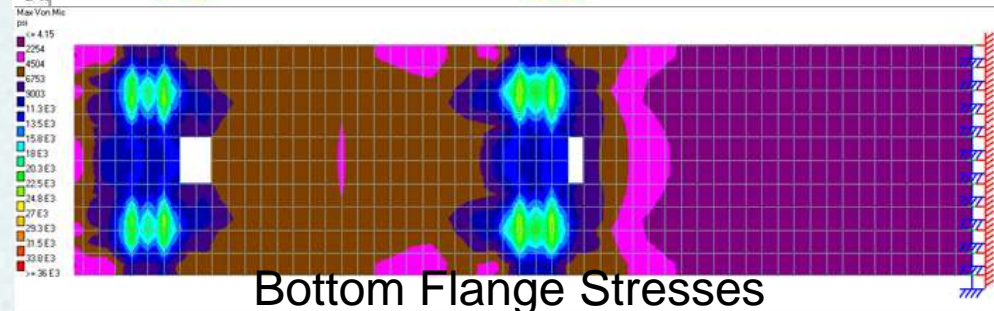
# Analysis: Finite Element Model, Web and Flange Stresses

Tie-Girder End

- Bearing Reaction : 5500 Kips

Web Stresses

Bottom Flange Stresses

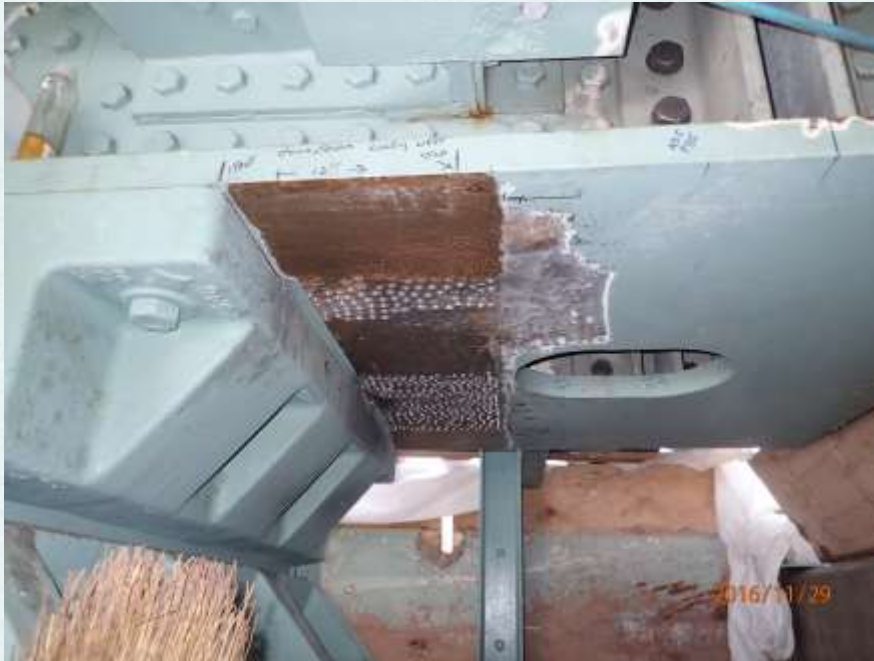
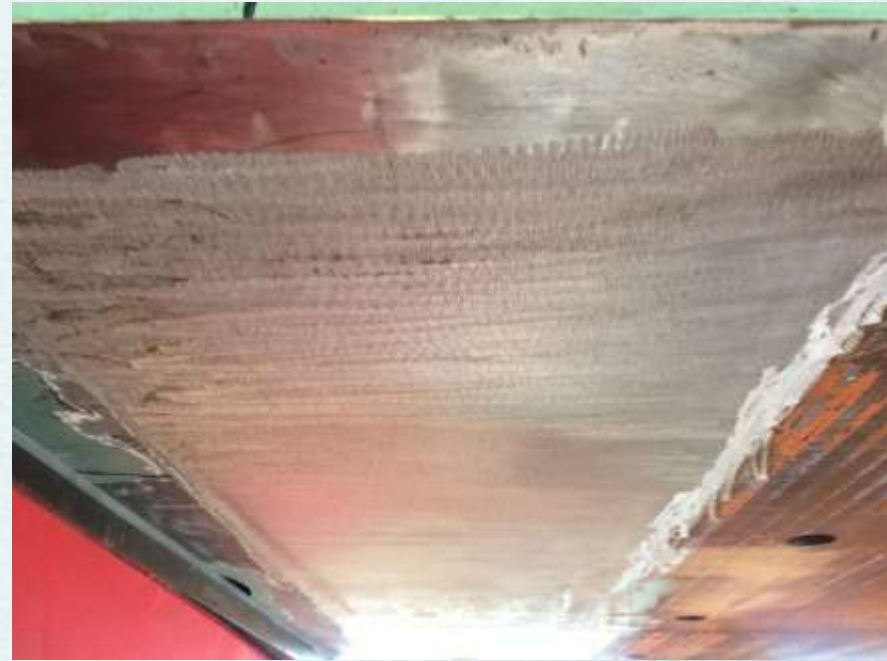
# Bottom Flange Surface Preparation

Bottom of flange was not “flat” (had approximately max.  $\frac{1}{4}$ ” belly):

- New sole plate is longer; bottom flange machined in the field.
- At the temporary jacking locations, “lead plates” were used.

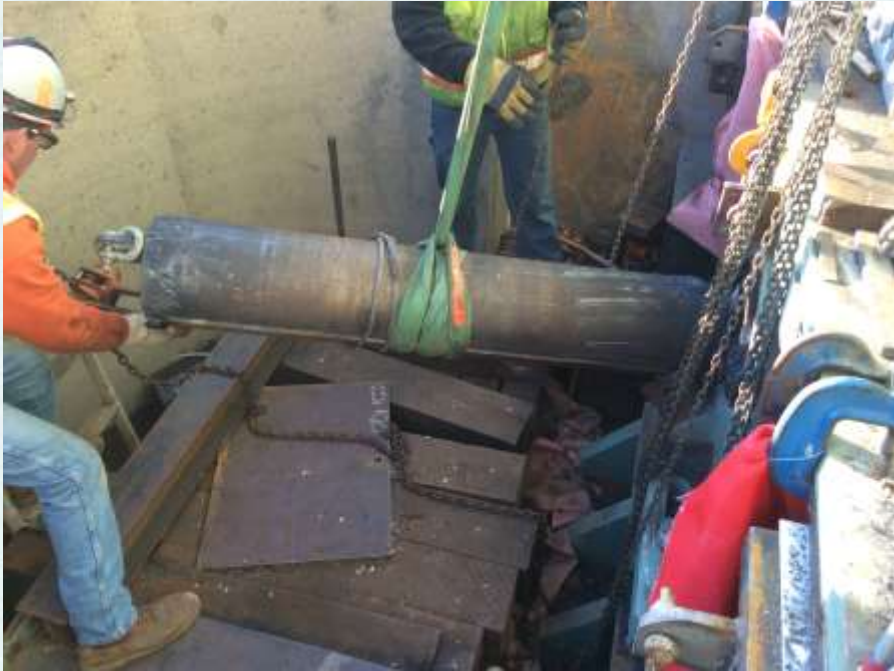
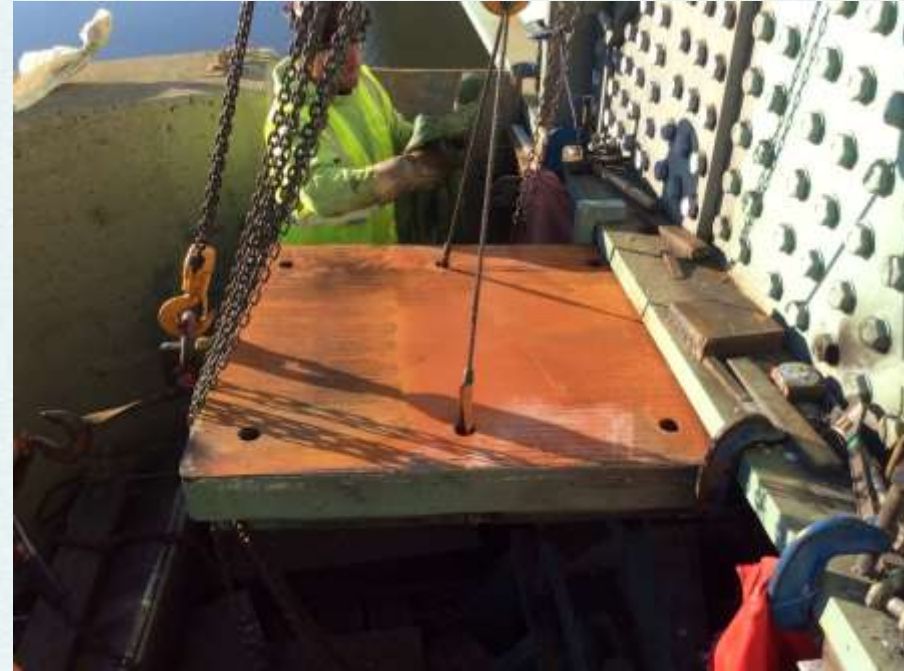
# Disassembly and Removal of Bearings

Pin Removal

Existing Bearing Removal

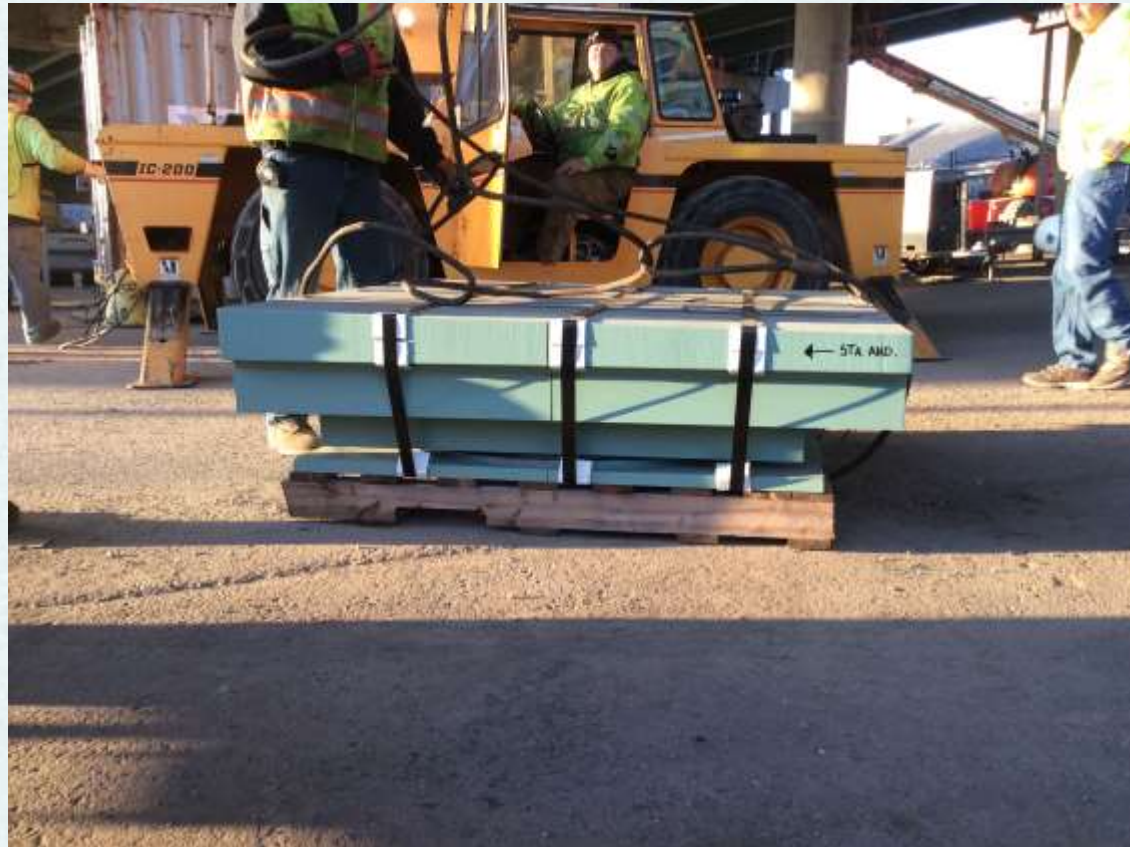
# Spherical Bearing

- Bearing Designed for 5500 Kips
