**ABCD Susquehanna Chapter
2014 Technical Conference**

**Holtwood Expansion Project
PPL Holtwood, LLC.**

**Cofferdam Design and Construction
(and Destruction)**

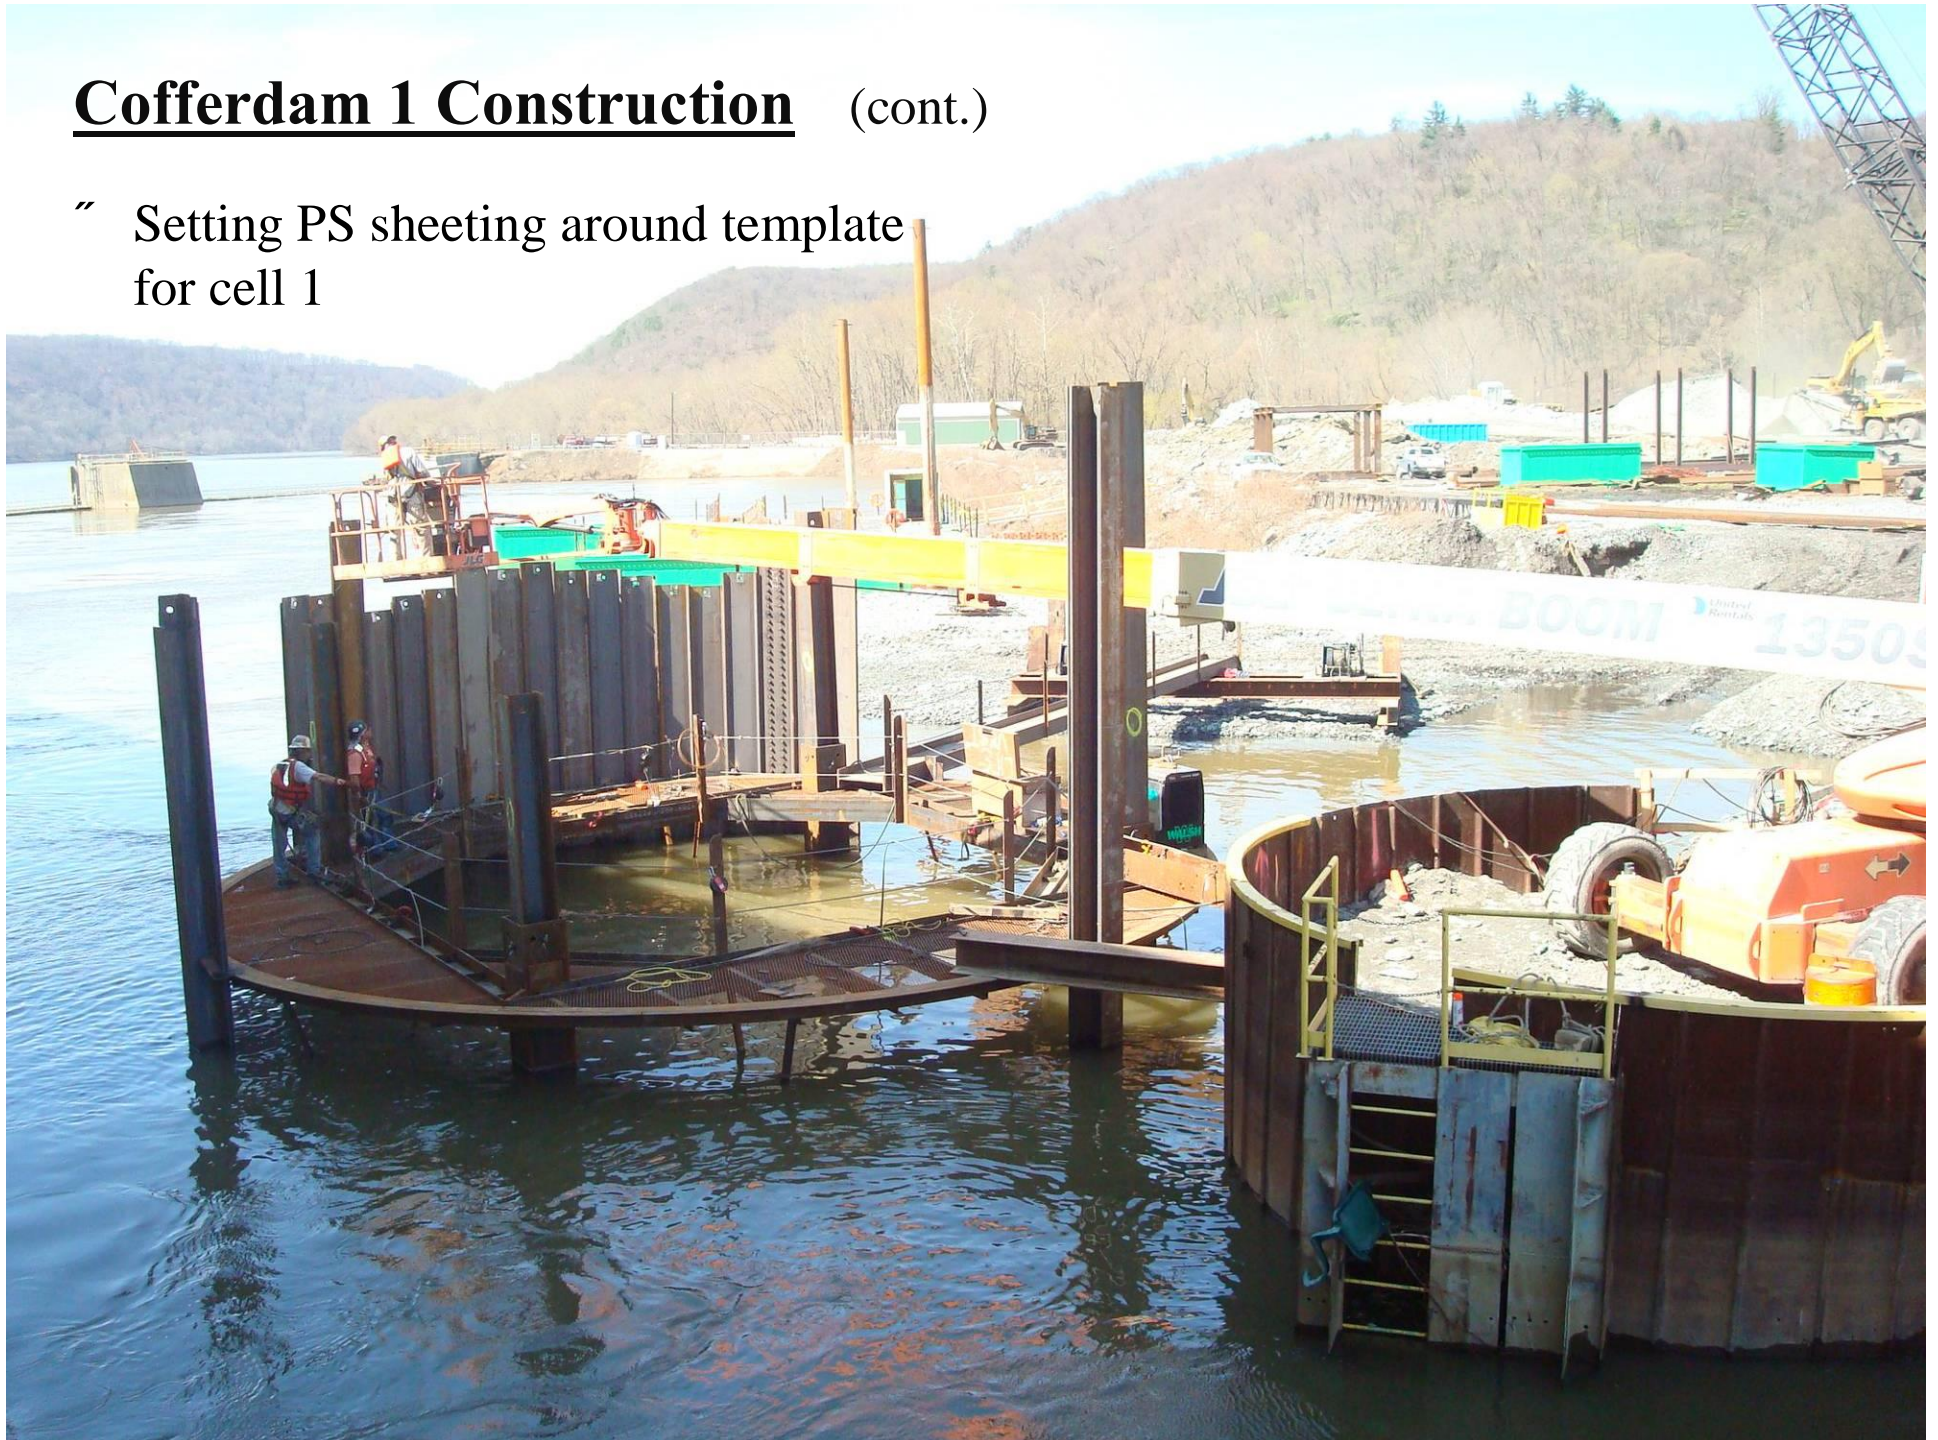
Cofferdam 1 Construction (cont.)

” Setting PS sheeting around template for cell 1

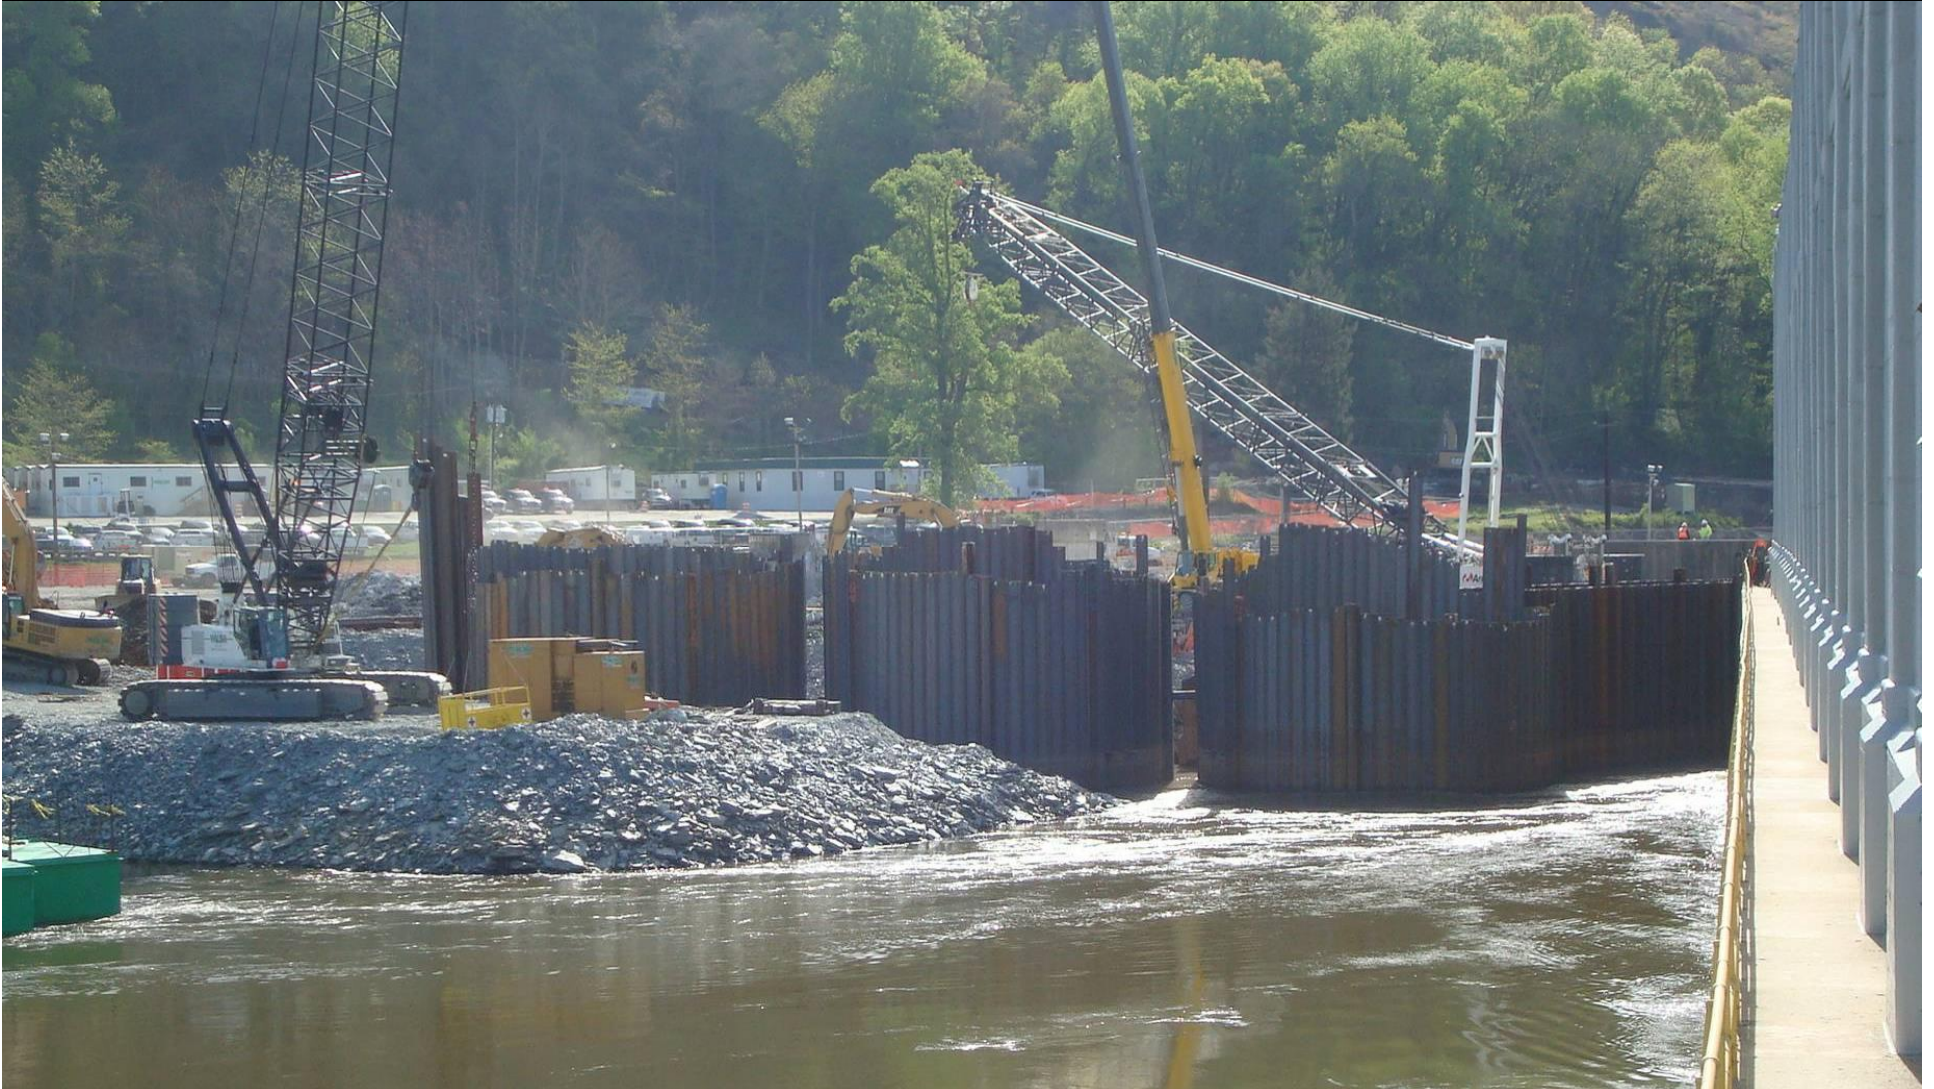
Cofferdam 1 Construction (cont.)

- “ All sheets in place for the three cells
- “ Cells constructed in a trench that was blasted/excavated into existing rock

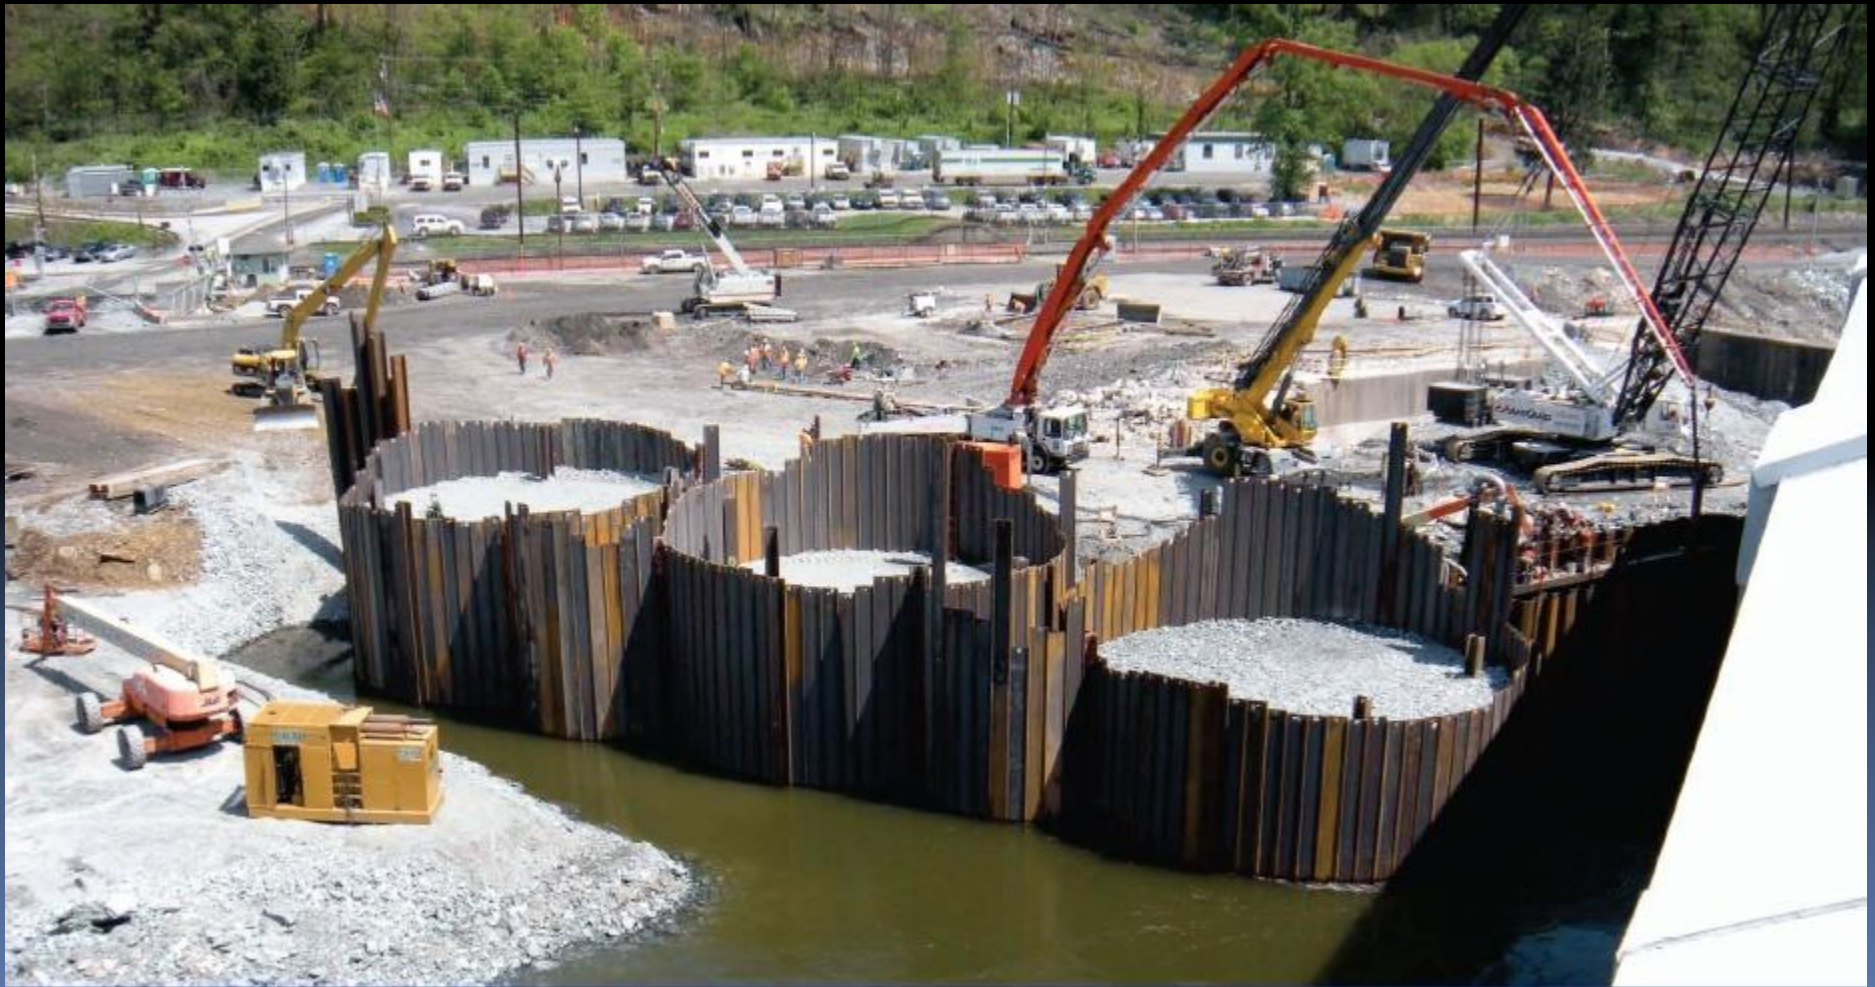
Cofferdam 1 Construction (cont.)

- “ Cells partially filled with stone
- “ Upstream diaphragm sheets placed
- “ Placing concrete in closure wall (discussed in next couple slides)
- “ Beginning to construct earthen cofferdam which ties into the end of cell 3

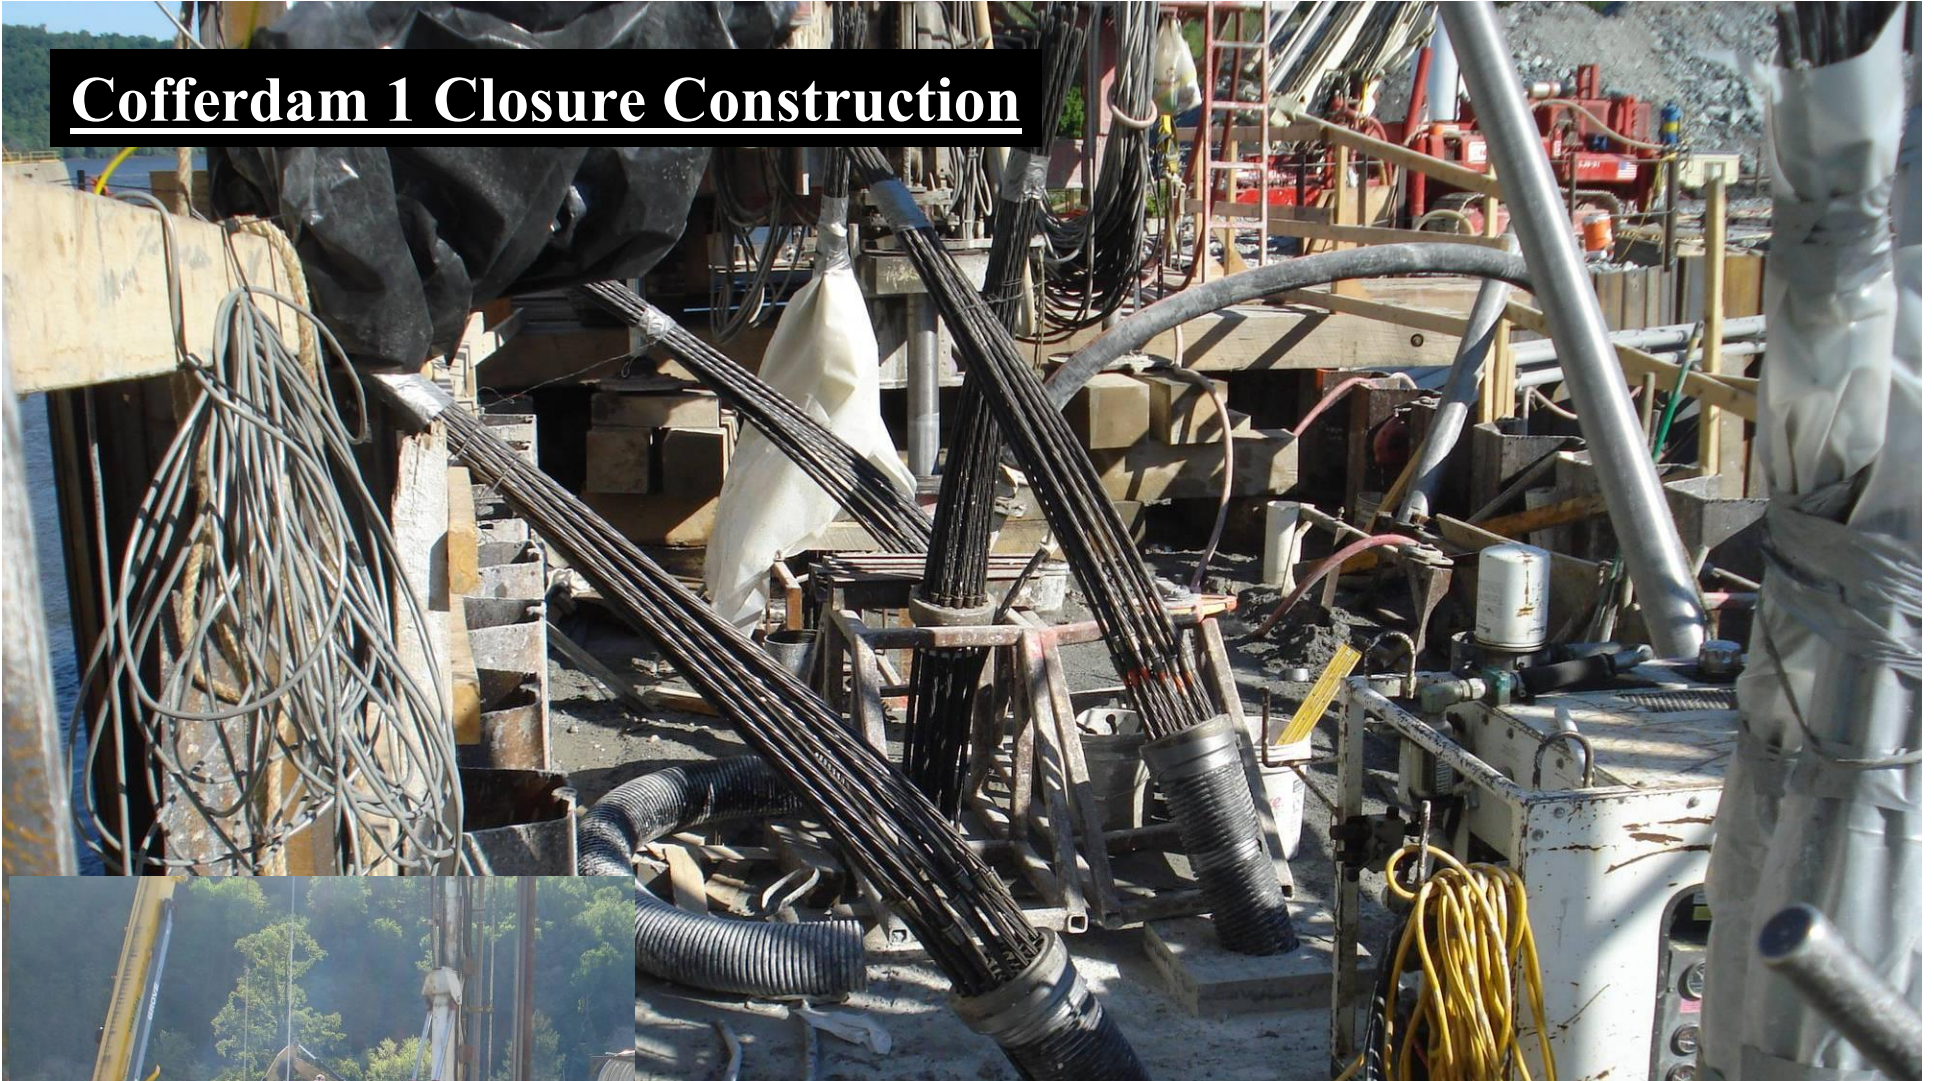
Cofferdam 1 Closure Construction

- ” Strand anchors installed 53ø into rock, prior to tensioning
- ” After tensioning, a concrete cap was poured over the anchor heads to provide a smooth walking surface, because this cofferdam became the only access into the existing powerhouse during construction

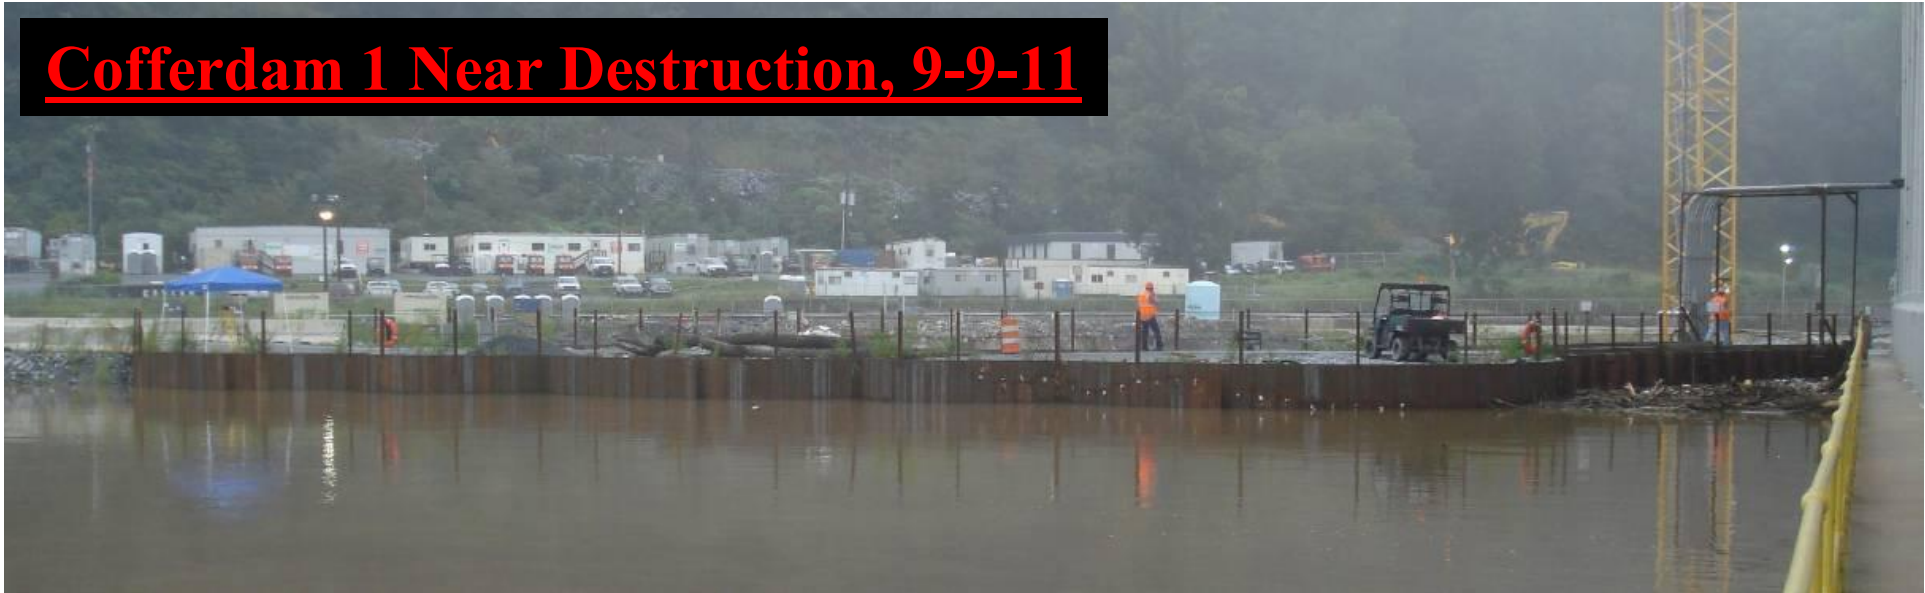
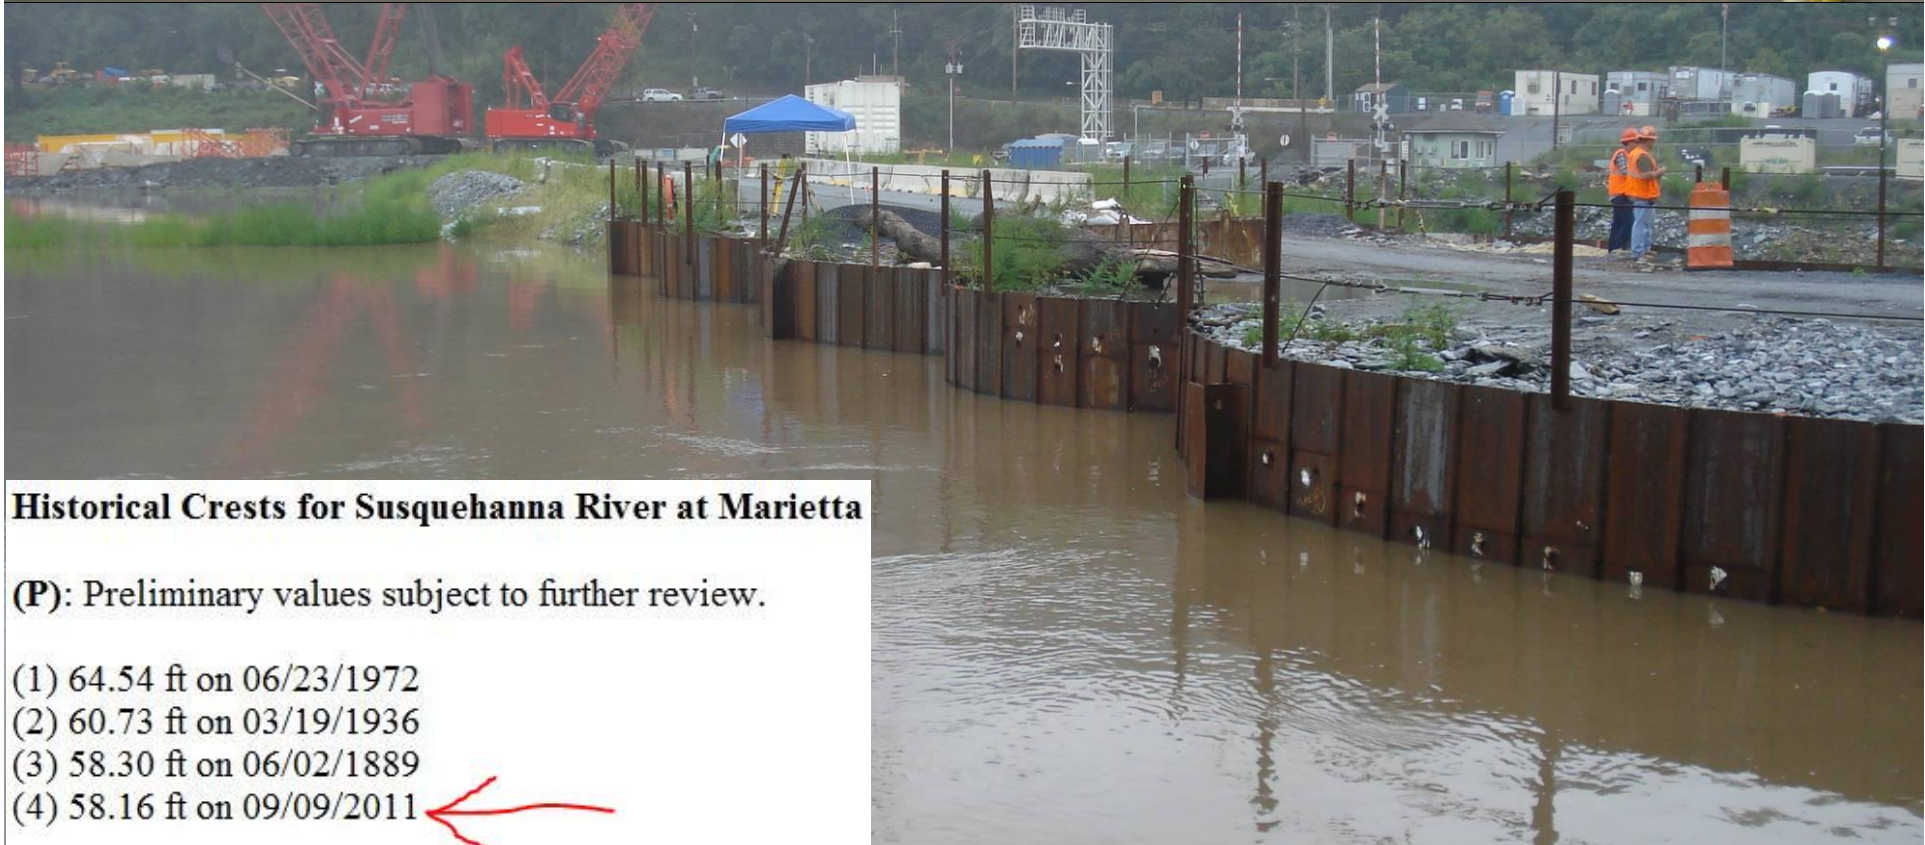
Cofferdam 1 Near Destruction, 9-9-11

- (1) 64.54 ft on 06/23/1972
- (2) 60.73 ft on 03/19/1936
- (3) 58.30 ft on 06/02/1889
- (4) 58.16 ft on 09/09/2011

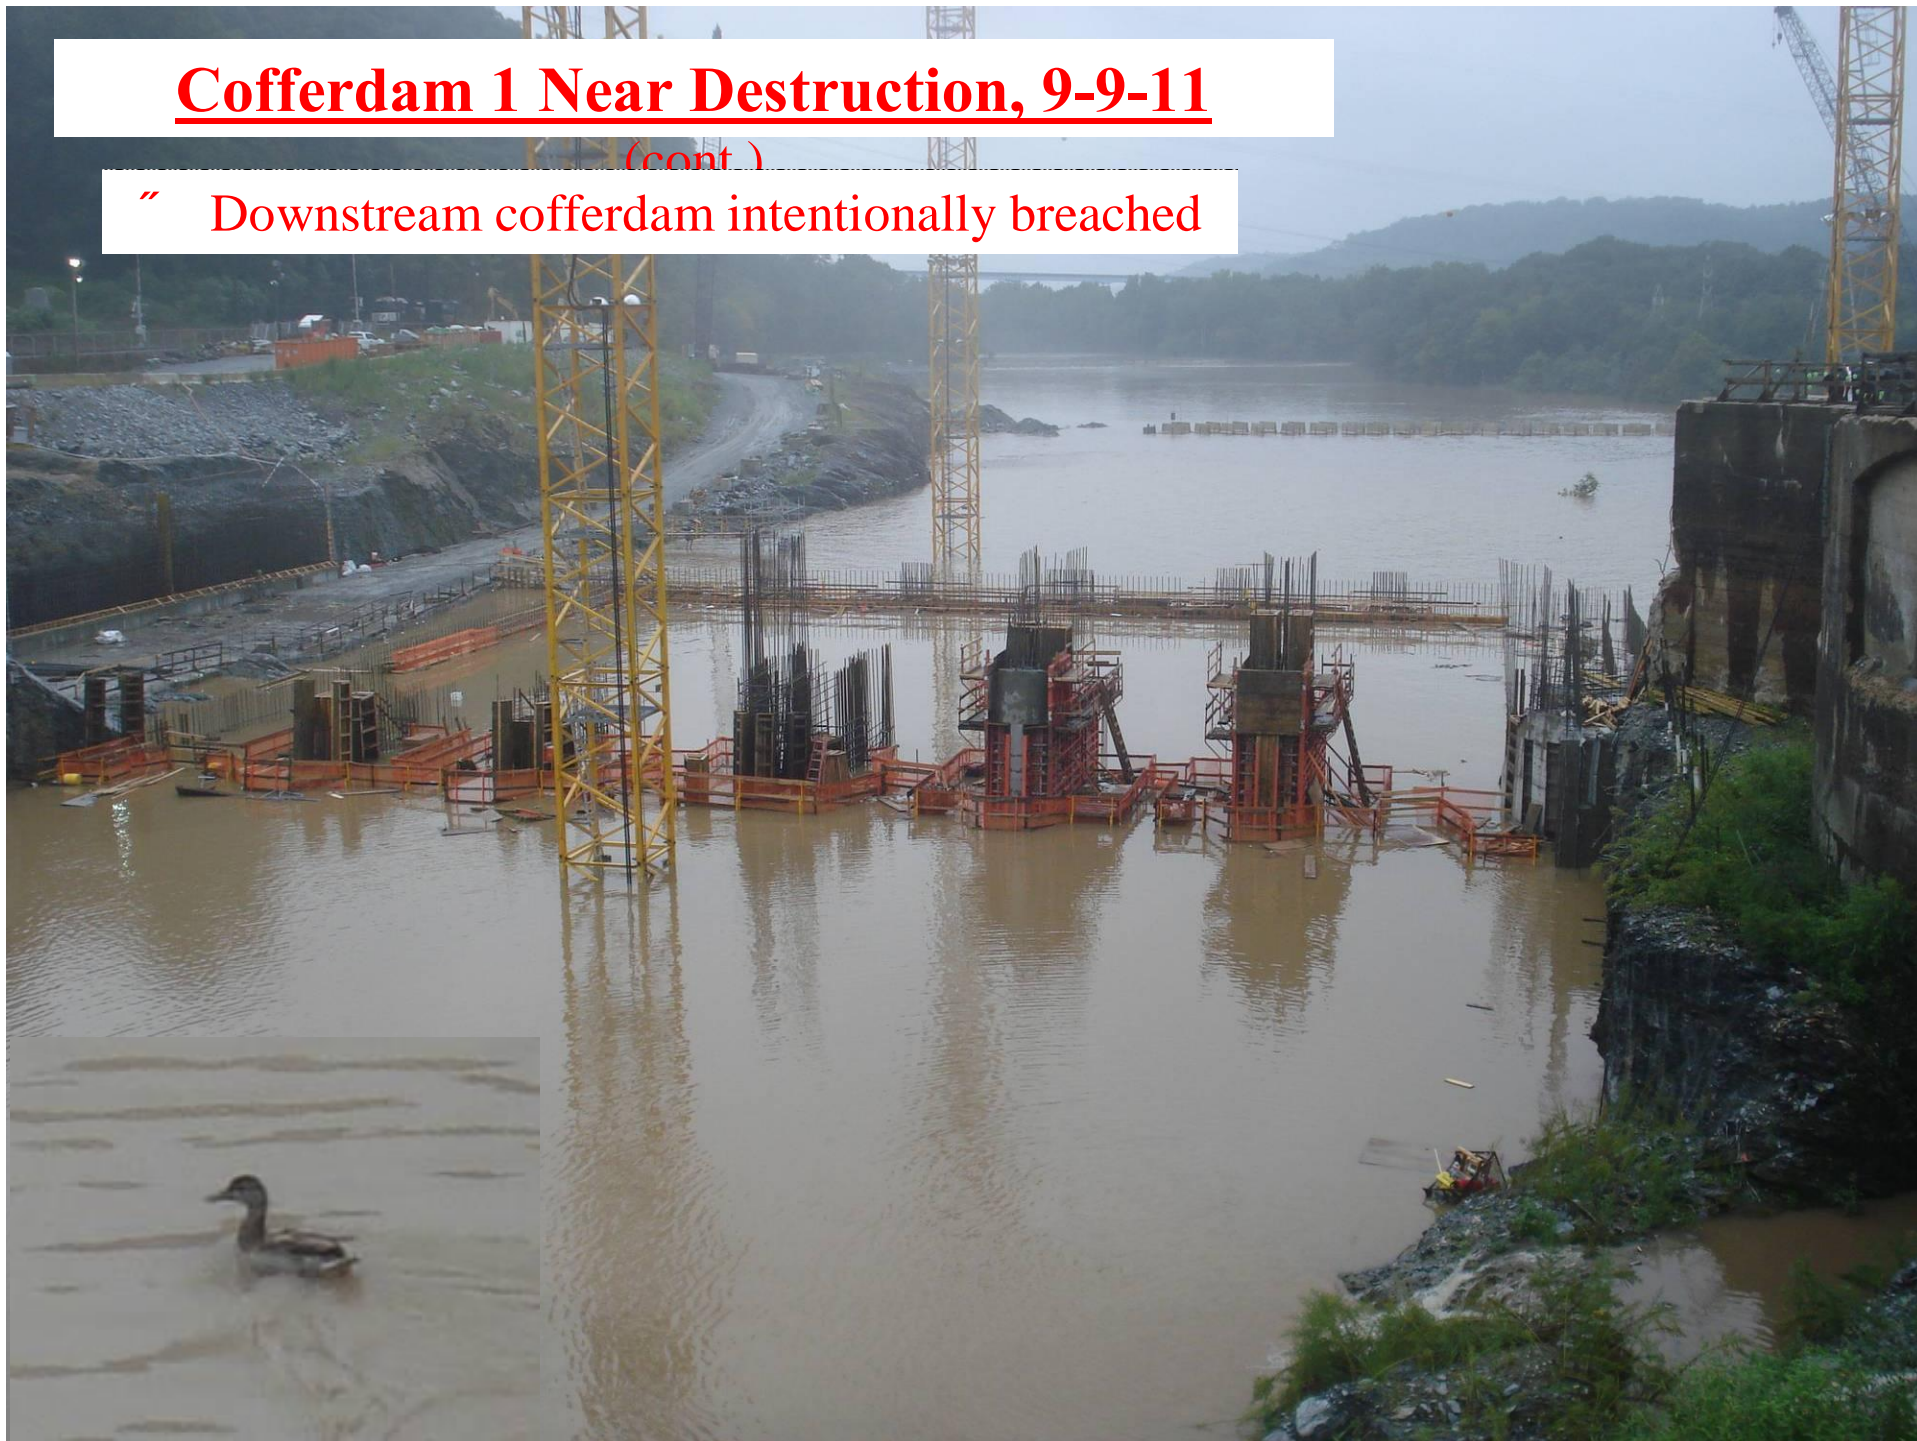
Cofferdam 1 Near Destruction, 9-9-11

“ Downstream cofferdam intentionally breached

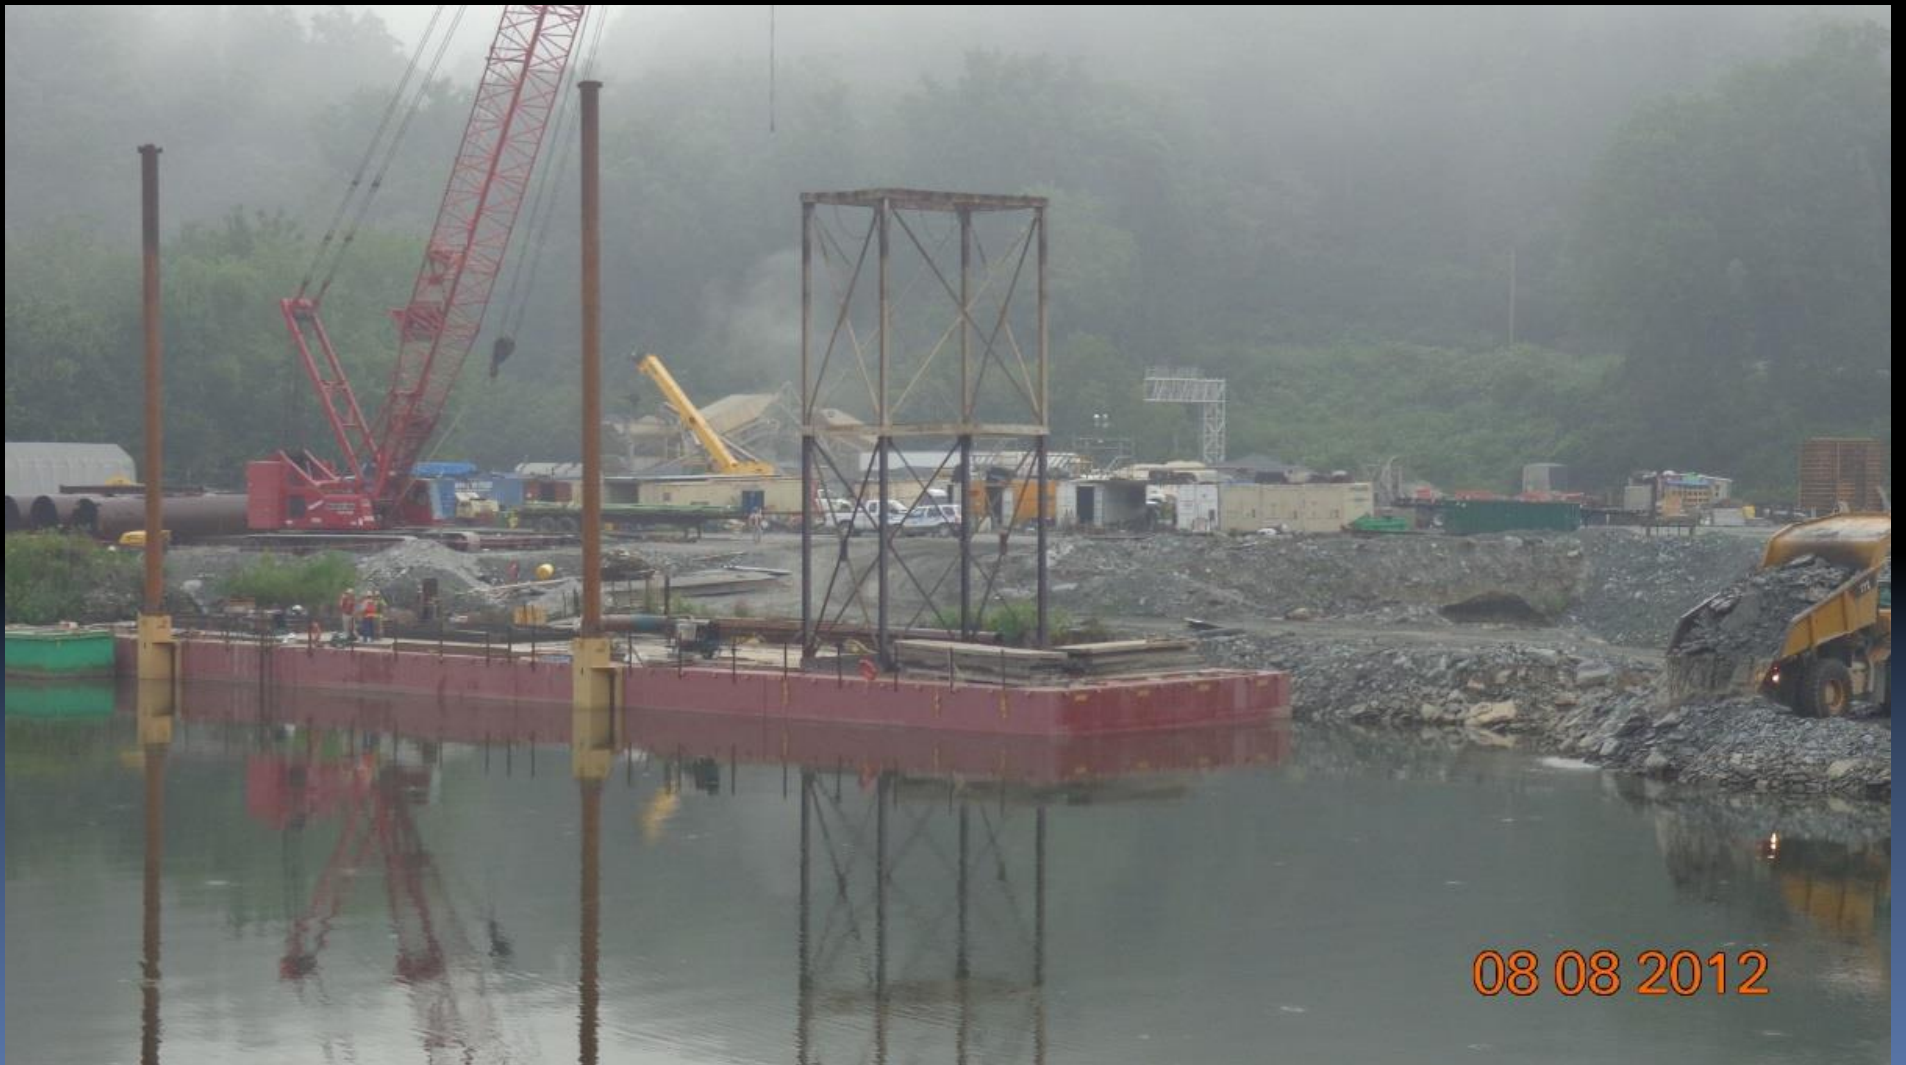
Cofferdam 3 Construction

“ Internal frames stood 50ø tall when full assembled

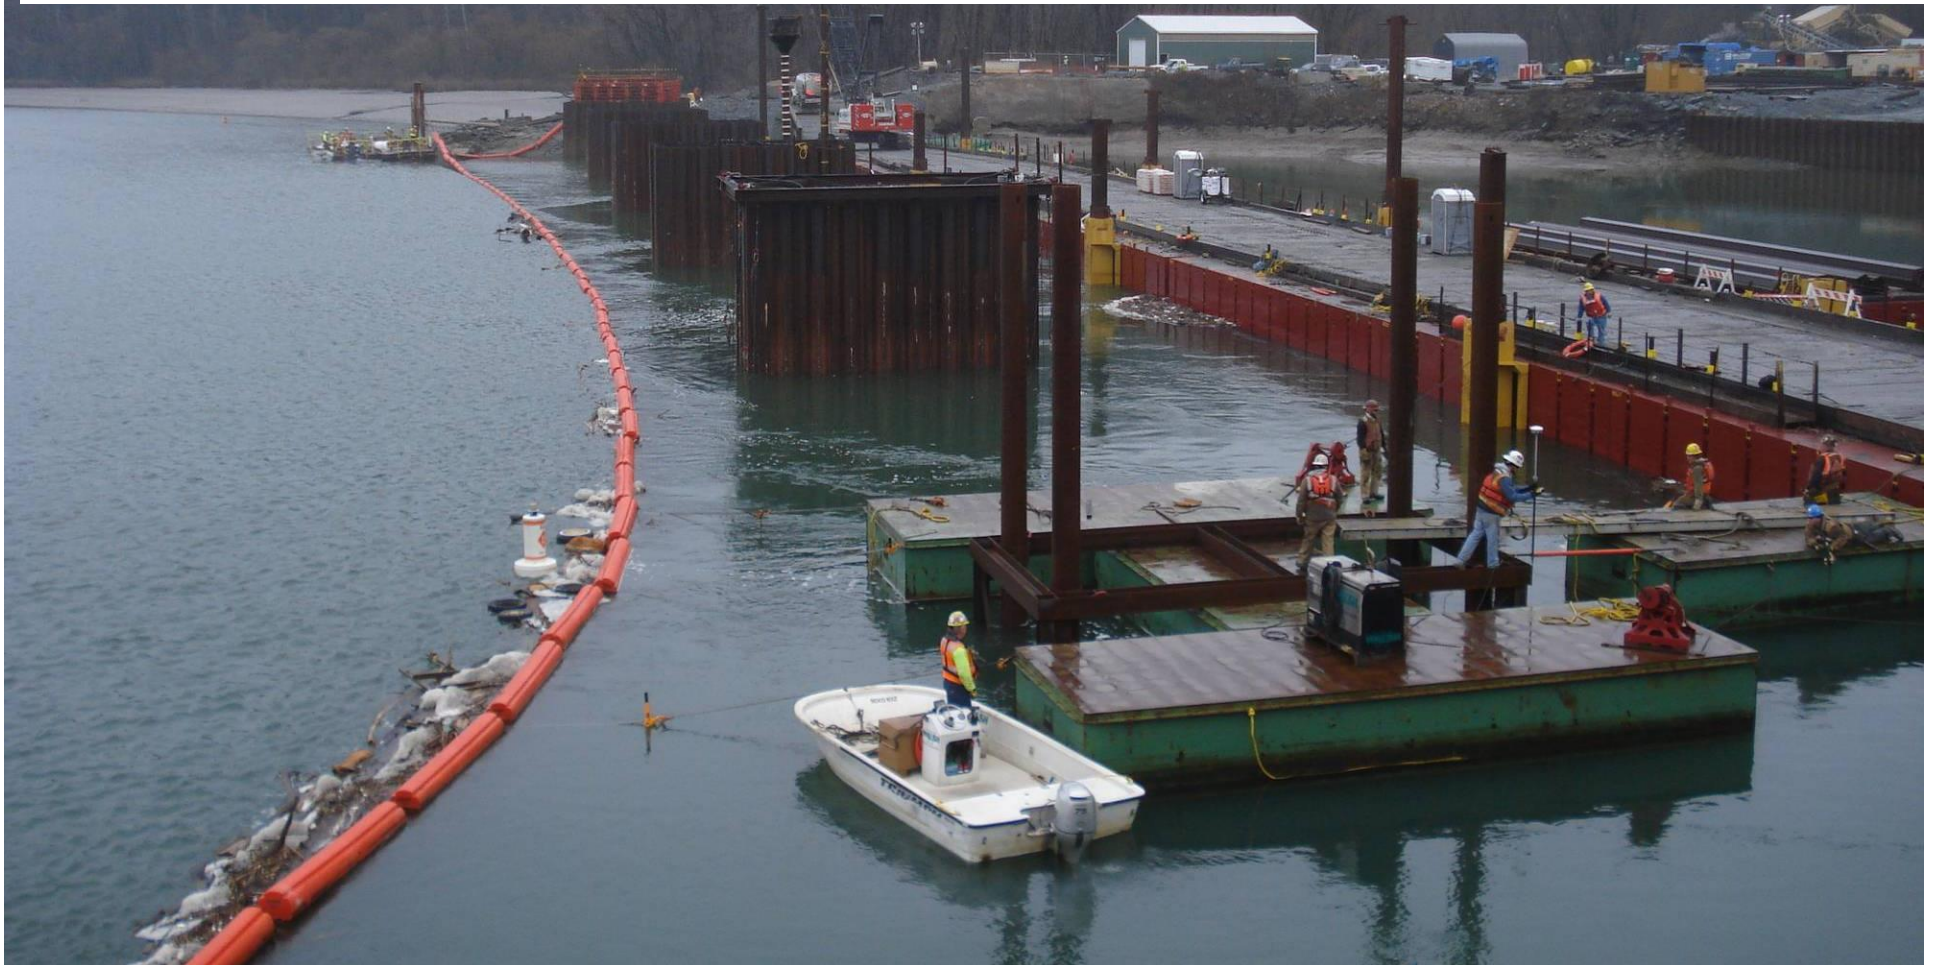
Cofferdam 3 Construction (cont.)

- “ Assembly line of construction
- “ Piers in background have been tremie poured
- “ Nearest completed cofferdam has external waler system clamped around cofferdam
- “ Positioning of internal frame assembly onto HSS corner spuds at nearest cofferdam

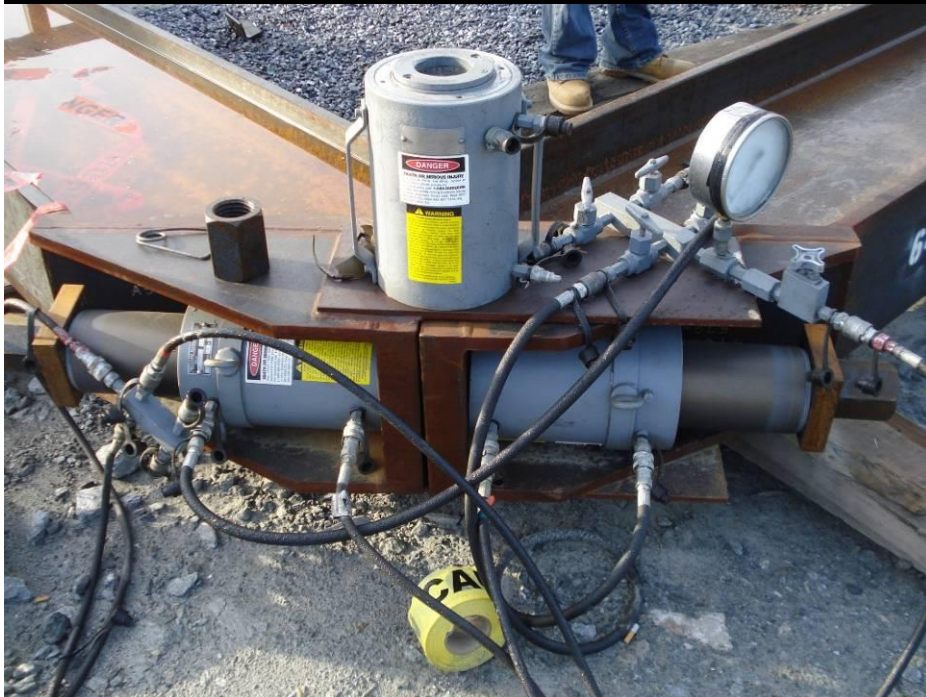
Cofferdam 3 External Waler Design

- “ 3 levels designed to resist 40ø tremie concrete pour
- “ 2 L shaped units connected at a pinned corner with center hole jacks, opposite corners designed as a full moment connection
- “ Jacks clamped the external waler system around the cofferdam to hold the sheets in place during the tremie pour

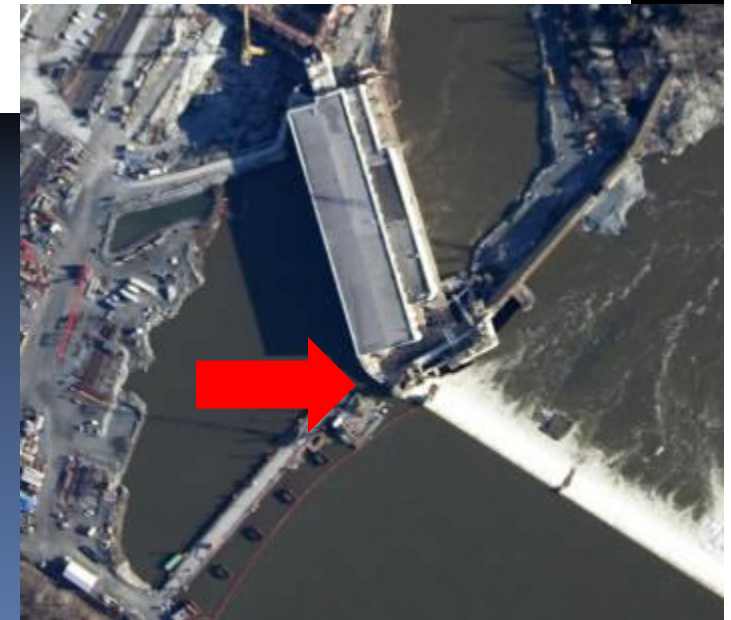
Cofferdam 5 Construction (cont.)

- “ Internal frames assembled on land into two units then lowered into position
- “ Divers made connections to the existing dam face

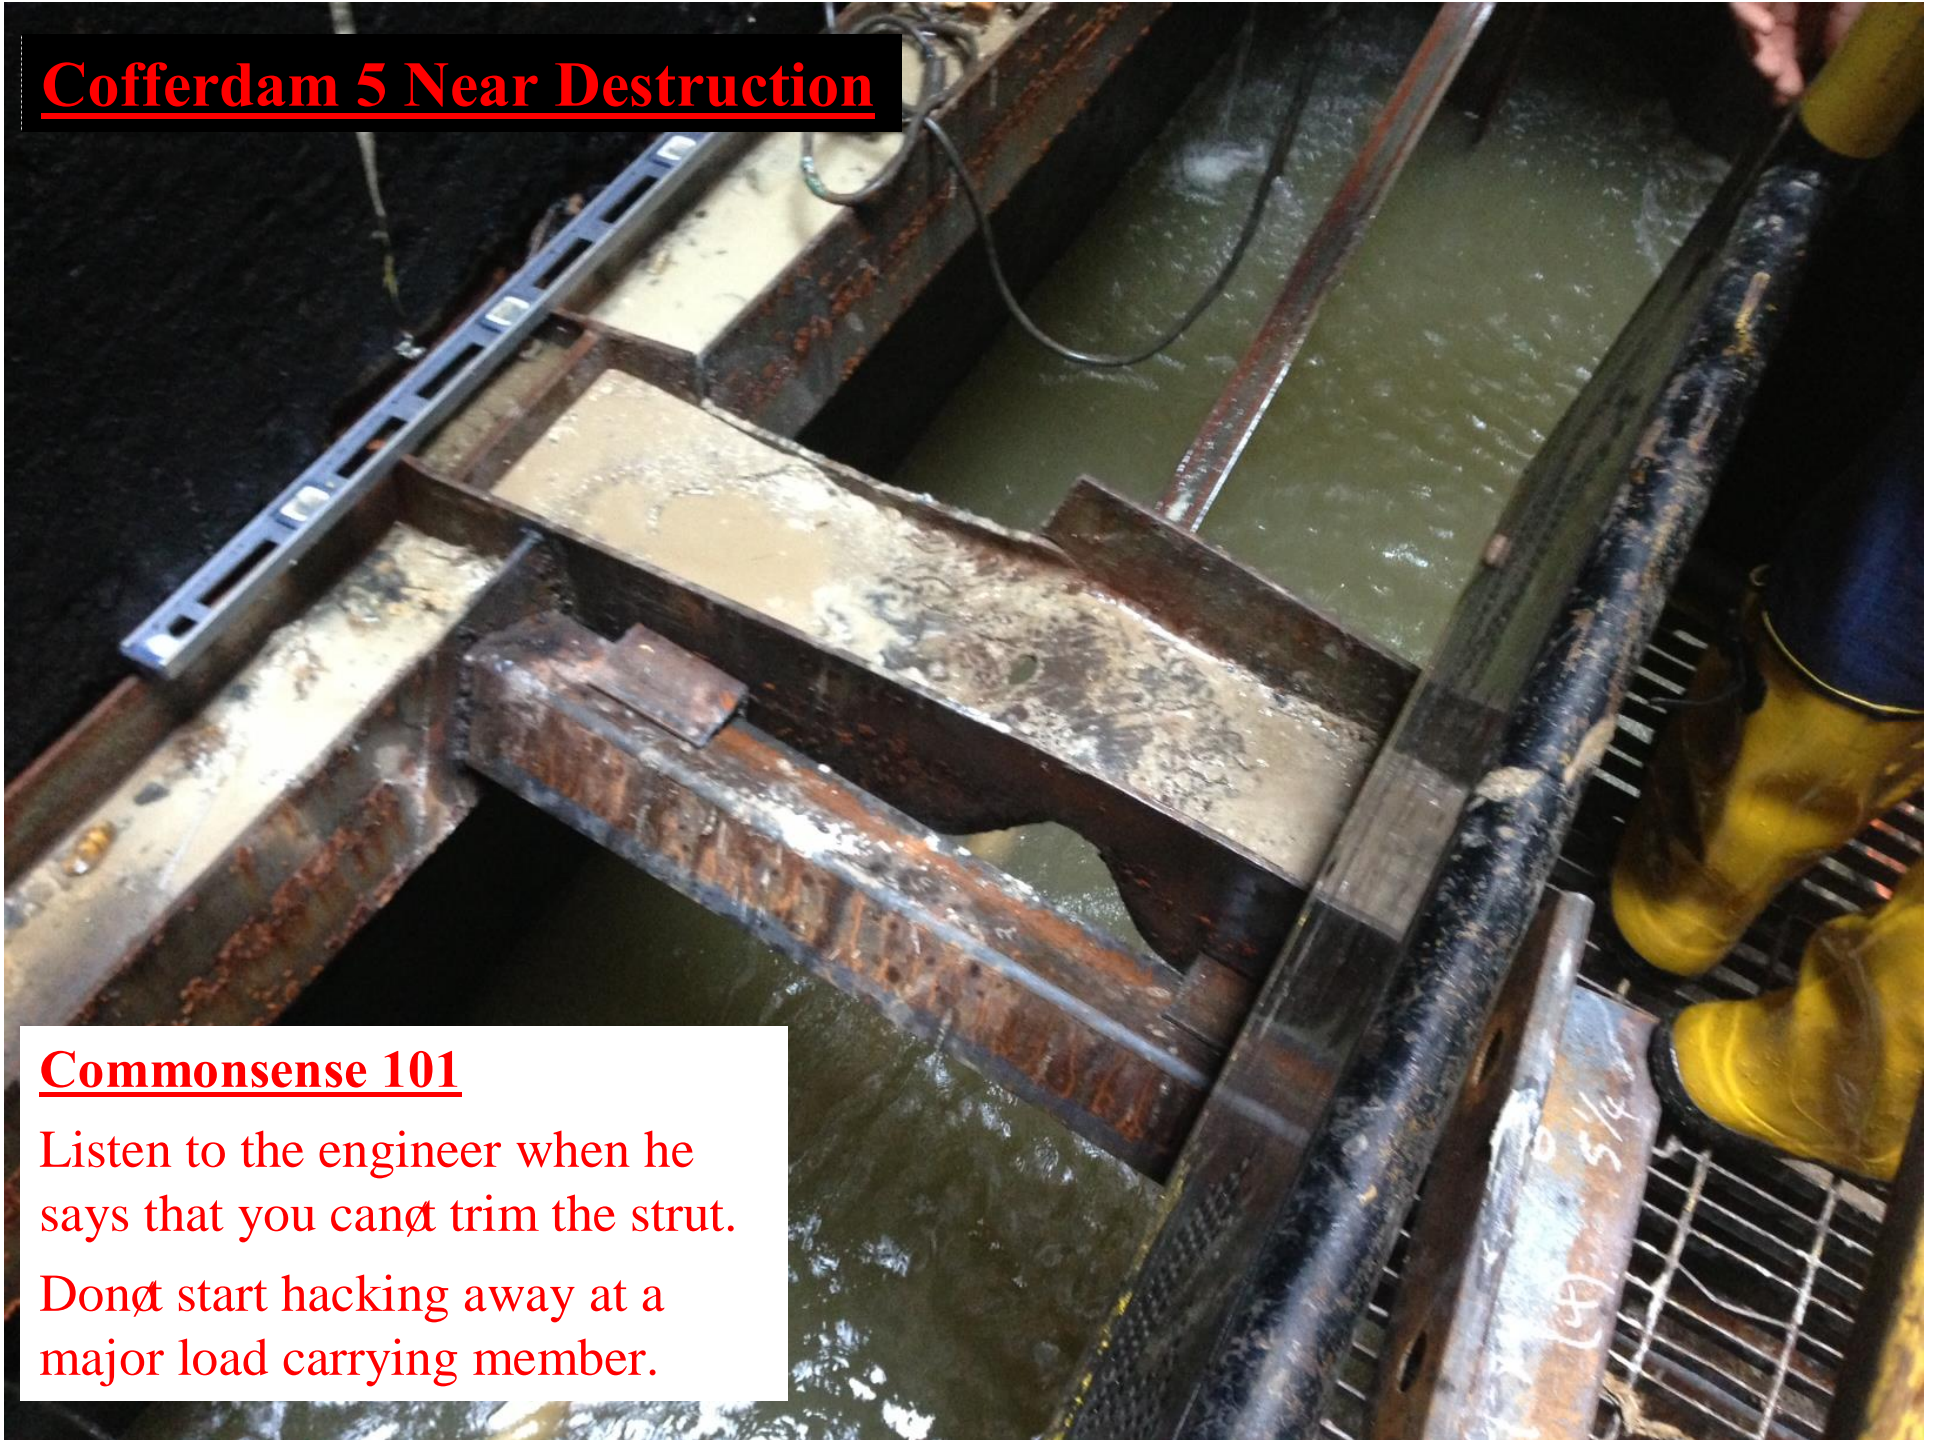
Cofferdam 5 Near Destruction

Listen to the engineer when he says that you cannot trim the strut.

Don't start hacking away at a major load carrying member.
