**ABCD Susquehanna Chapter
2014 Technical Conference**

**Holtwood Expansion Project
PPL Holtwood, LLC.**

**Cofferdam Design and Construction
(and Destruction)**

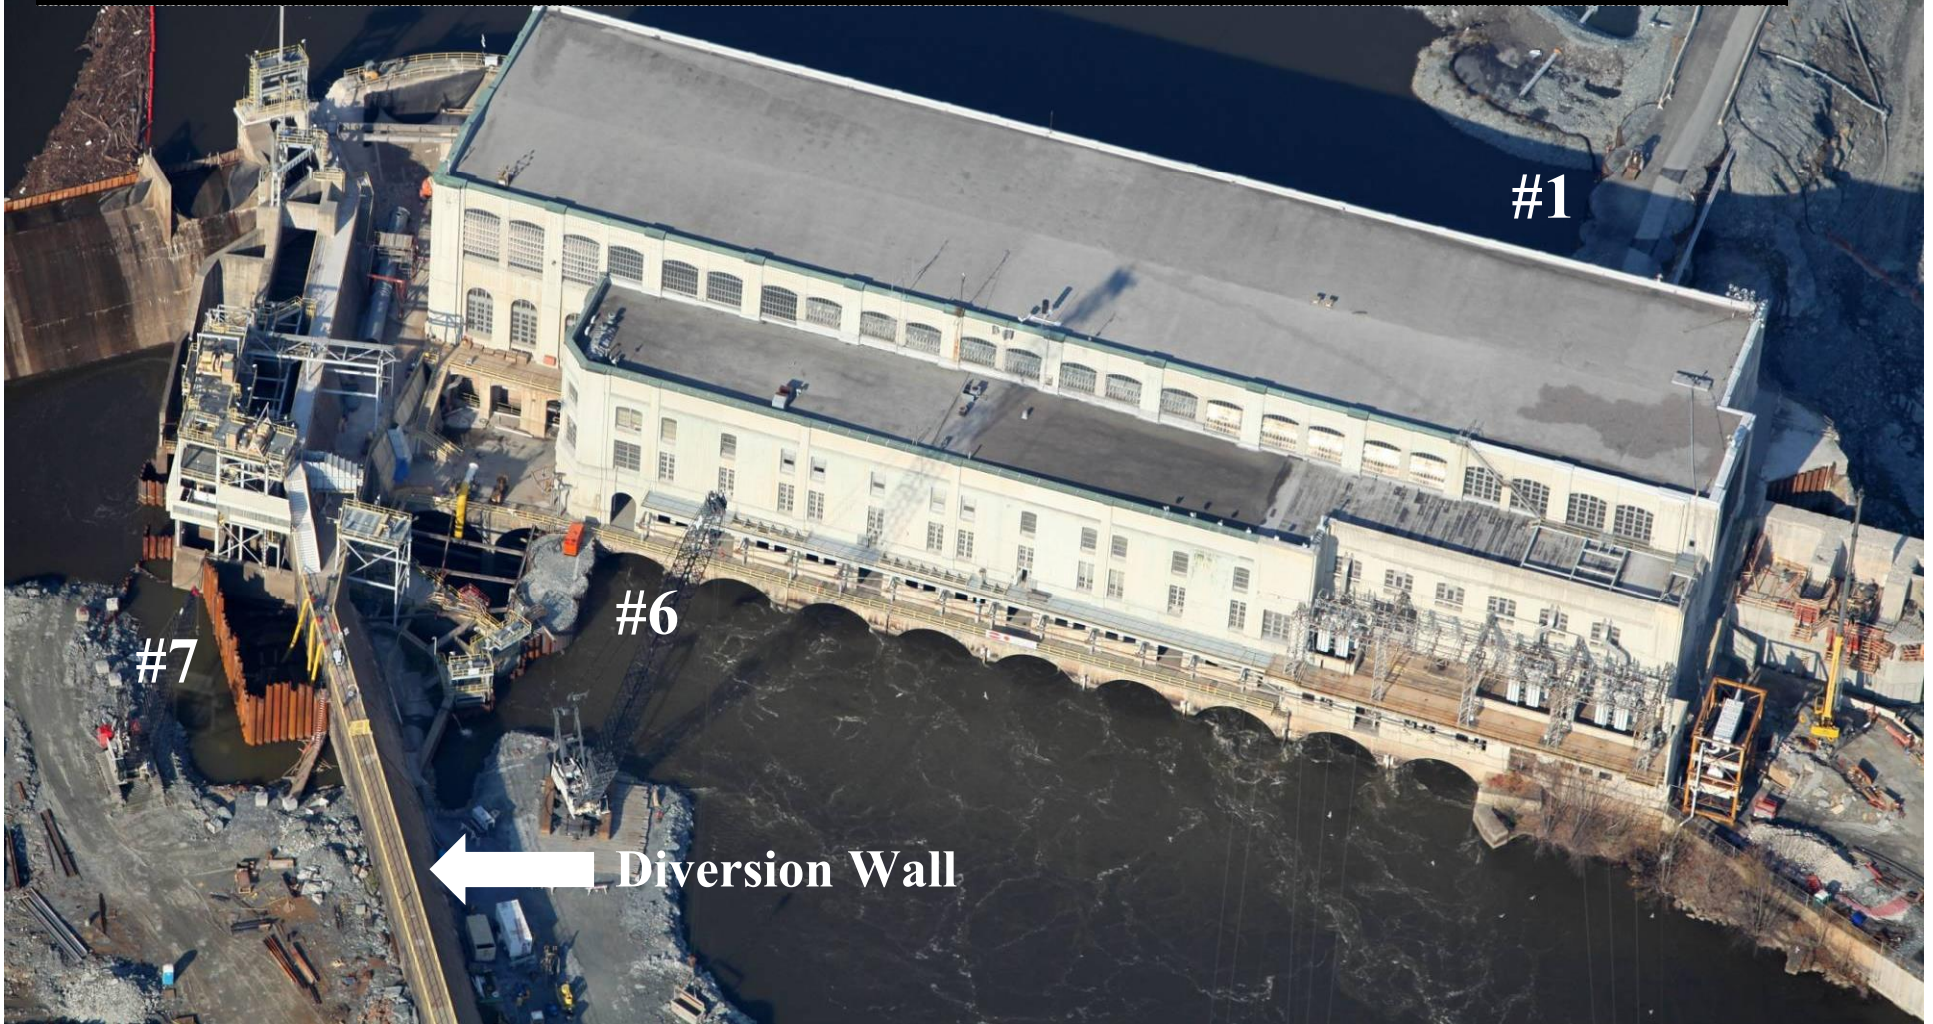
Cofferdam 6 & 7

Tunnel construction to discharge all water from the existing unit 1 to the other side of the diversion wall. Increases water flow to the fish lift entrance C located on that side of the wall.

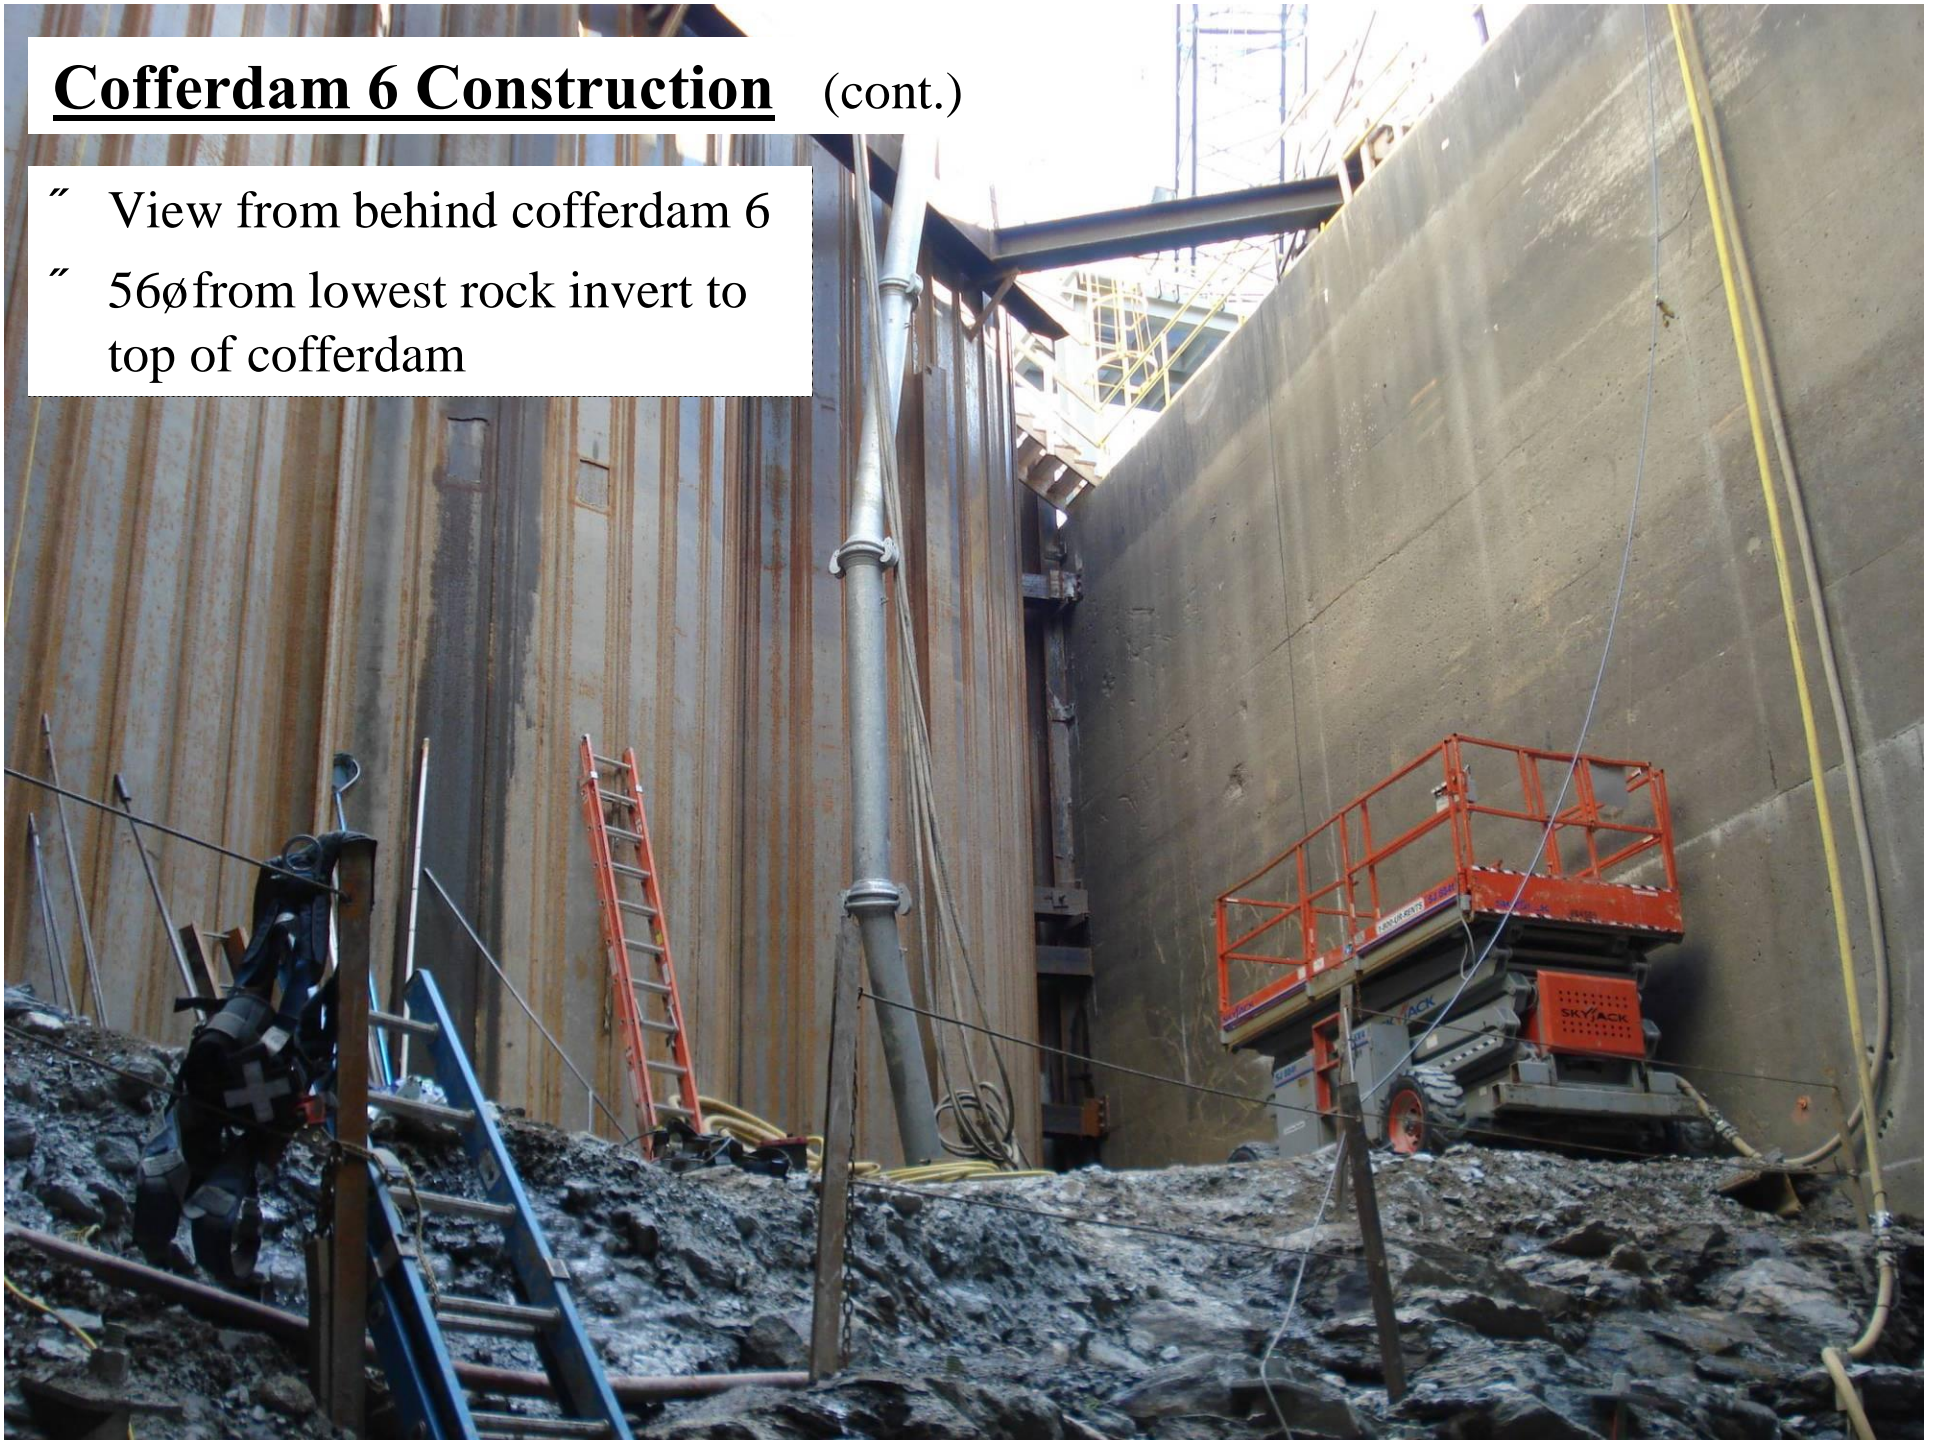
Cofferdam 6 Construction (cont.)

- ” View from behind cofferdam 6
- ” 56ø from lowest rock invert to top of cofferdam

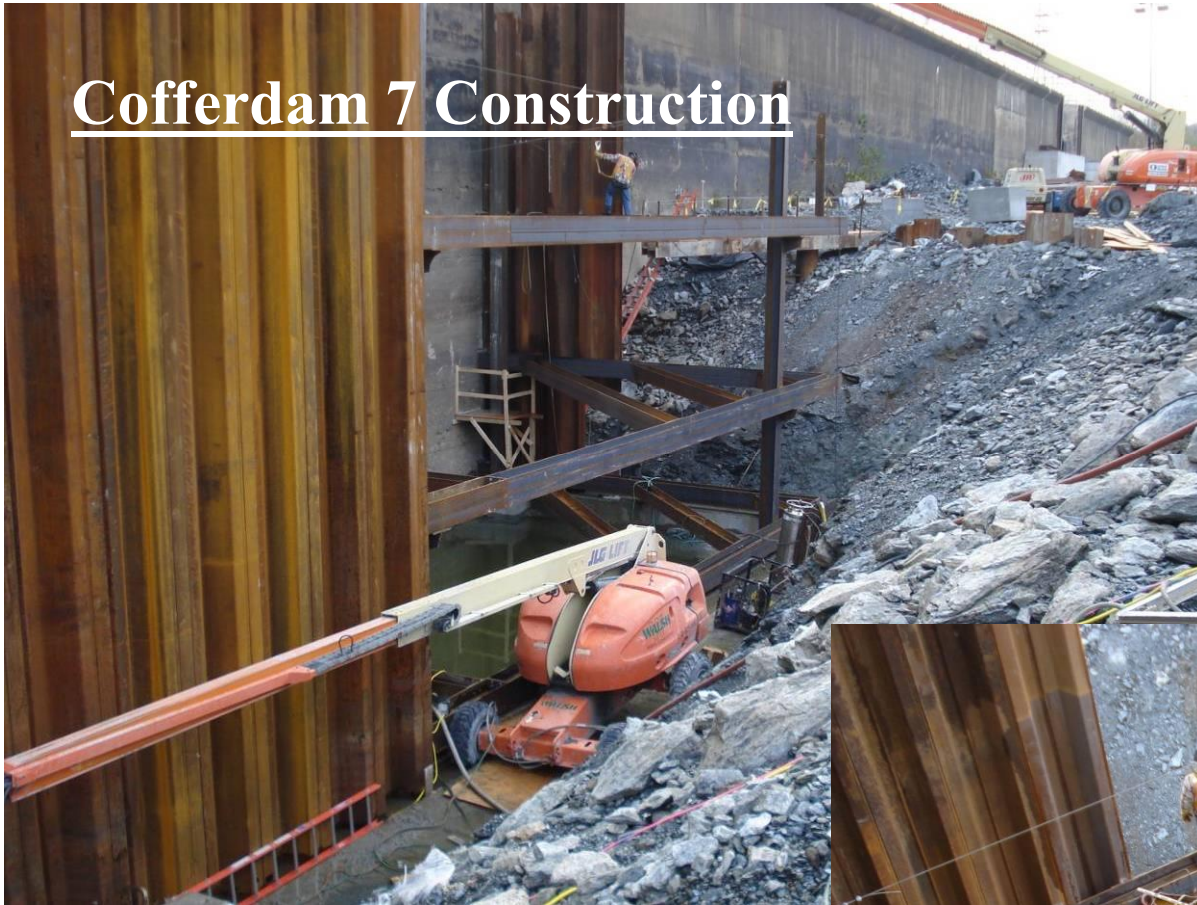
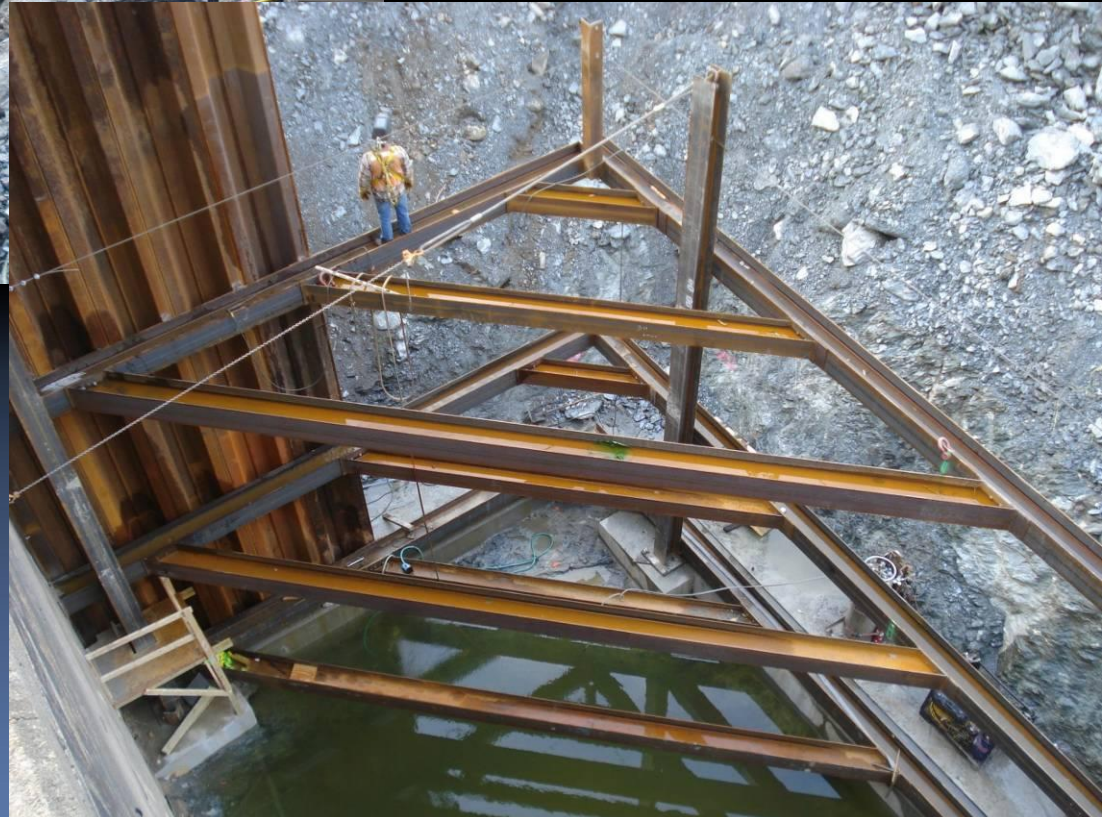
Cofferdam 7 Construction

- “ Frames erected onto support piles
- “ Setting PZ sheets
