## 2015 Technical Conference

# I-495 in Wilmington, DE – The Leaning Towers Lateral Squeeze Effects on Pile Supported Bridge Piers Due to Mudwave Emergency Response and Retrofit

Presented to: ABCD Susquehanna Chapter September 3, 2015

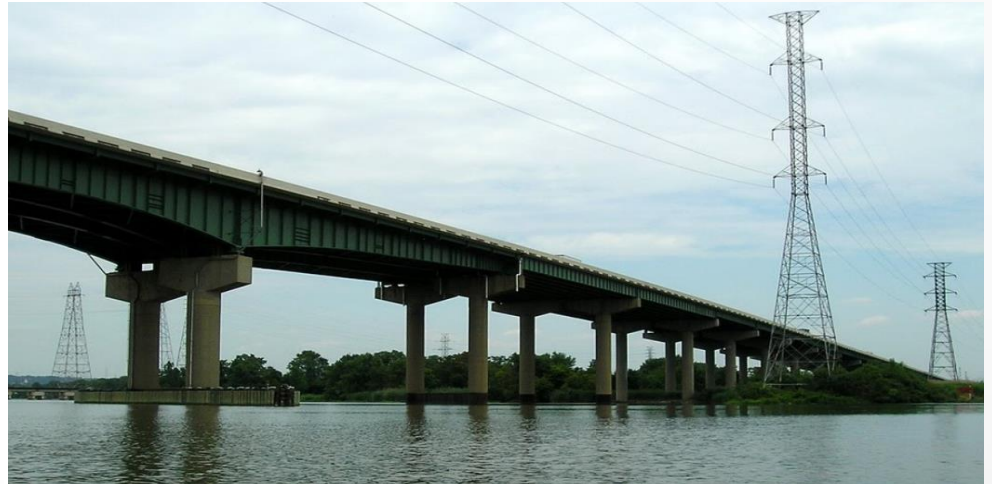
- BR 1-813
- I-495 over the Christina River
- ADT=90,000
- Length – 4,390-ft
- 38 spans
- Welded Steel Plate Girder Superstructure
- Pier Ht = +/- 60-ft
- Variable Foundations
- Inspected October 2012
  - No deficiencies

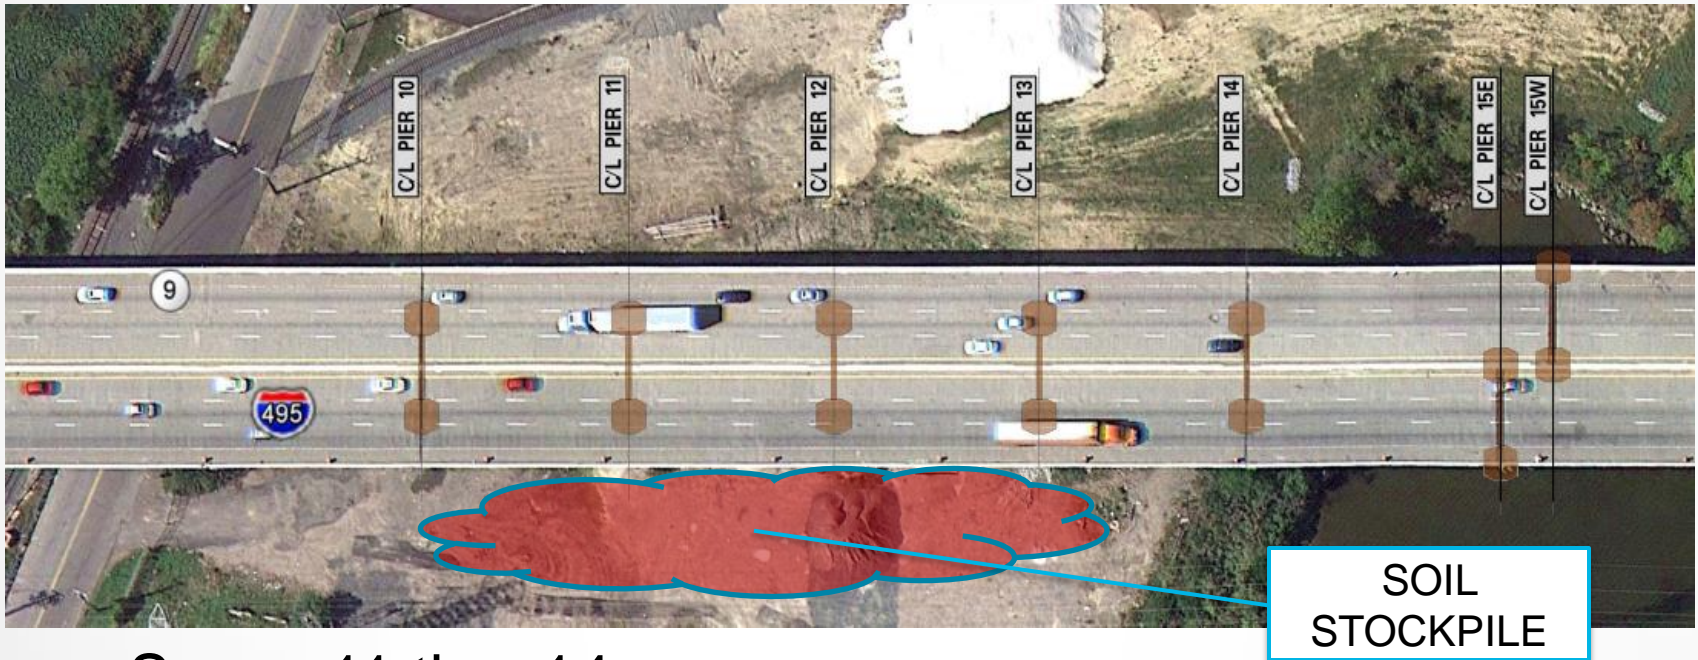
- Spans 11 thru 14
  - 4-span continuous
  - All spans 109-ft
  - Piers 10 thru 14
  - Pier 10 – Cast-in-Place Concrete Piles
  - Remainder – H-Piles
- Span 15
  - Simple span
  - SB – 160.03-ft
  - NB – 132.87-ft
  - Pier 15 – H-Piles

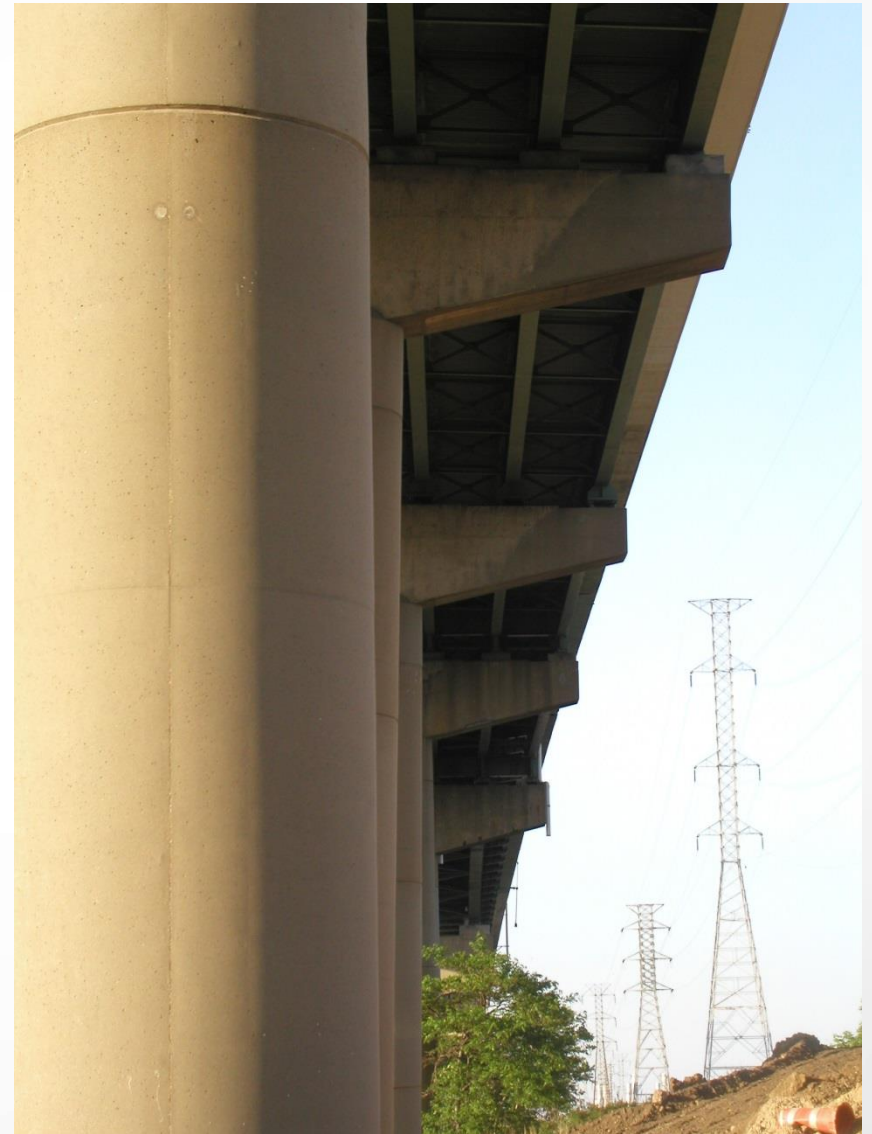
- June 2<sup>ND</sup> 2014 at 2:17 PM
  - AECOM arrived on-site  
4:00PM
- Piers Tilted
- Tension Cracks in Soil
- Displacement of Bridge Superstructure

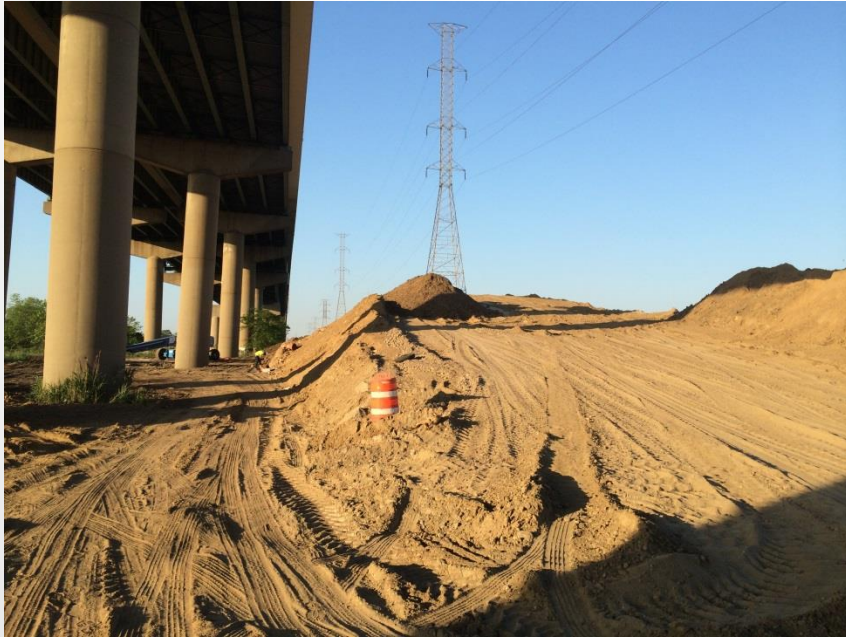
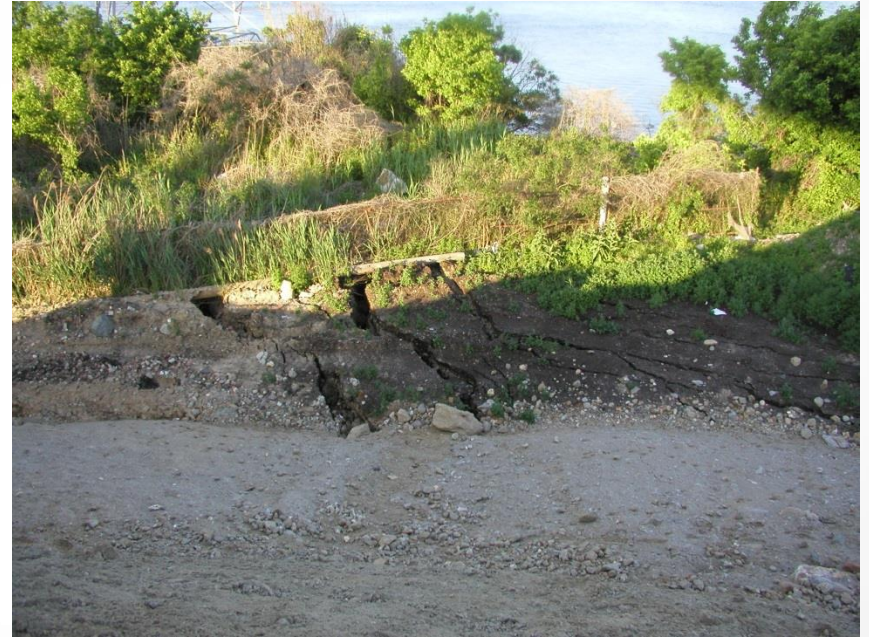
Embankment and Soil Tension Cracks East of Structure

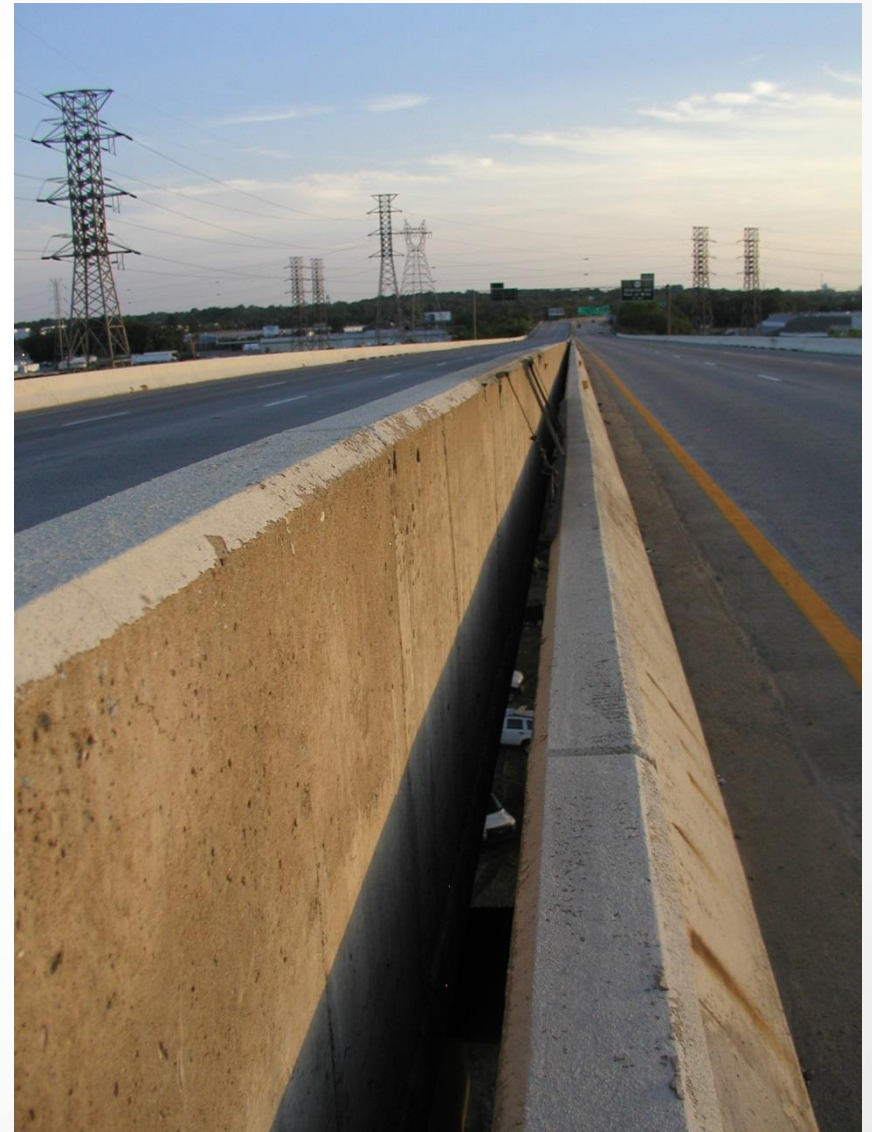
- NB and SB Superstructure Rotated to the East
  - 18-inch difference in elevation of median barriers
  - + 3-inch gap in median barriers

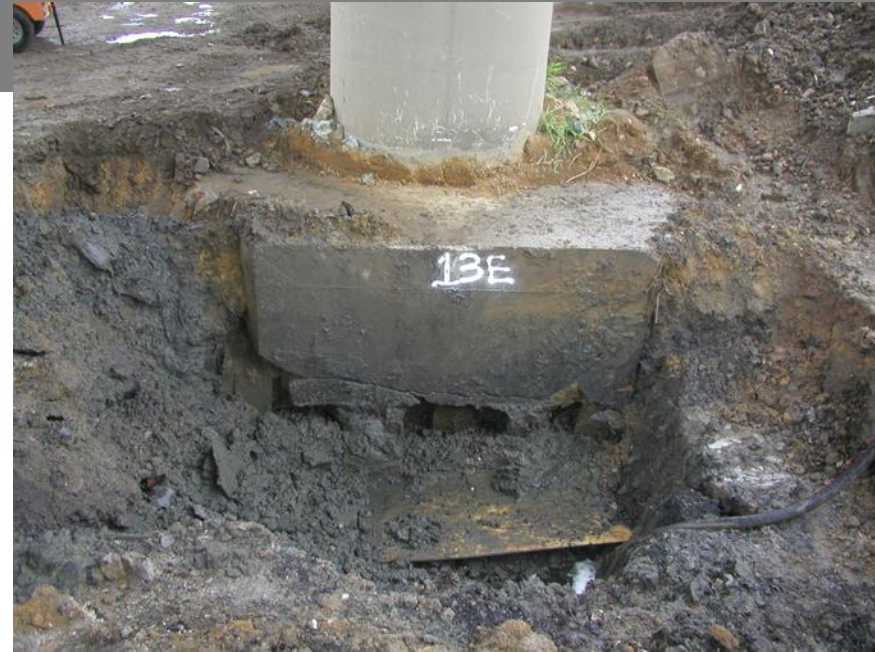
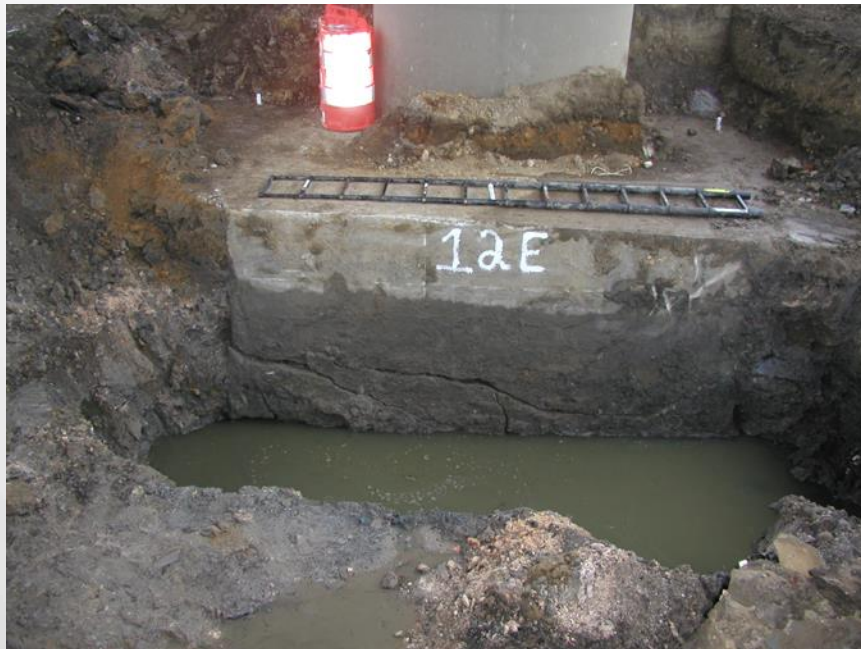
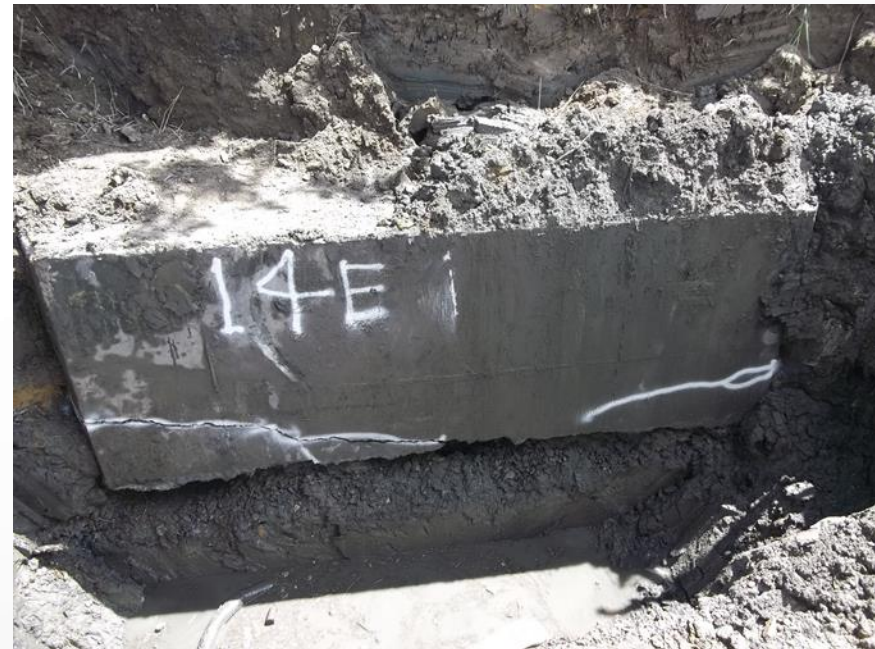
- Pile Cap Inspection
  - Large Horizontal Cracks
  - No Pile Corrosion
  - Local Buckling on One Pile

- Replace Piers 12 and 13
  - Pile cap cracked
  - Column insufficient for eccentric loading
  - Cannot rely on capacity of existing piles
- Drilled Shafts w/ Grade Beam
  - 4-ft diameter
  - Casing to bedrock
  - 130-ft to 160-ft below grade
  - **Rebar from Tappan Zee**
  - Support Temporary and Permanent Repairs
  - **Geotechnical Design**

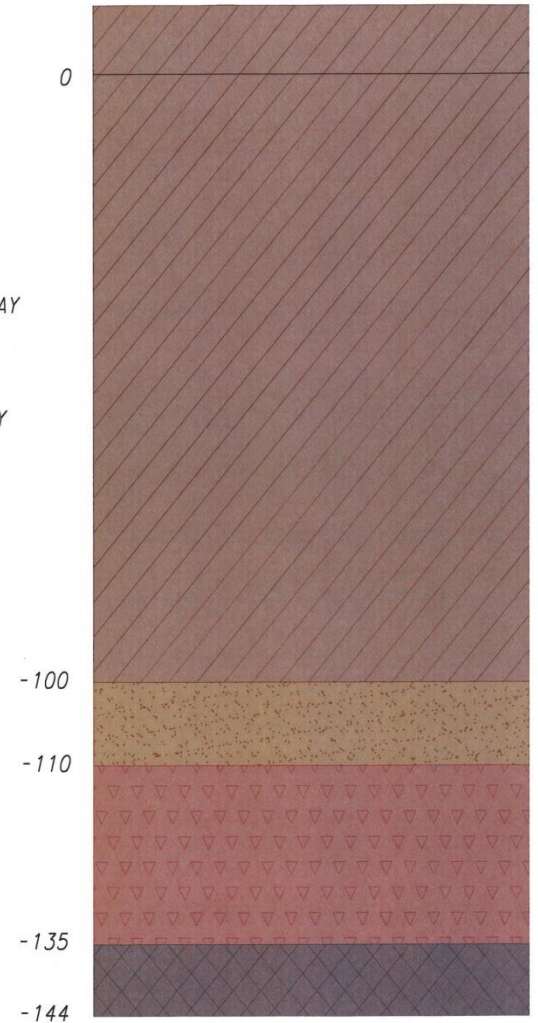
- Generalized Soil Profile
  - Soft Organic Clay
  - Dense Sand
  - Stiff Silty Clay
  - Bedrock

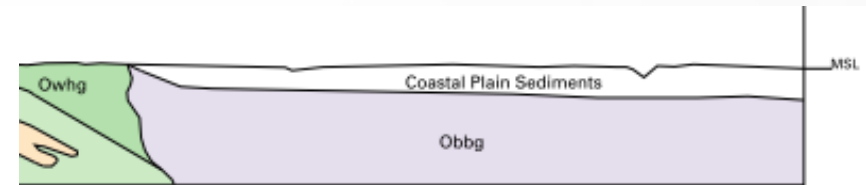
DELAWARE GEOLOGICAL SURVEY  
BEDROCK GEOLOGIC MAP OF THE PIEDMONT OF DELAWARE AND ADJACENT  
PENNSYLVANIA  
GEOLOGIC MAP SERIES, NO.10

**Obbg** **Brandywine Blue Gneiss**  
Medium- coarse-grained granulites and gneisses composed of plagioclase, quartz, orthopyroxene, clinopyroxene, brown-green hornblende, magnetite, and ilmenite. Mafic minerals vary from < 5-30 modal percent. A lineation due to a preferred orientation of quartz and mafic minerals is obvious on weathered surfaces. Unit contains thin, discontinuous fine-grained mafic layers.

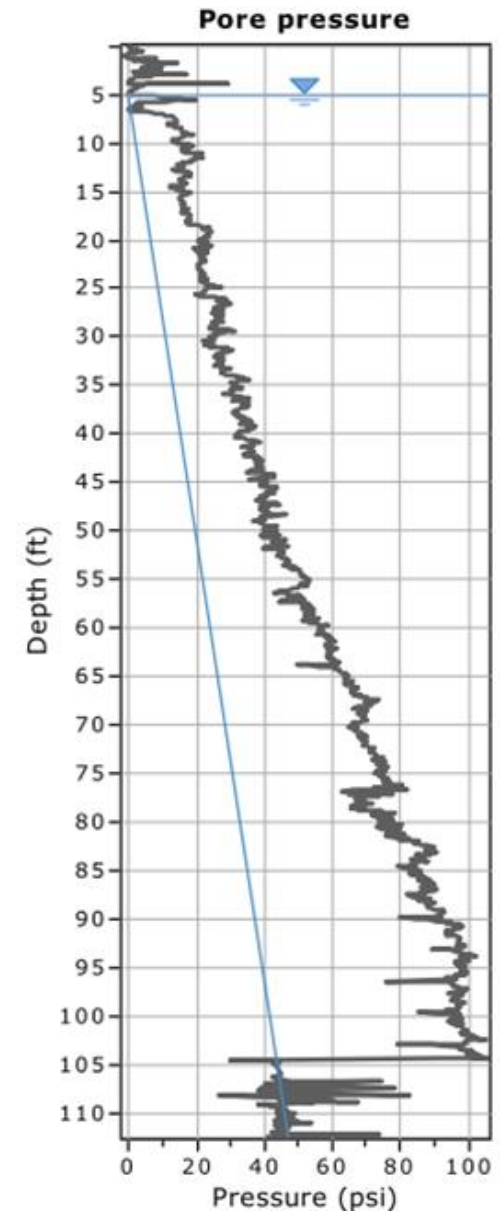
CPT: C-12E

- Cone Penetrometer  
Pore Pressure Readings

- Increased Pore Water Pressure  $\geq$  action level of 1.0 psi/ ft of depth.
- In-situ testing in the form of Cone Penetrometer Tests with piezometric readings indicated excess pore water pressure at or above the 1.0 psi/ft action level

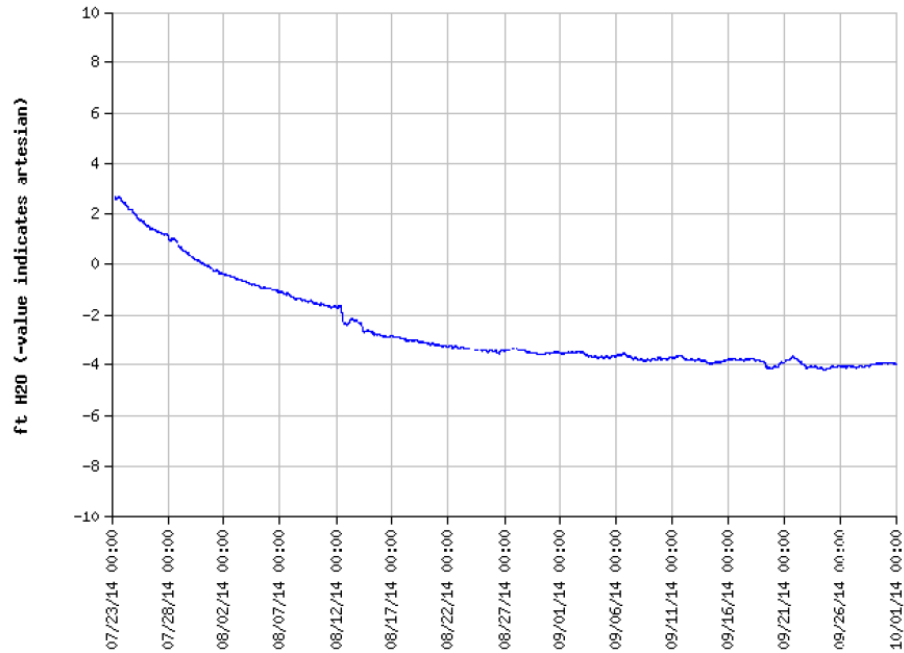
PLOT OF PRESSURE HEAD IN FEET  
VS. TIME  
JULY 15 THROUGH OCTOBER 1, 2014

- Piezometer Readings
  - Subsequent piezometer readings indicated that the excess pore water was very slow to drain
  - This was confirmed by the Laboratory Consolidation Tests conducted on undisturbed samples ( $C_v = 0.01$  to  $0.02$  ft<sup>2</sup>/day).

Y-AXIS ZERO REPRESENTS GROUND SURFACE, +/- EL 10

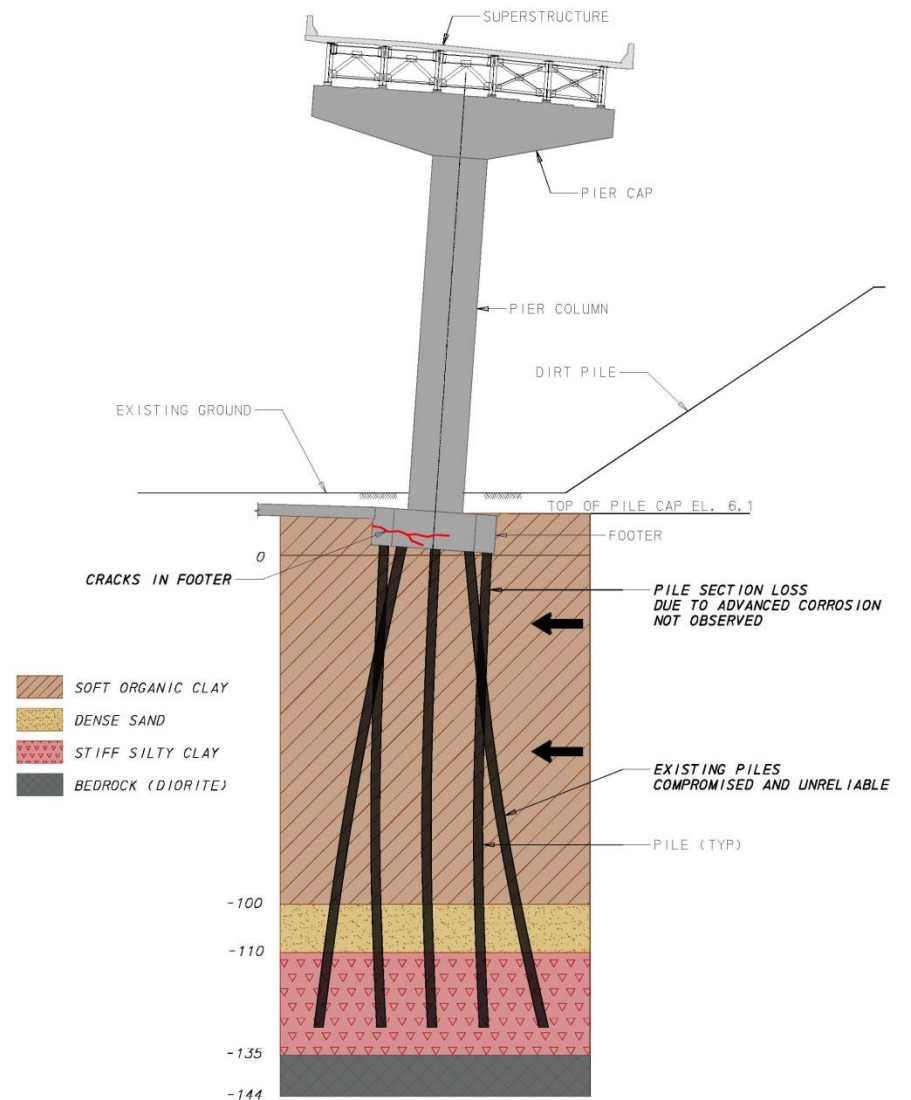
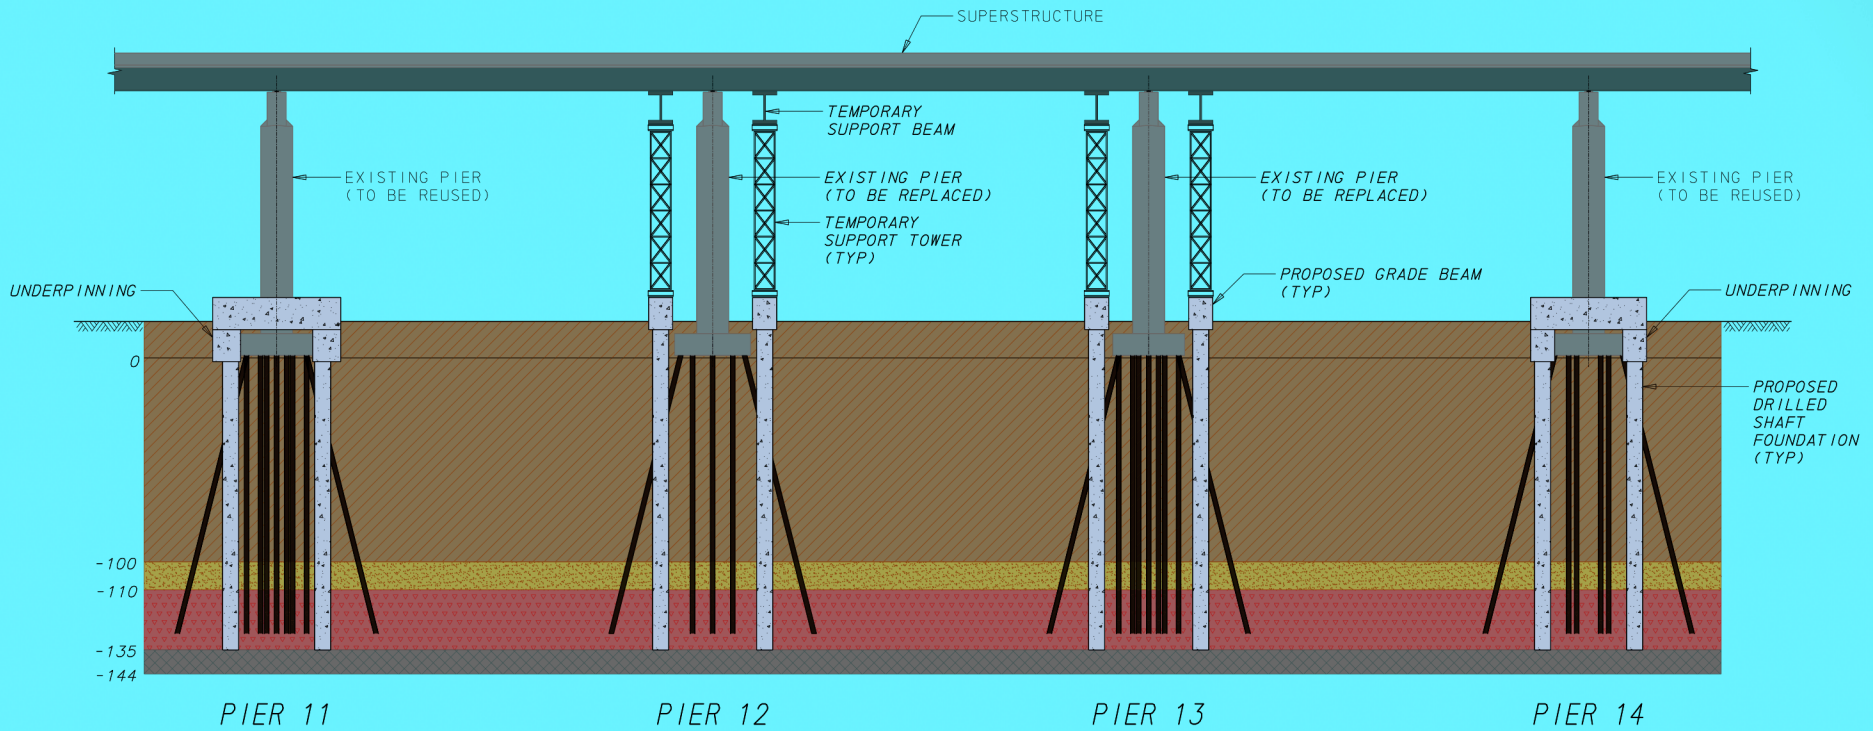
PROPOSED FOUNDATION REPAIR / TEMPORARY SUPPORT ELEVATION

- Excess pore water pressures within the influence zone of the impacted piers made advancing borings extremely difficult
- Although dissipated during drilled shaft construction the overstressed subsoil continued to cause problems.

SOFT ORGANIC CLAY
-

DENSE SAND
-

STIFF SILTY CLAY
-

BEDROCK (DIORITE)

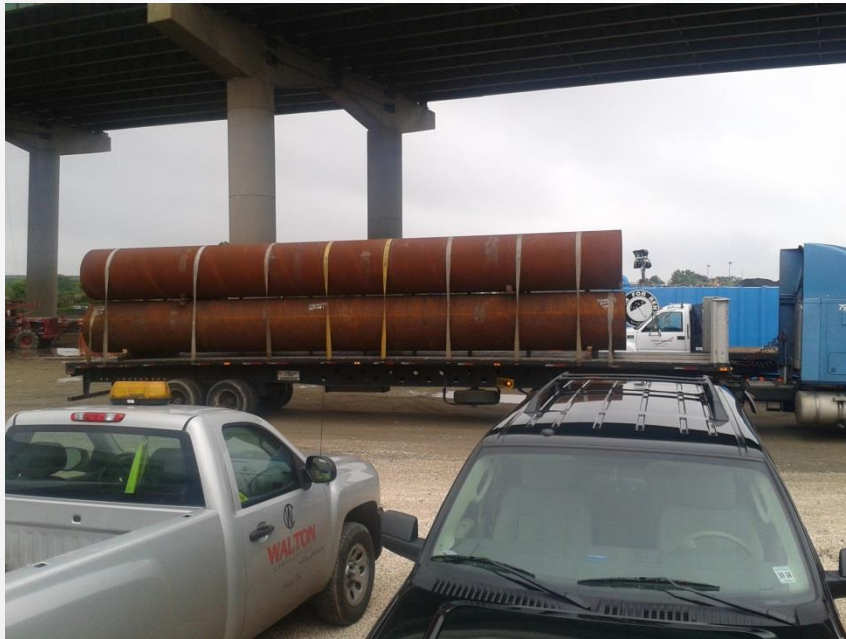
First Delivery of Casing 6/12/2014

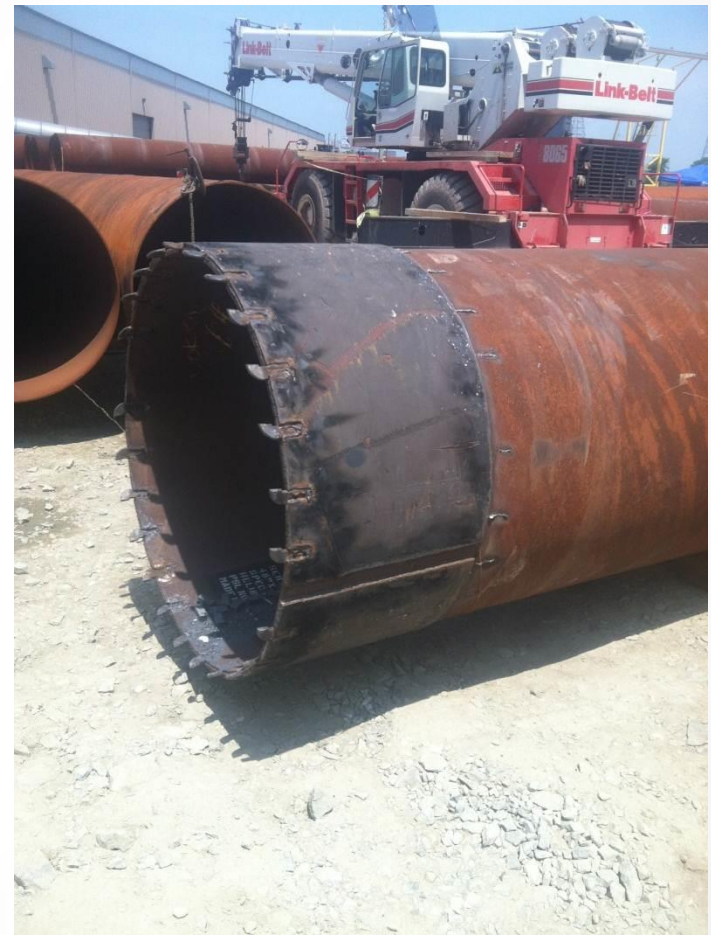
Cutting Teeth Welded to Casing

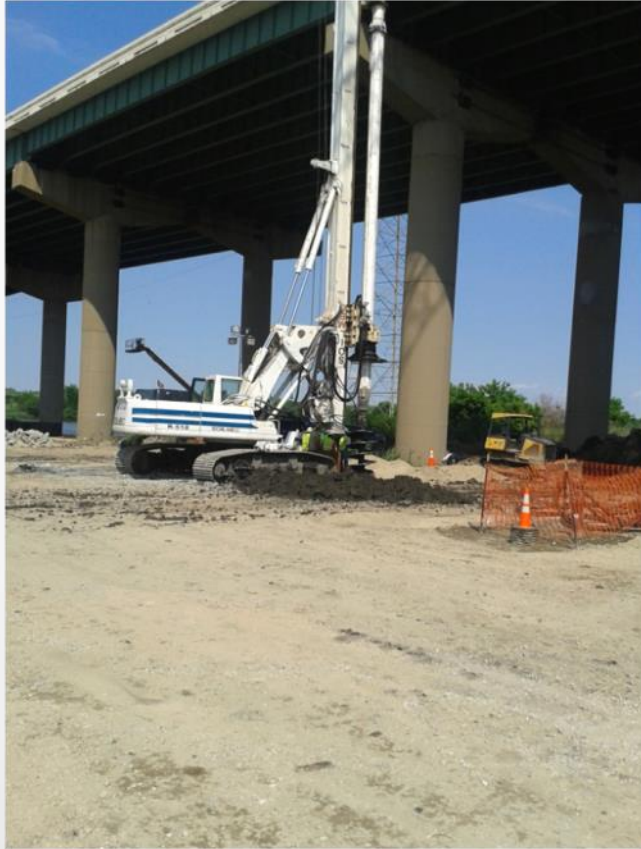
First Drill Rig on Site 6/13/2014

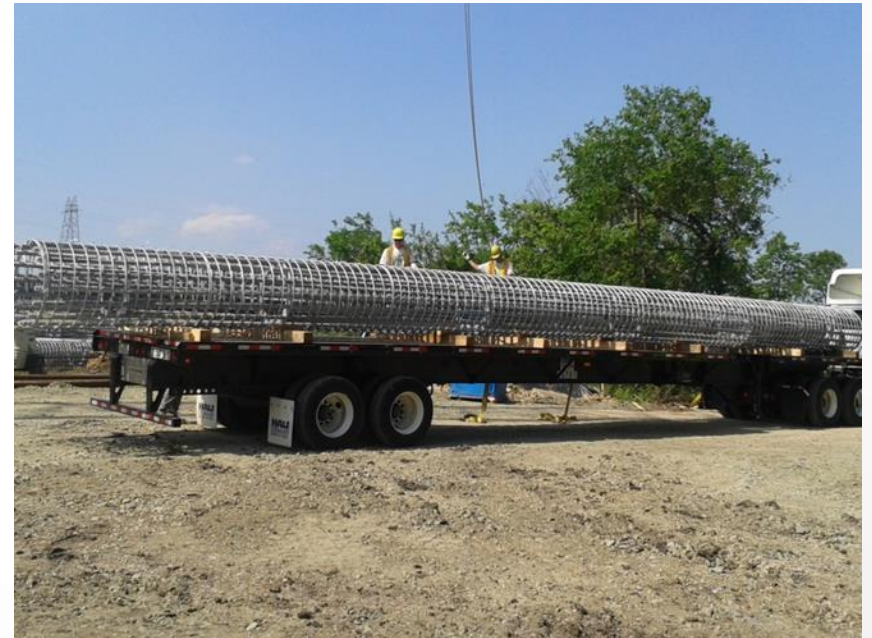
Rebar Cage from Tappan Zee project  
6/16/2014

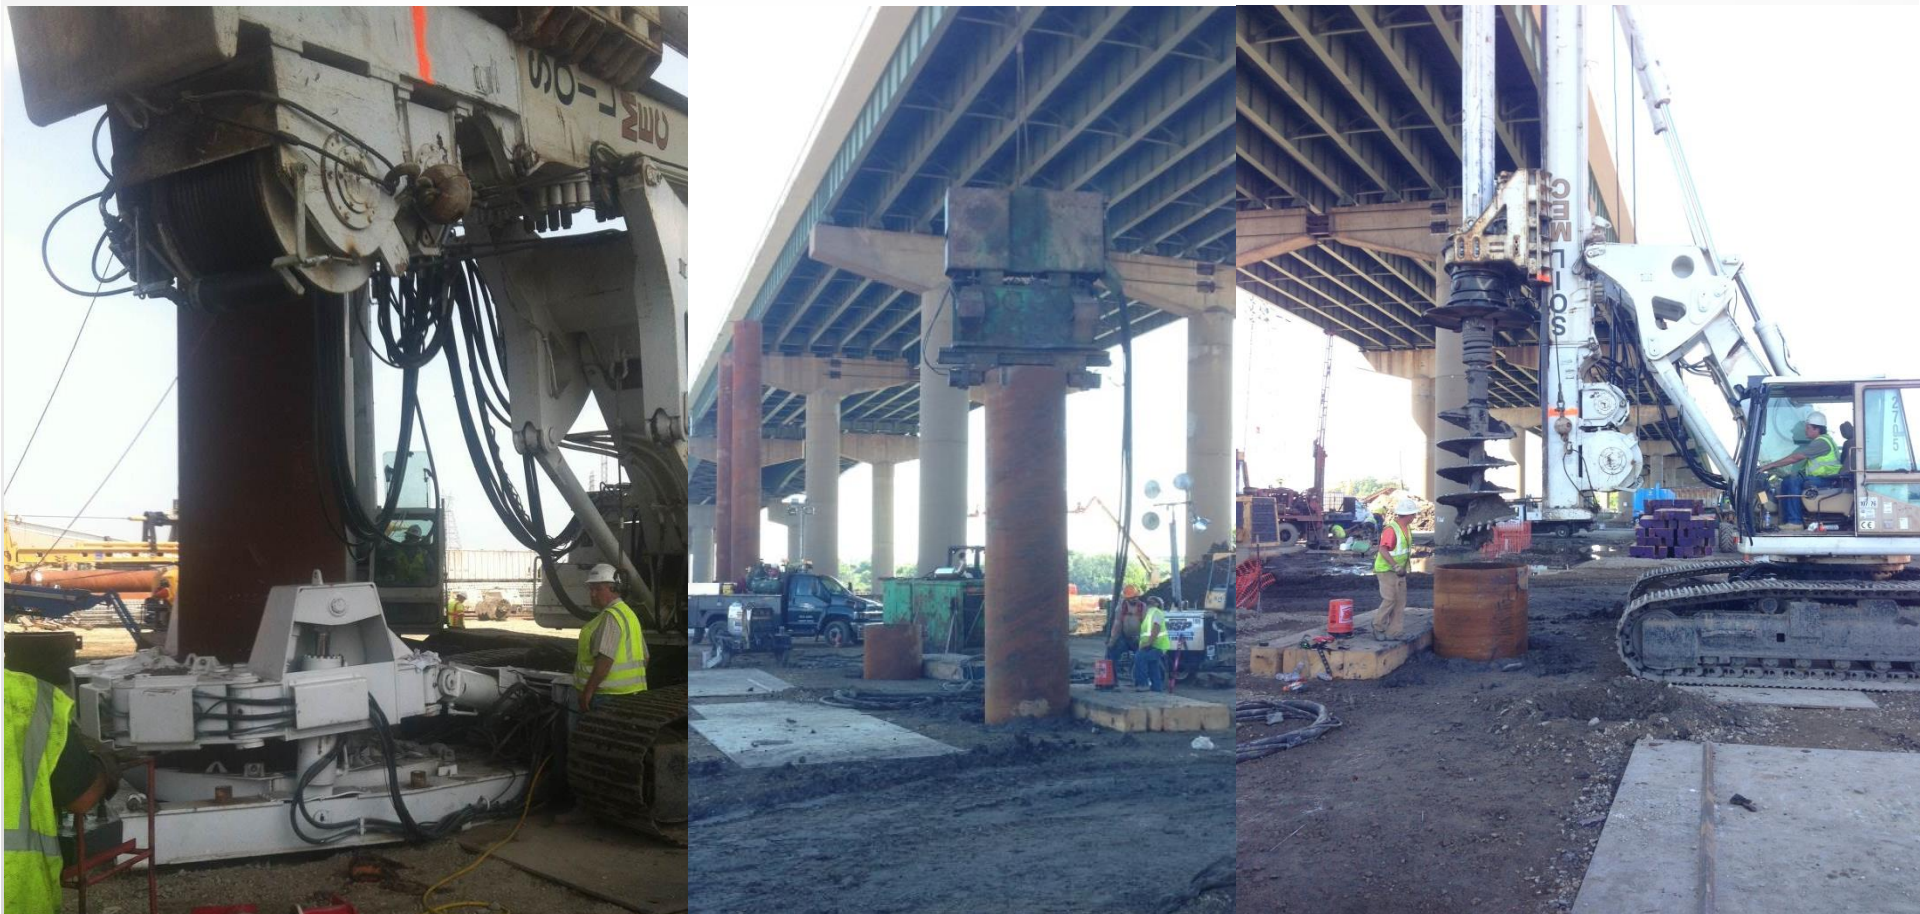
Began oscillating in casings on 6/13/2014

Vibratory hammer used on 6/15/2014

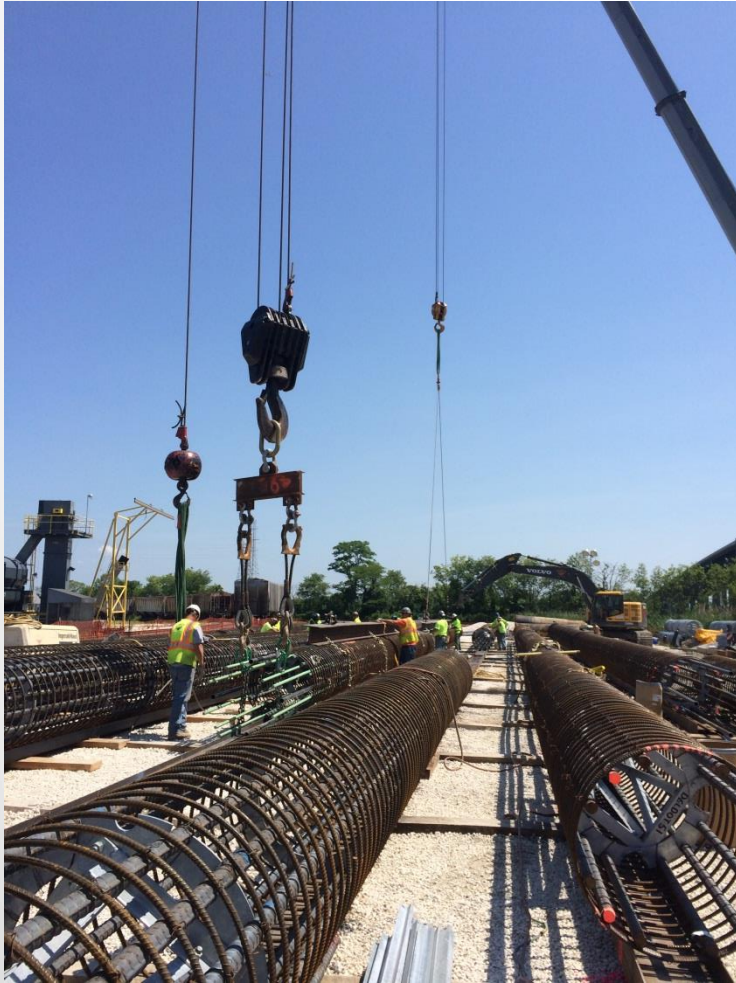
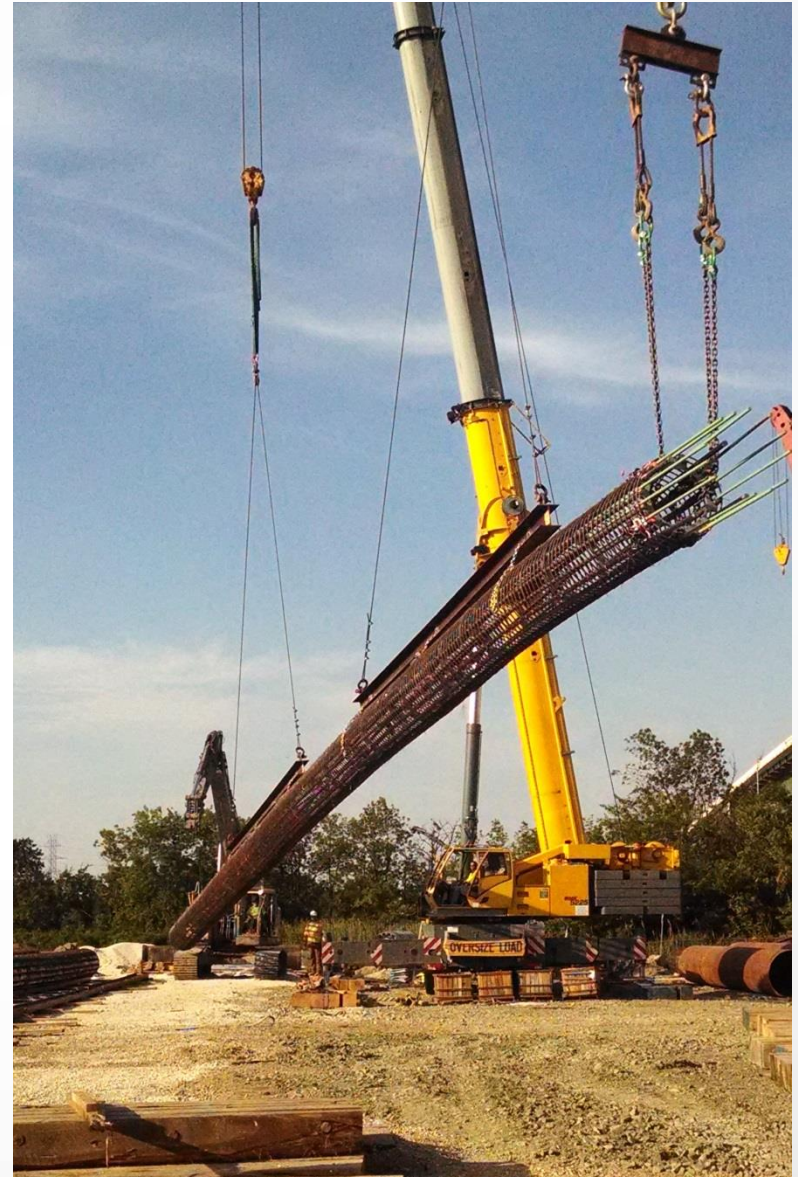
Right: Lifting 160 foot long Rebar Cage  
Below: Splicing of Rebar Cages in Yard

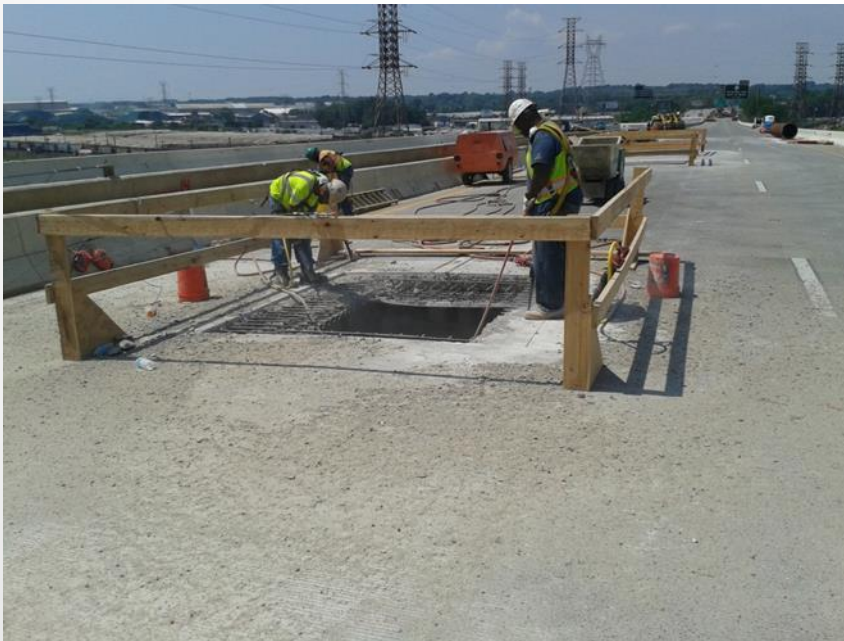
Access Holes in Bridge Deck for Placement of Drilled Shaft Rebar

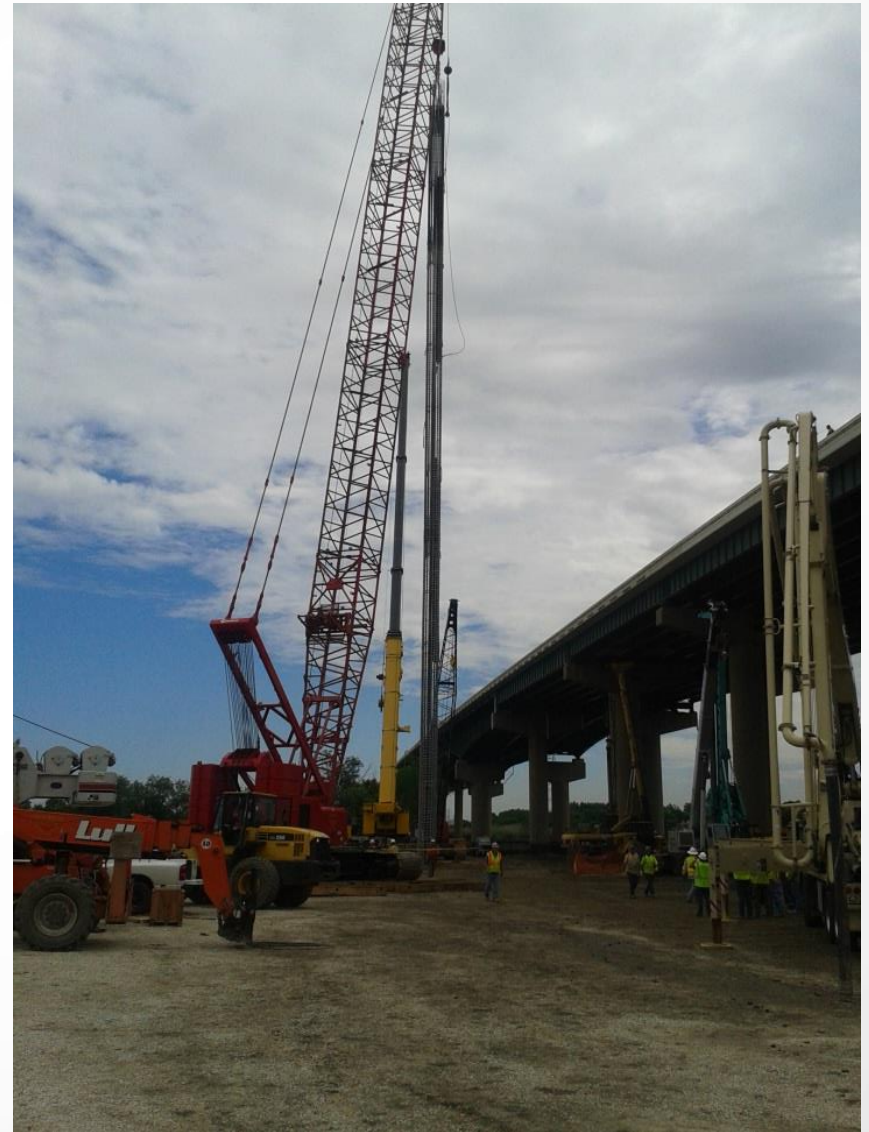
First Drilled Shaft Reinforcing Cage Placed 6/21/2014

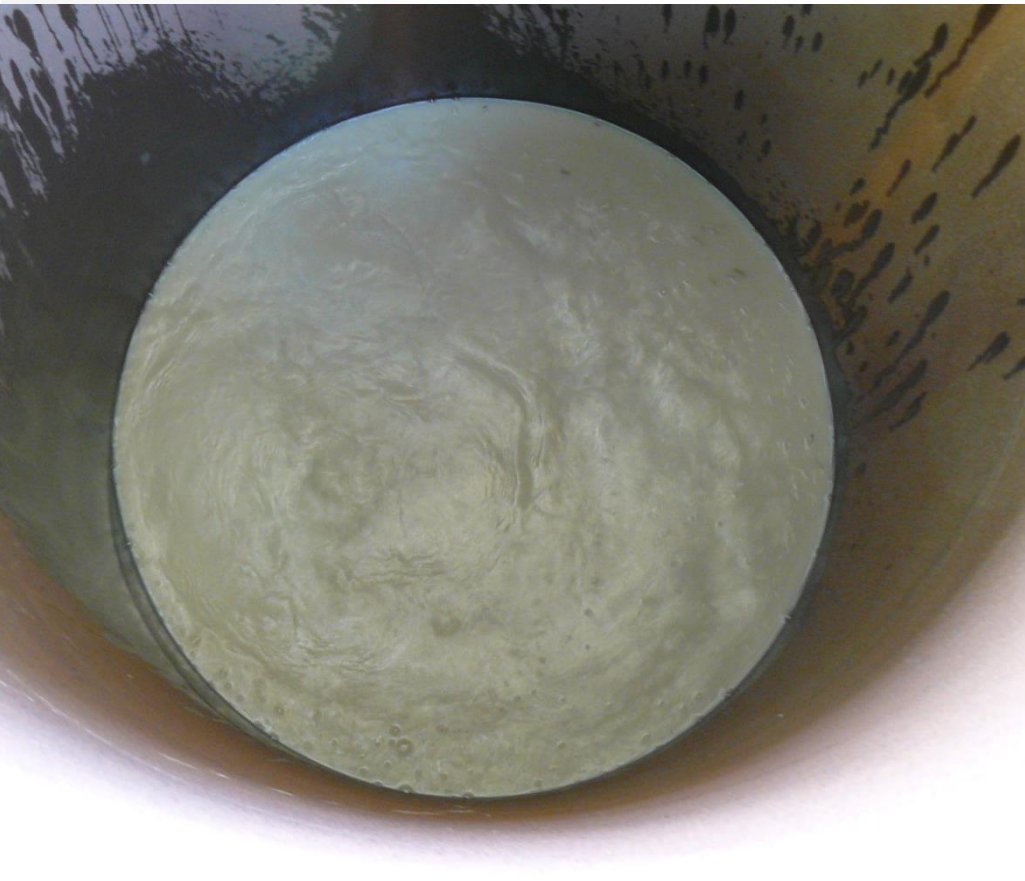
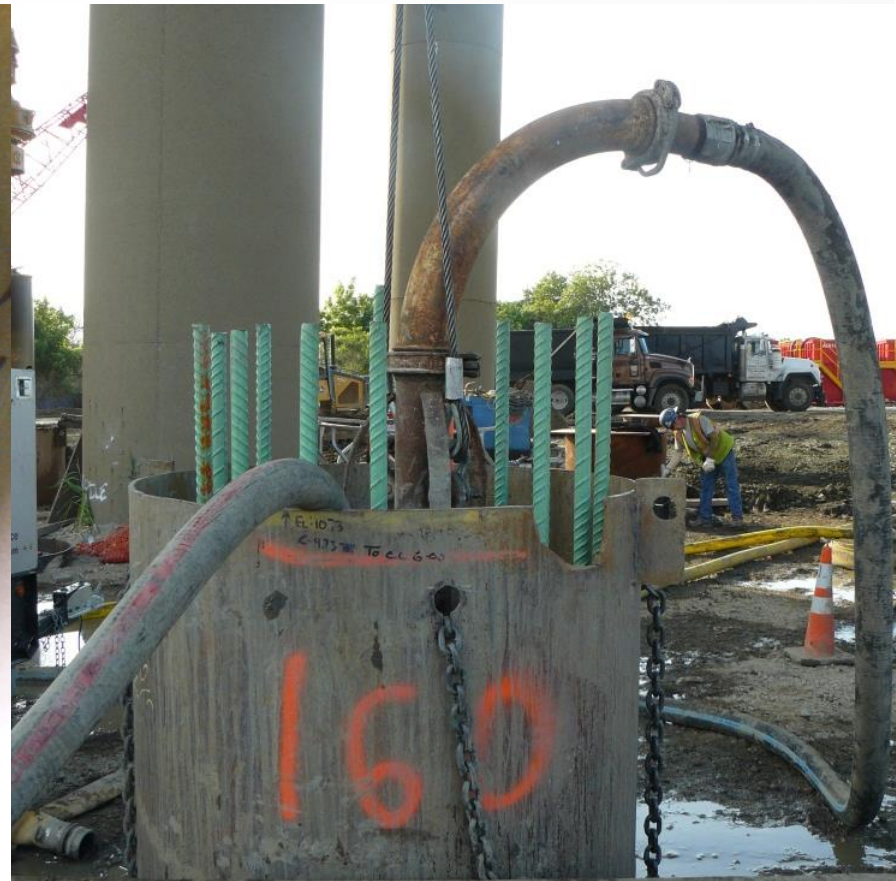
- Drilled Shafts – Pouring PCC
  - Casings went to bedrock and were filled with a slurry.
  - SCC concrete was tremie poured from the bottom and slurry was pumped out and recycled.
