pennsylvania
DEPARTMENT OF TRANSPORTATION

GEORGE N. WADE BRIDGE REHABILITATION

I-81 Over the Susquehanna River,
Norfolk Southern Railroad,
and North Front Street

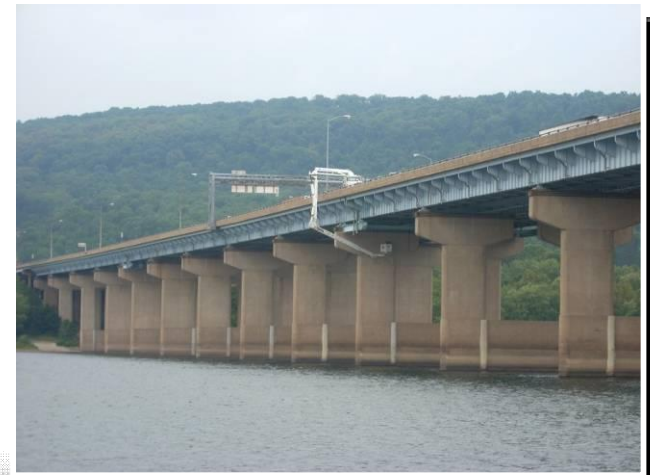
- Dual 44 Span Structure – Fracture Critical – Built 1973
 - 10 Approach Spans – Painted Steel Multi-Girder on R/C Multi-Column Bents
 - 34 Mainline Spans – Painted Steel Girder / Floorbeam / Stringer on R/C Hammerhead Piers
 - 6 Pin & Hangers
 - 5188' - Mainline Structure Length
- 5 Connecting Ramps
 - Curved Steel Multi-Girder on Hammerhead Piers

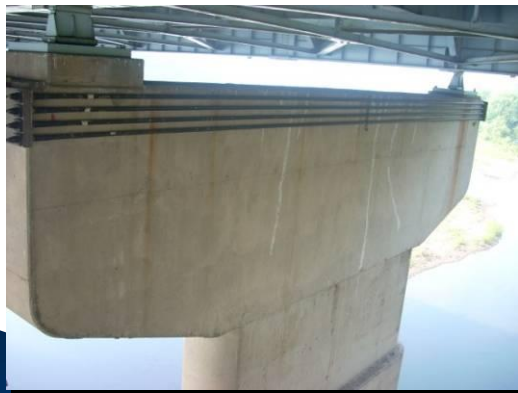
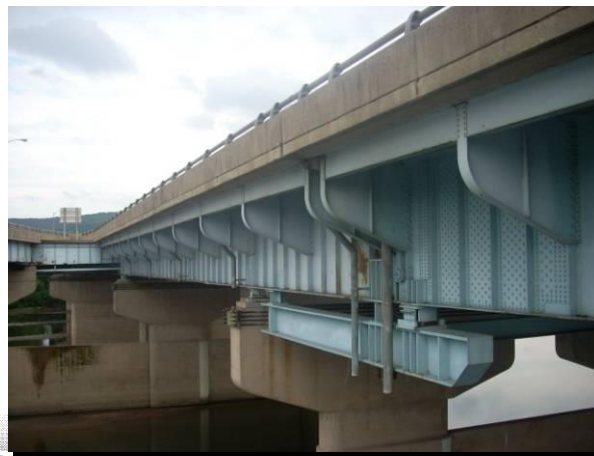
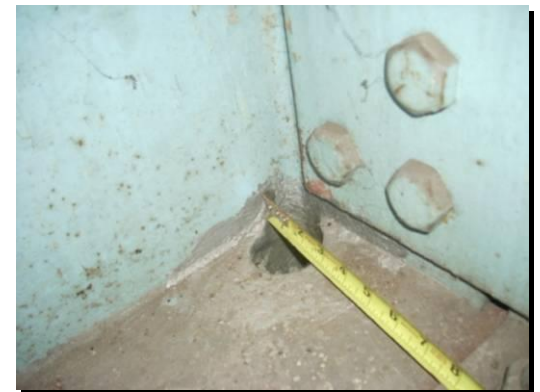
- 1974 Latex Modified Concrete Wearing Surface
- 1990 Post Tensioned Pier Caps 7-41
- 1990 Auxiliary Bearing (Catcher Beams) Installation at Pin & Hangers
- 2001 Hoan-like Details drilled

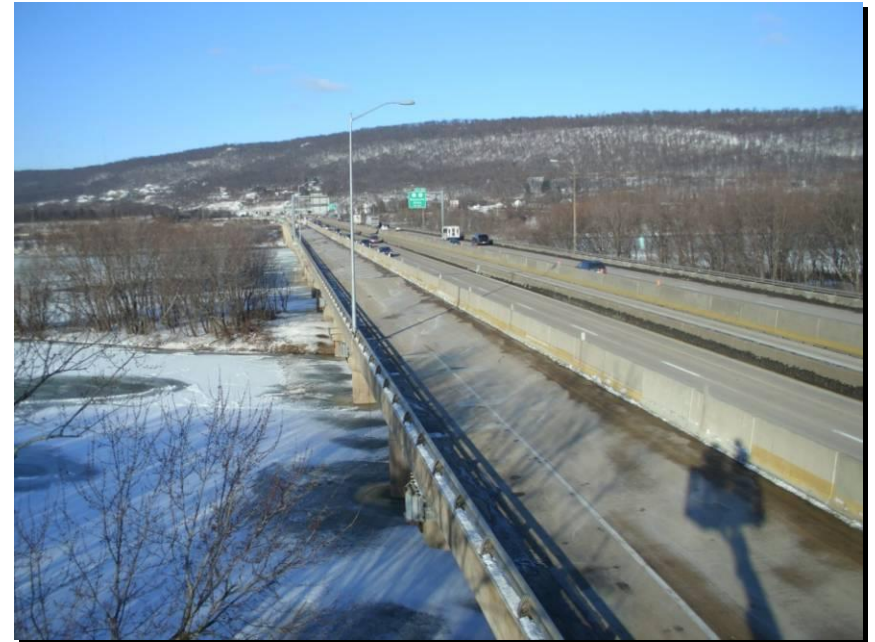
- Ground Penetrating Radar
 - Compared GPR to chain drag
- LMC Overlay
 - Deck had <1% debonding/delaminated concrete
- Deck Joints
 - Sliding Plate Joints
 - Other Leaking Joints (old version of strip seal joints)
 - Neoprene Troughs under Tooth Dams had Failed

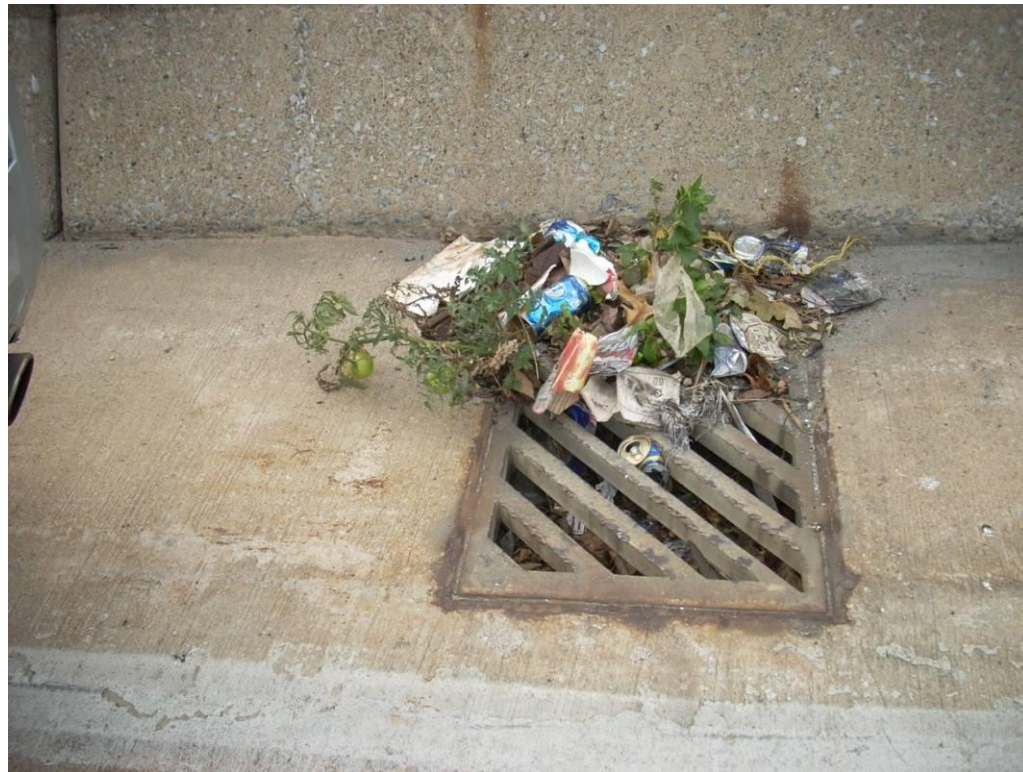
Photo 6

- **Inspection – Deck Photos**
 - Inspection Findings

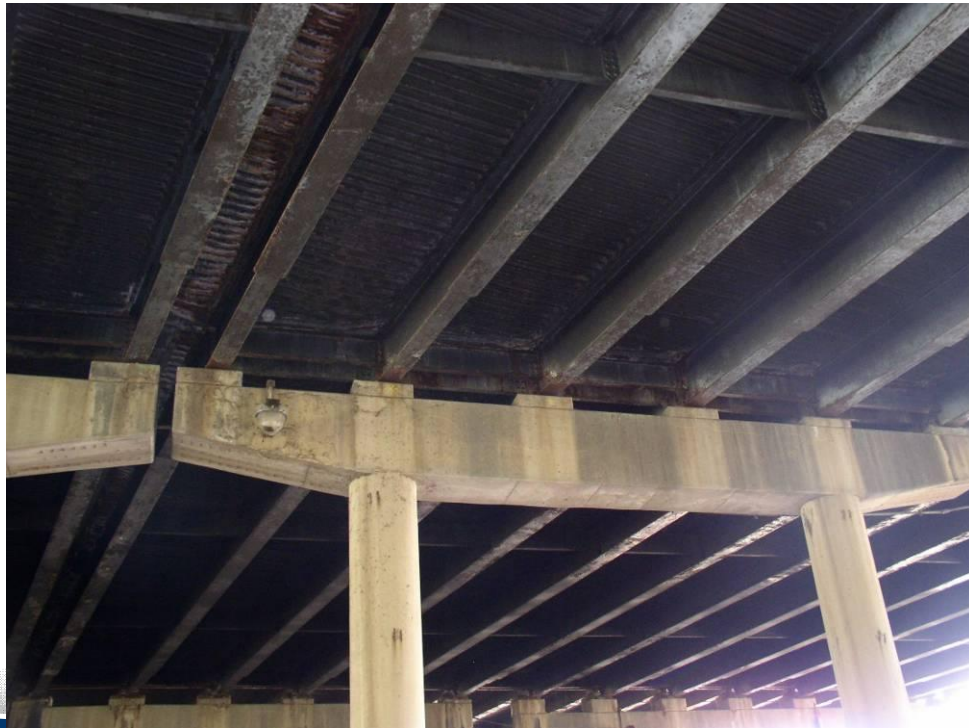
- **Inspection – Superstructure Approach Spans**
 - Beam End Section Loss Requiring Repairs in 2007
 - Other Beam End and Steel Deterioration
 - Frozen Bearings
 - Paint Failure

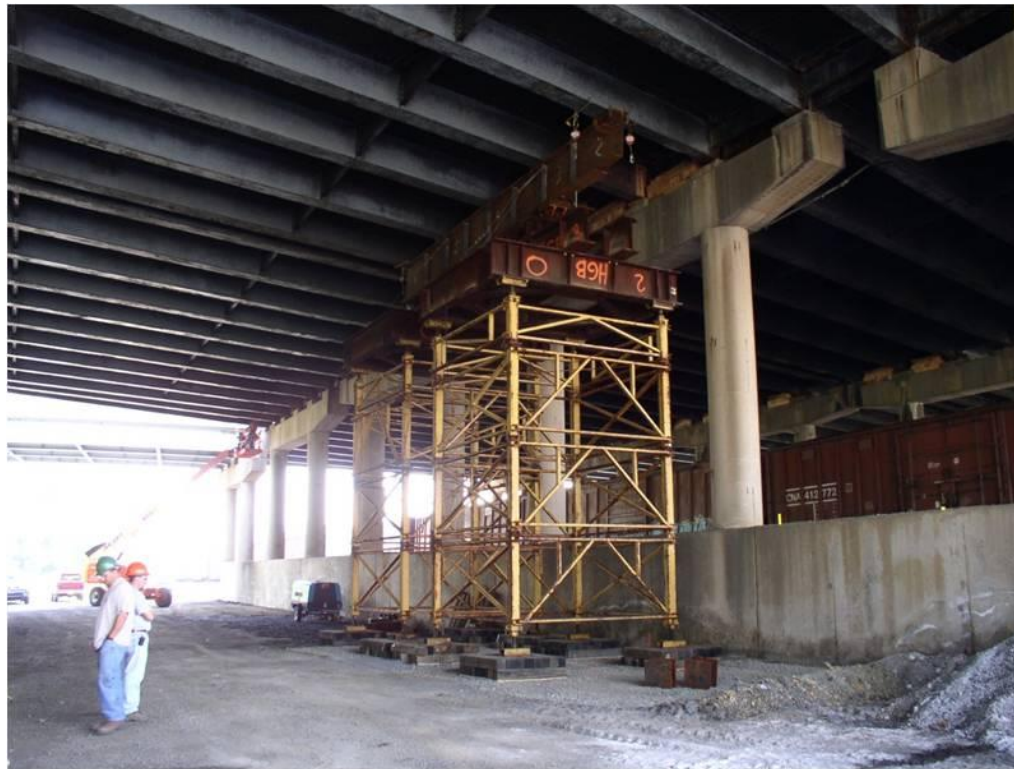
- **Inspection – Beam End Repairs**
 - Temp Support Towers Utilized and Traffic Maintained

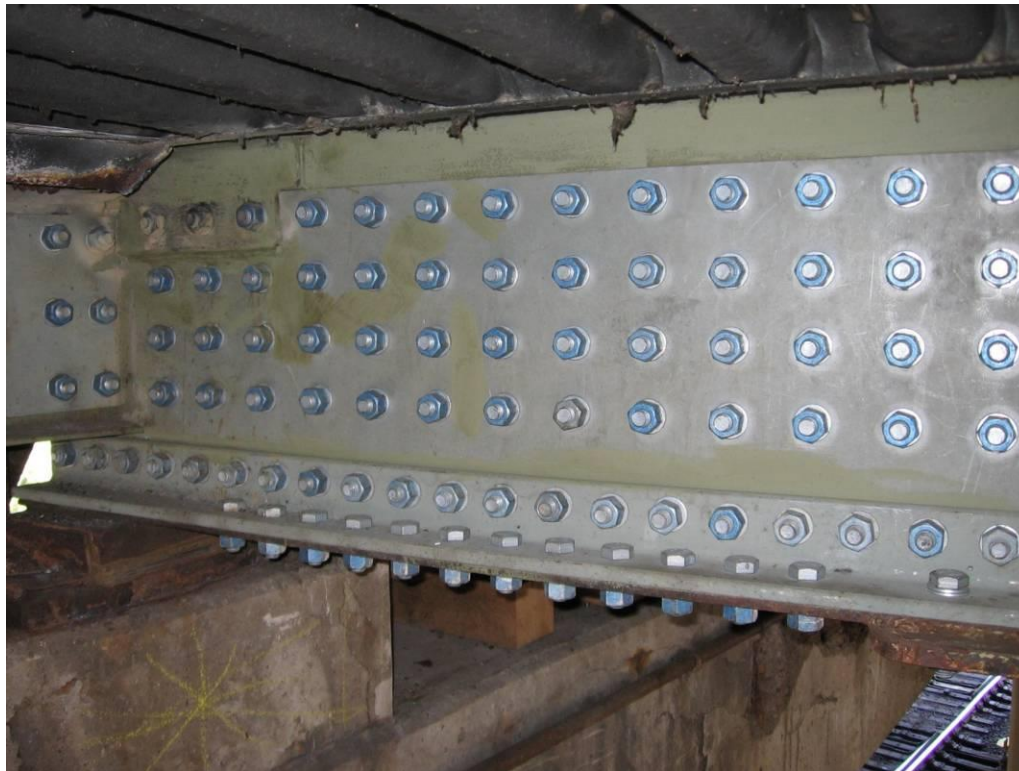
- **Inspection - West Shore Beam End Repairs**
 - GF also designed bolted steel plate repairs

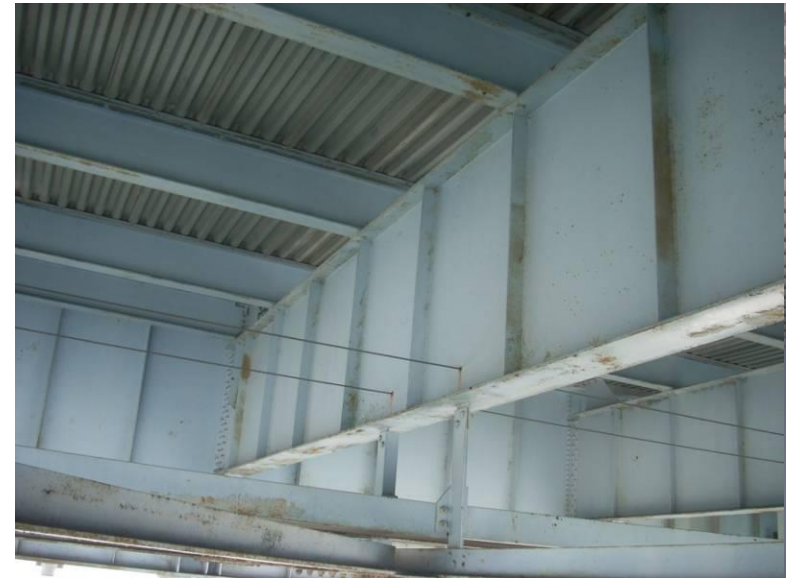
Photo 7

1. Floorbeam Cracks
2. Section Loss on Double FBs
3. Auxiliary Bearing Failure
4. Intersecting Welds
5. SIP Forms Falling
6. Hoan Details
7. Other Fatigue/Fracture Details

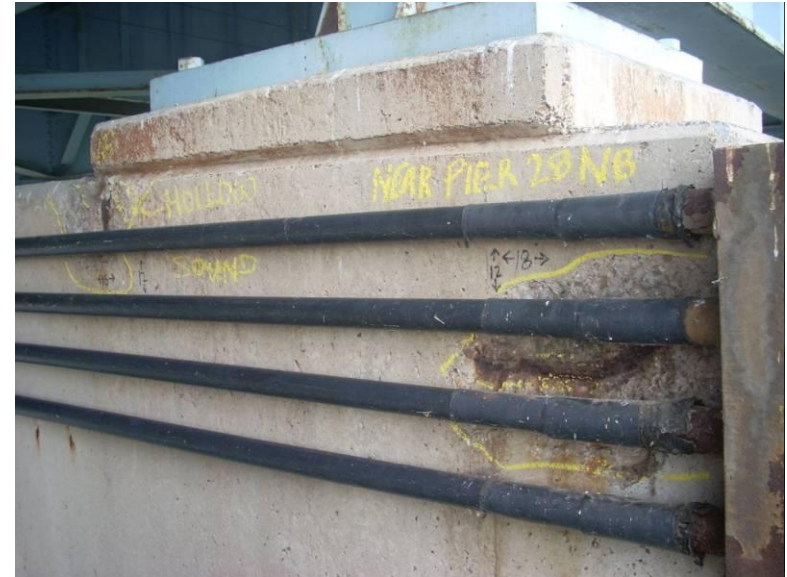
Photo 9

- High Chloride Content
 - 20.2 lb/cy found
 - DM-4 states 1.4 lb/cy = corrosion
- Pier 6, 42, & 43 Heavy Spalling & Delam.
- Voids around Footings
- Vert. Cracks on Hammer Heads
- Pedestal Spalls
- Spalling at P/T End Blocks

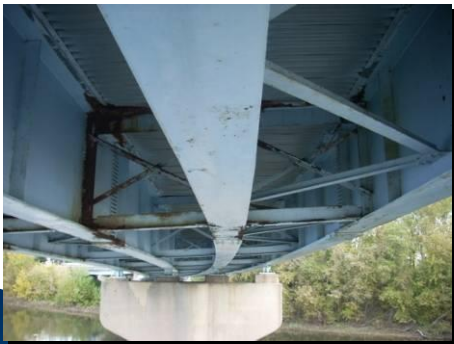
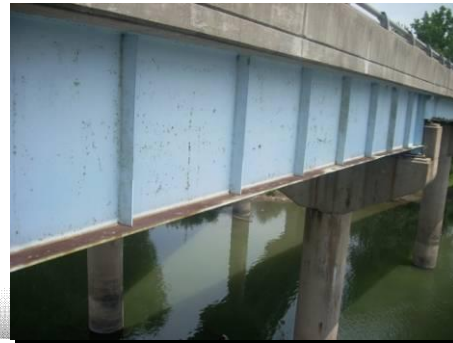
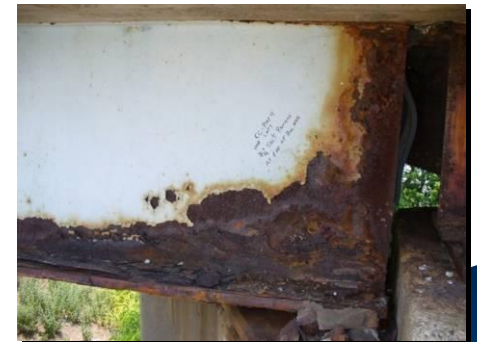
- Ramps B & C – Paint Failure, No Significant Issues
- Ramp A-A – Heavy Section Loss to Steel Members under deck open joint
- Ramp B-B – Rust w/ minor Sect. Loss - top of outside flange
- Ramp C-C – Heavy Rusting & Beam End Section Loss
- Ramps B-B & C-C - Spalling & Delam. on piers

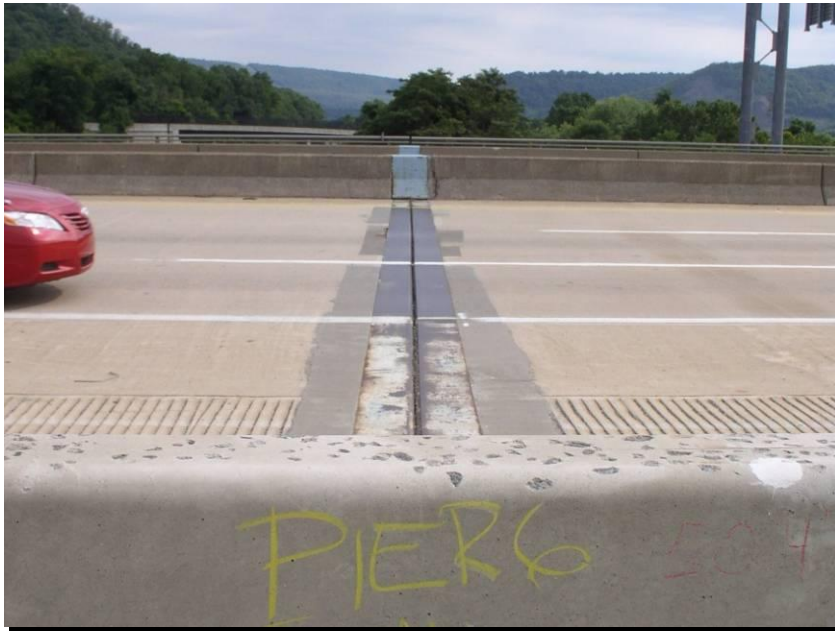
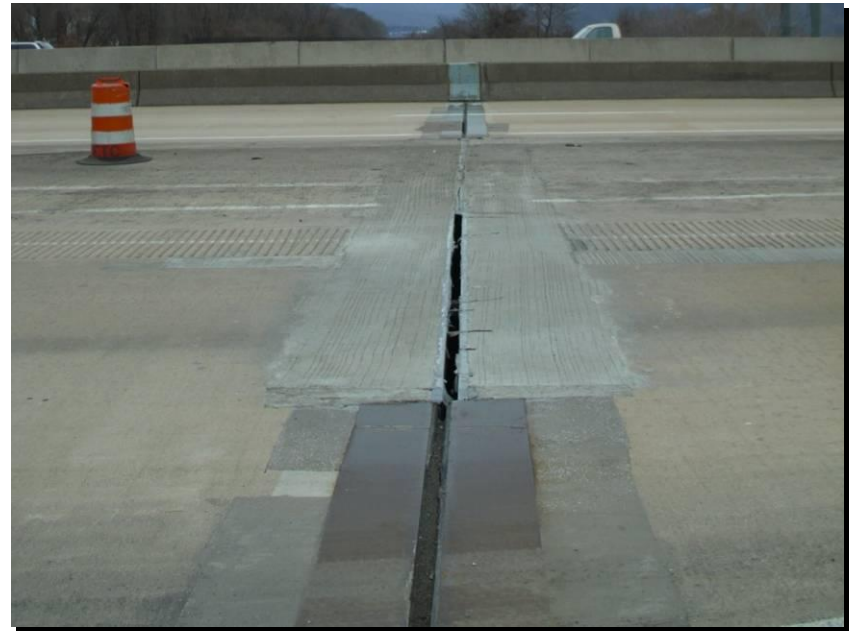
- 6 Locations - Leaking Joints or Sliding Plates
- Repair – Replace all leaking joints & sliding plate joints w/ Strip Seals

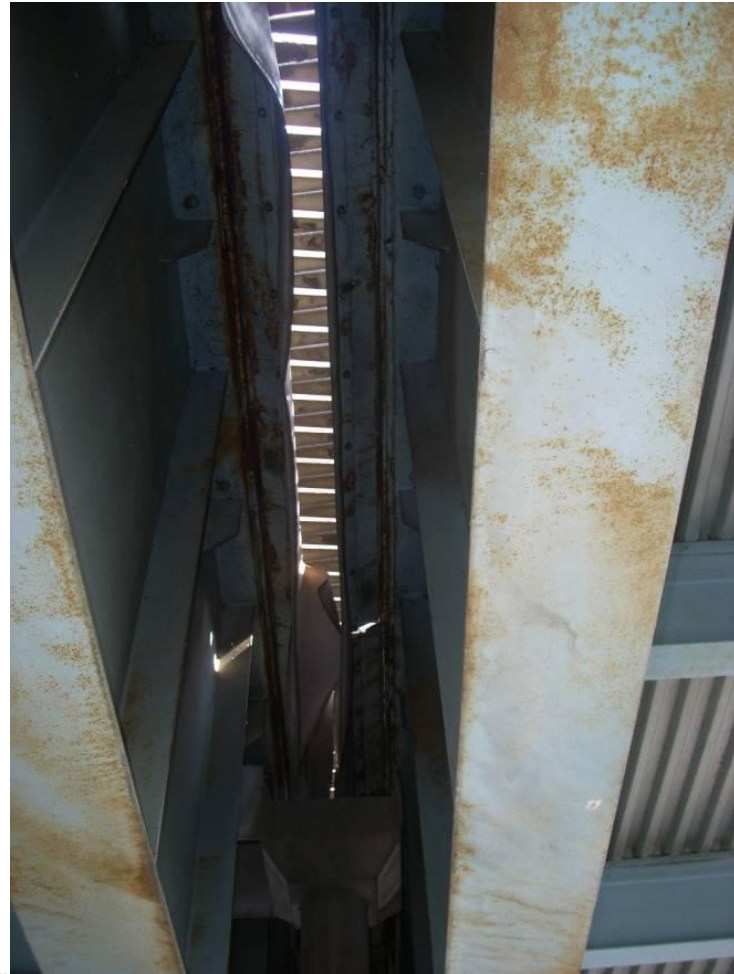
- **Rehabilitation - Deck**
 - Tooth Dam Troughs torn

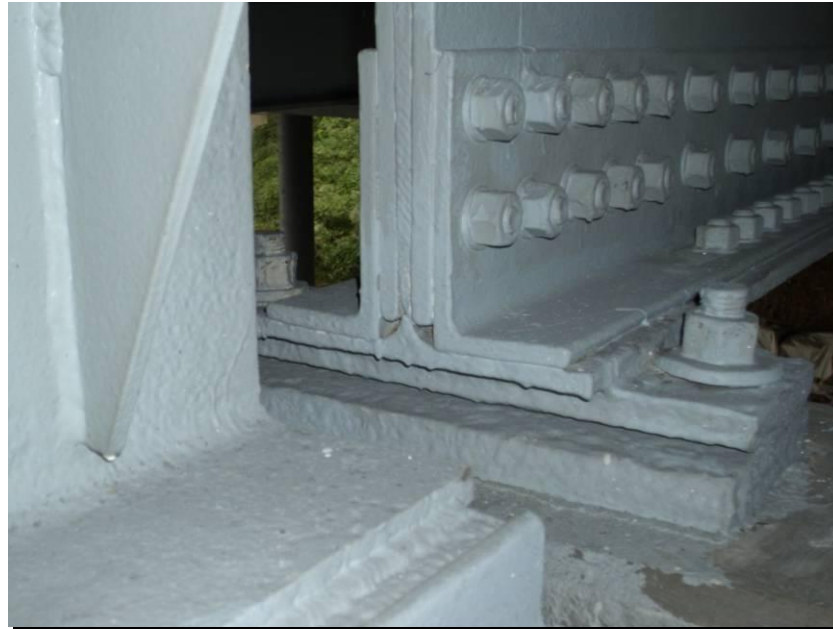
- Previous Beam End Repairs (July 2007)
- Additional Repairs – Bolted Steel Plates (35 Locations at Piers 2 and 3)

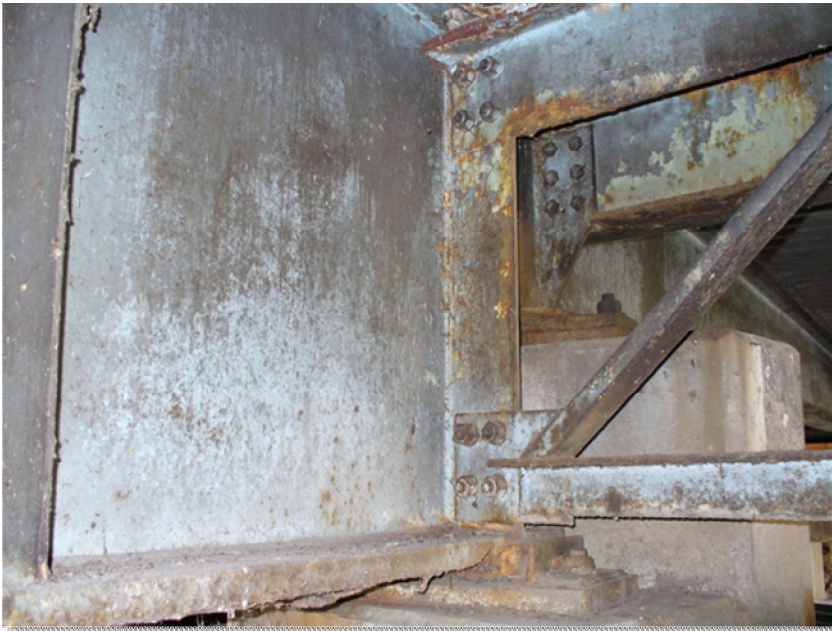
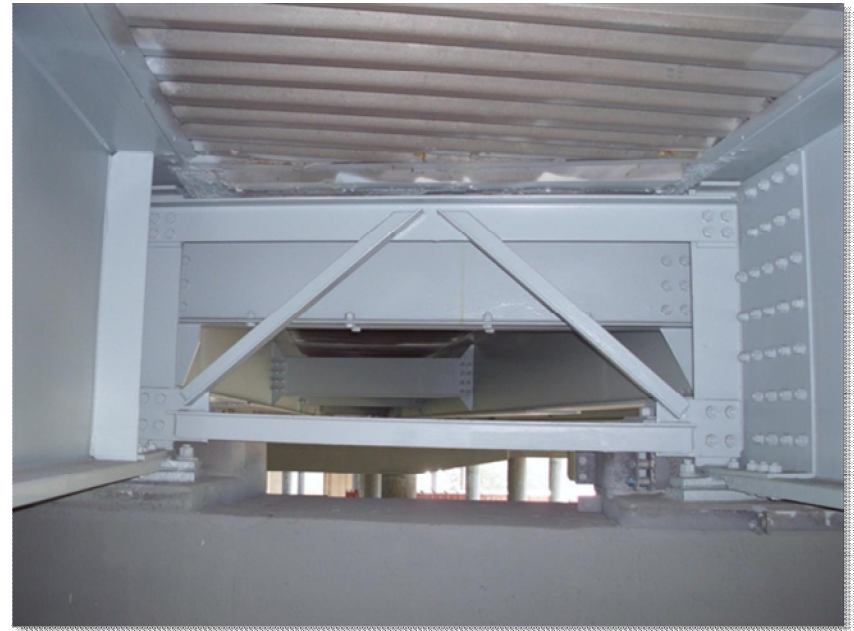
- Type 1 Repairs at K-frame Diaphragms
- 8 Locations at Pier 1

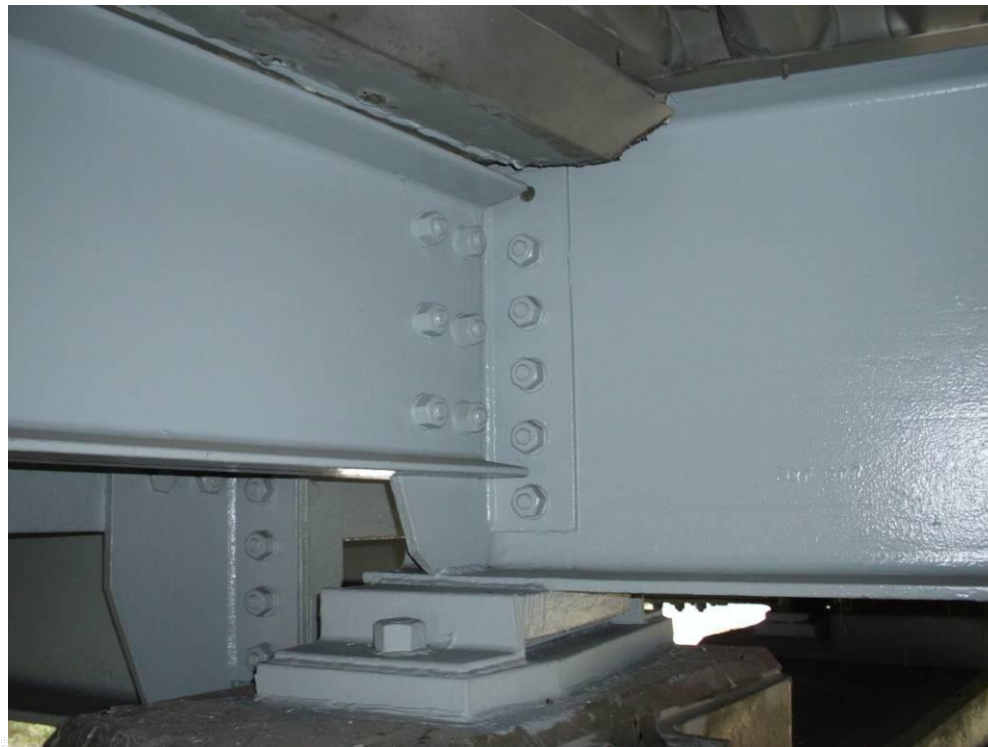
- **Rehabilitation – Superstructure**
 - Type 2 Repairs at Existing Channel Diaphragms
 - 35 Locations at Piers 1, 2, and 3

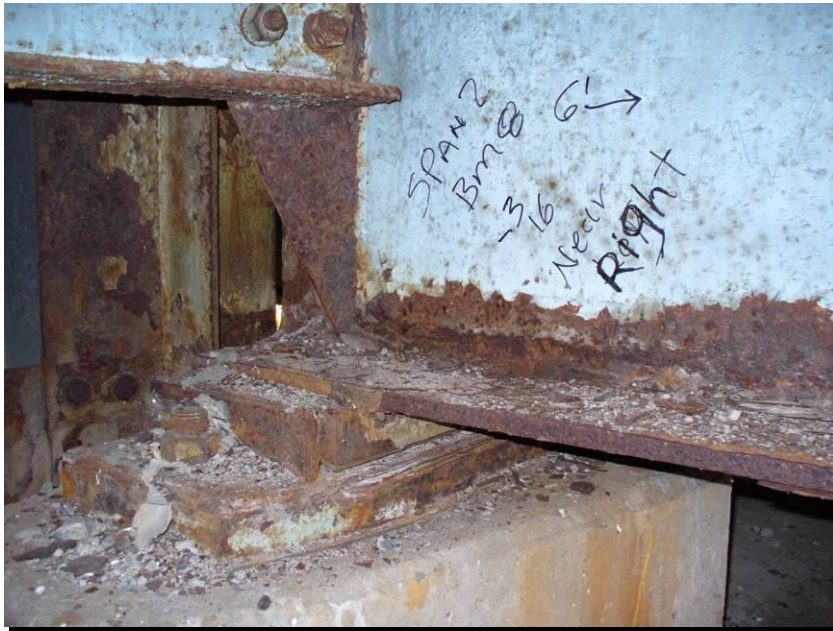
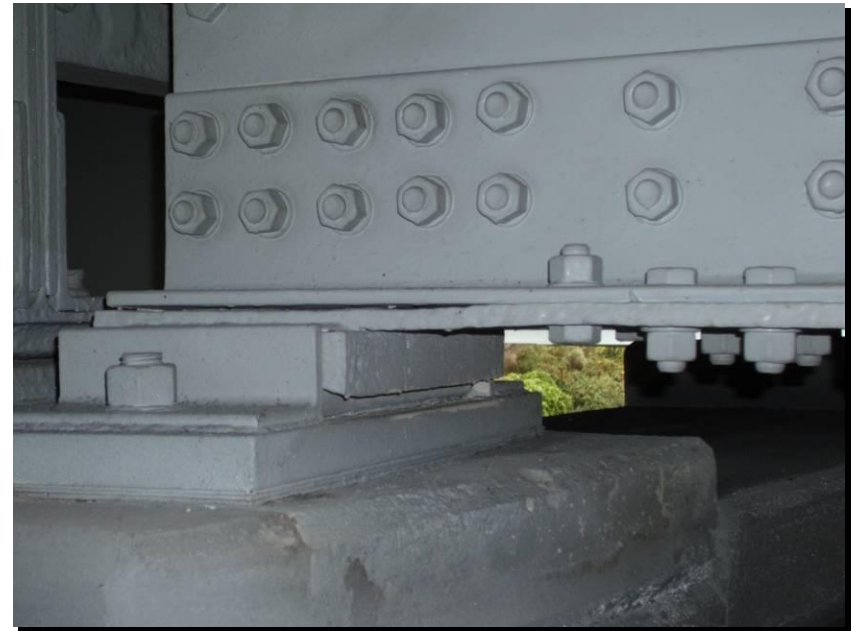
- Frozen Sliding Bronze Plate Bearings
- Repair - Replaced in-kind (168 Locations; all Exp. Brgs in Spans 1-6)

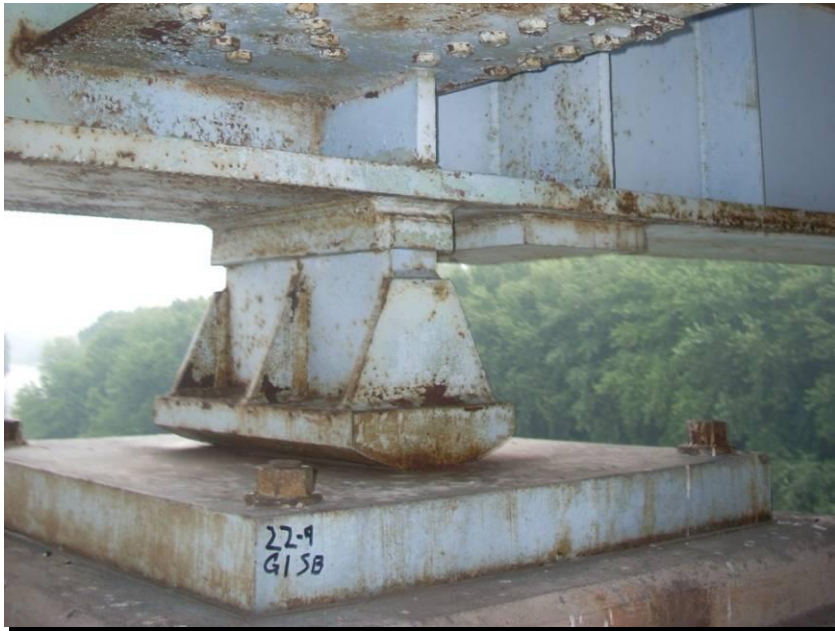
- Rocker Bearings – Spans 8-41
- Repair – Welded Wedges to Masonry Plates (127 Loc. - Seismic Retrofit)

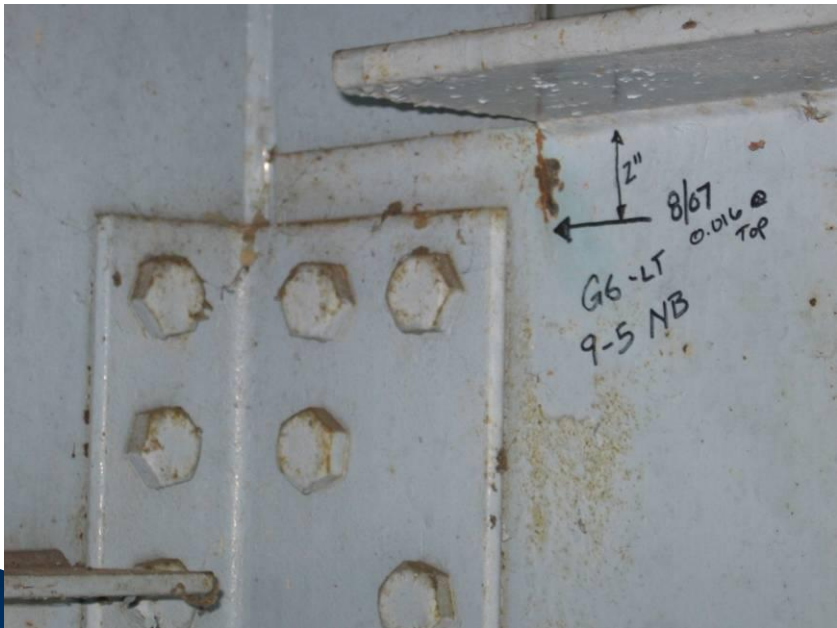
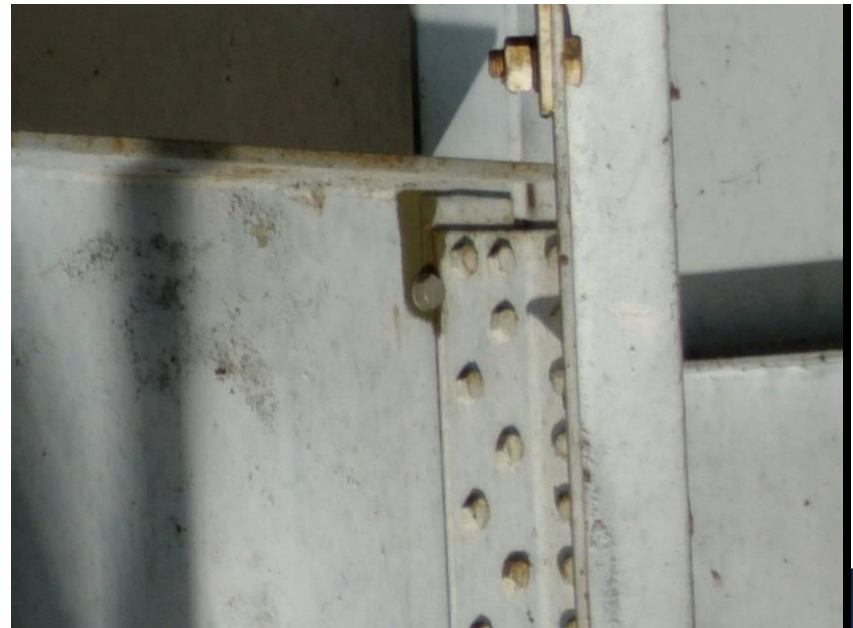
- Floorbeam Cracks at end of flange weld
- Repair – Sawcut Crack, Drill Arrest Hole, & Install H.S. Bolt
- 34 Locations

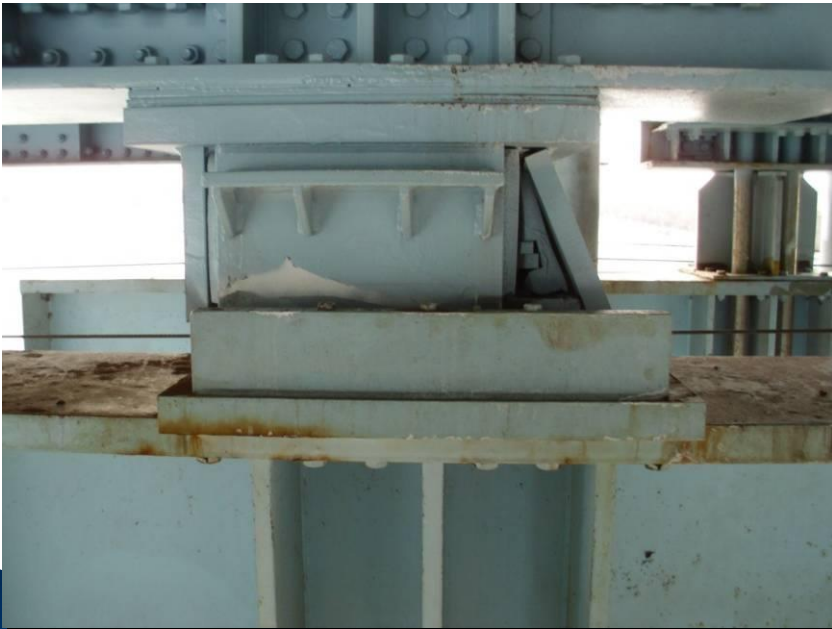
- **Rehabilitation – Superstructure**
 - Auxiliary Bearings (Catcher Beam) Failure
 - Repair - Prepared by M&M (original designer)
 - 22 Locations

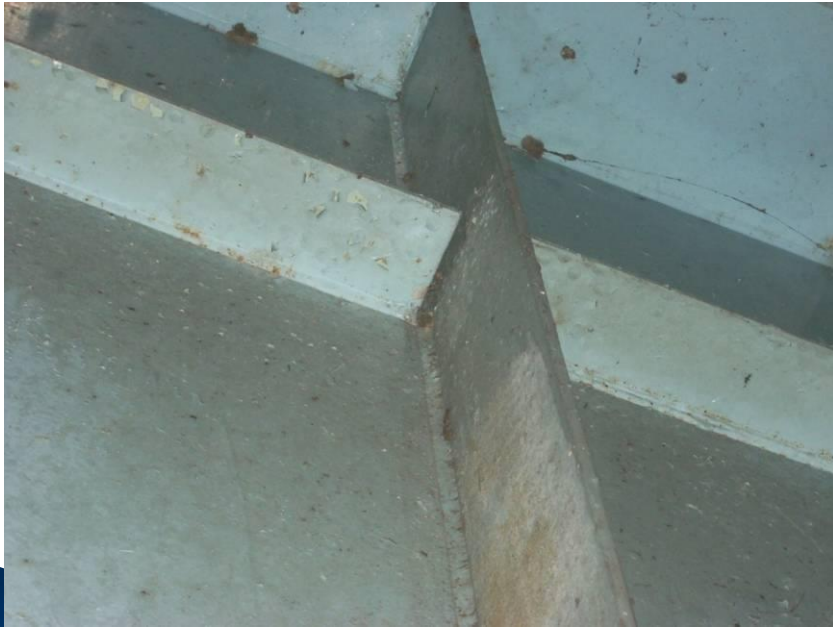
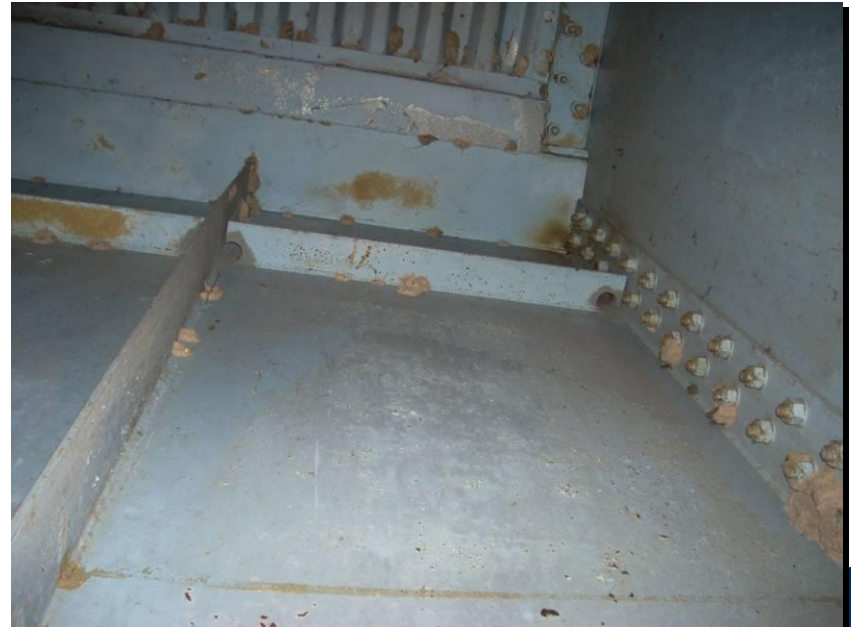
- Inters. Welds in Tension Zones – Trans. / Long. Stiff
- Repair – Remove weld material by drilling large hole
- 971 Locations

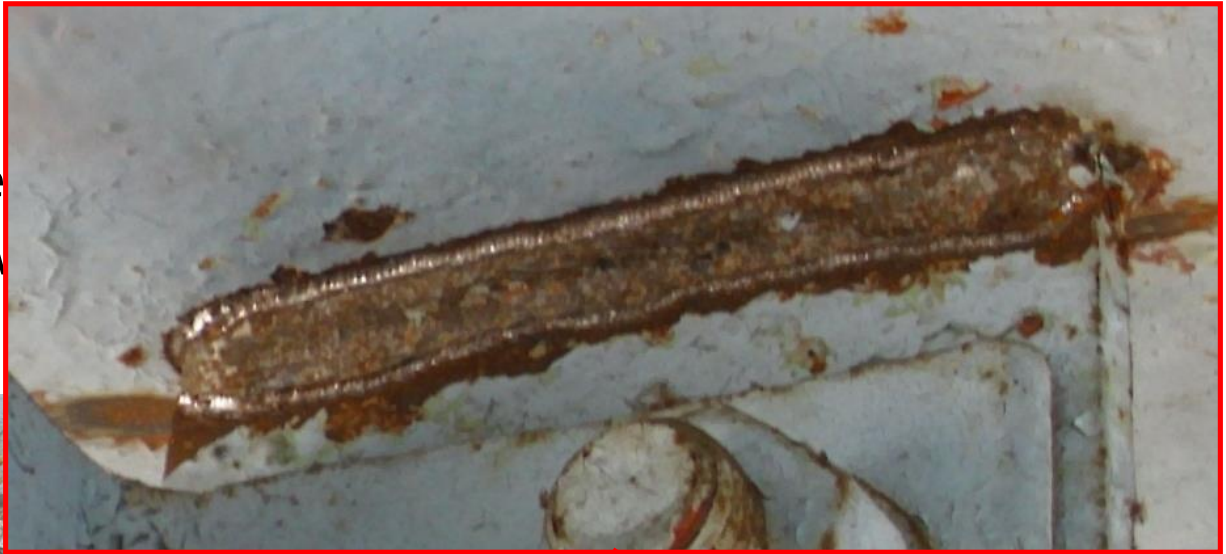
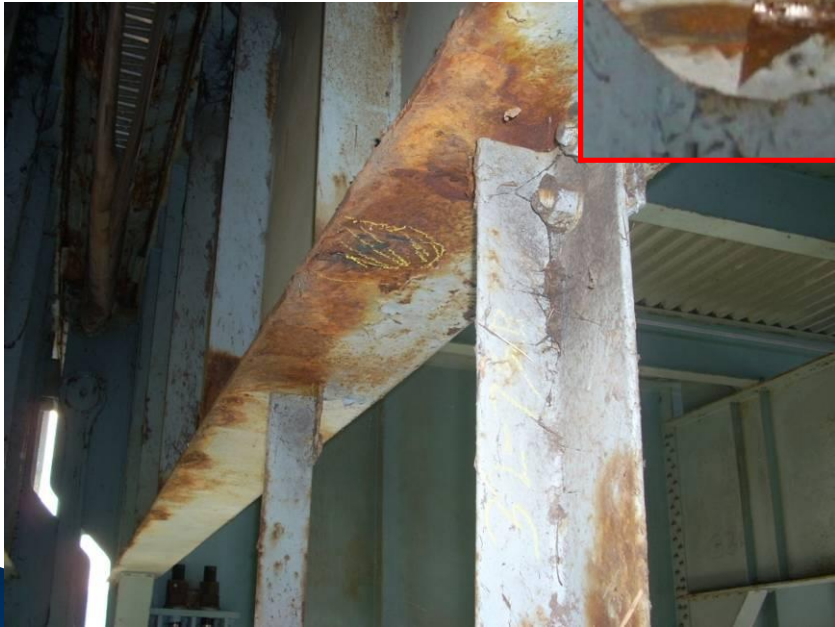
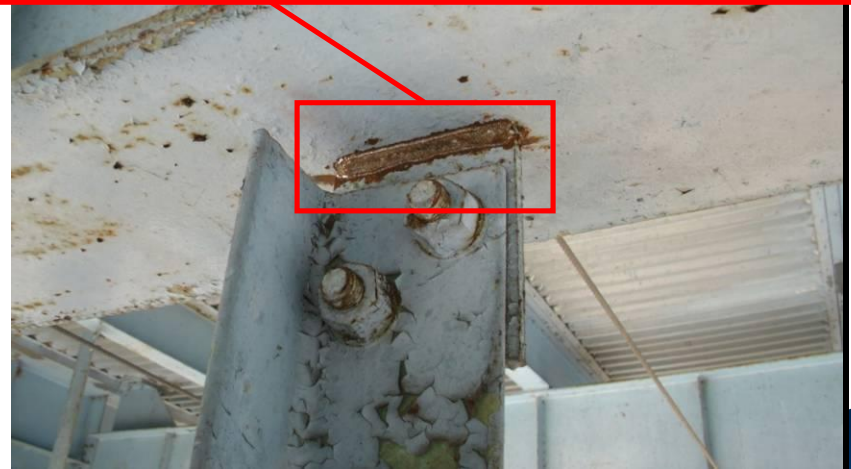
- Fatigue Details – We
- Repair - Peening at V
- 282 Locations

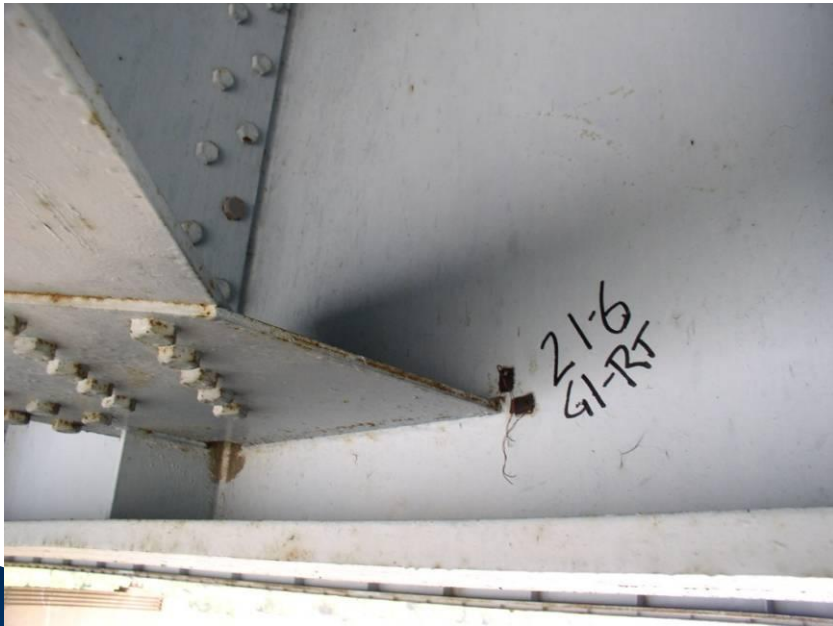
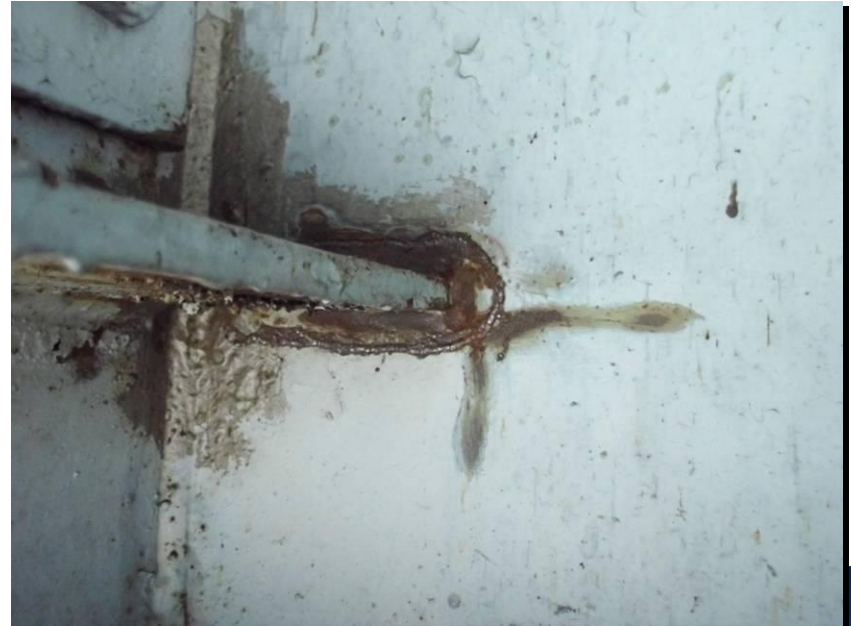
- Fatigue Details – Weld Termination at Gusset Plates (Fatigue Cat. E)
- Repair - Peening at Weld Toe
- 1900 Locations

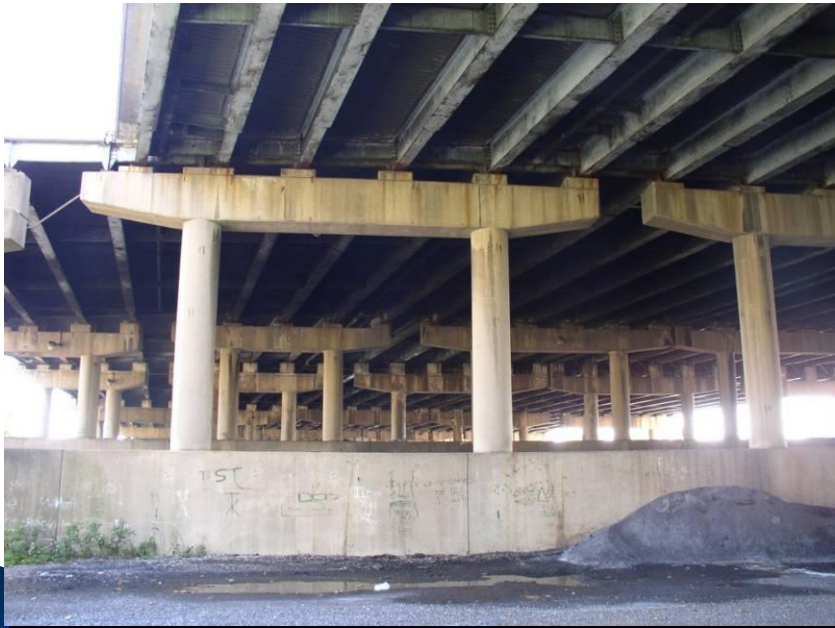
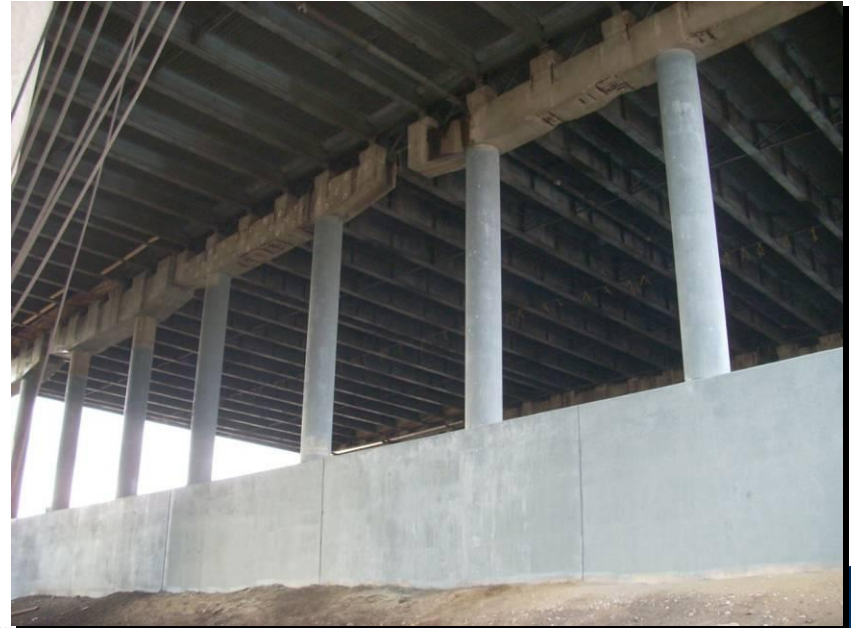
- High Chloride Content
- Repair - Piers 1 thru 5 – Activated Arc Spray Zinc Coating
- Repair - Pier 6 – Embedded Anodes

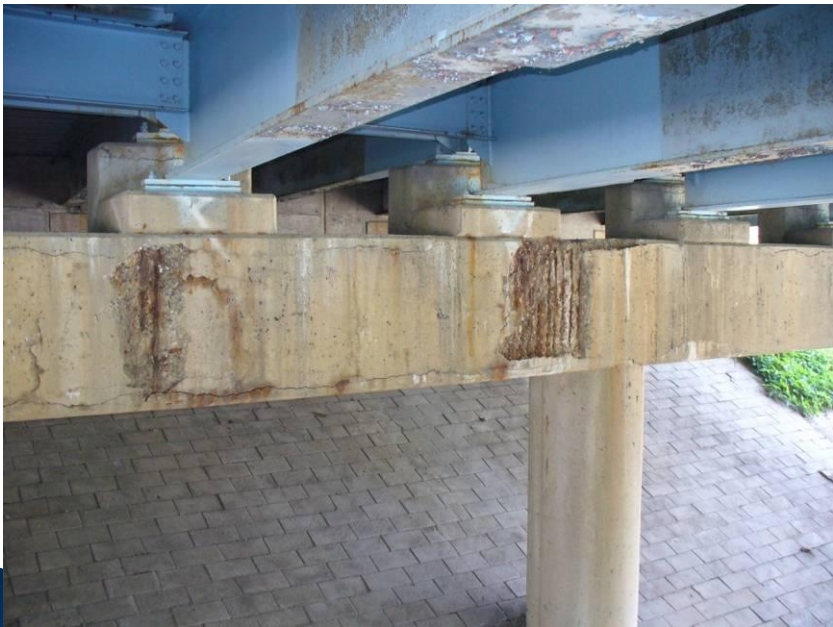
- Concrete Caps with Heavy Delamination & Spalling
- Piers 6, 42, 43
- Repair – New concrete encasement installed around caps.

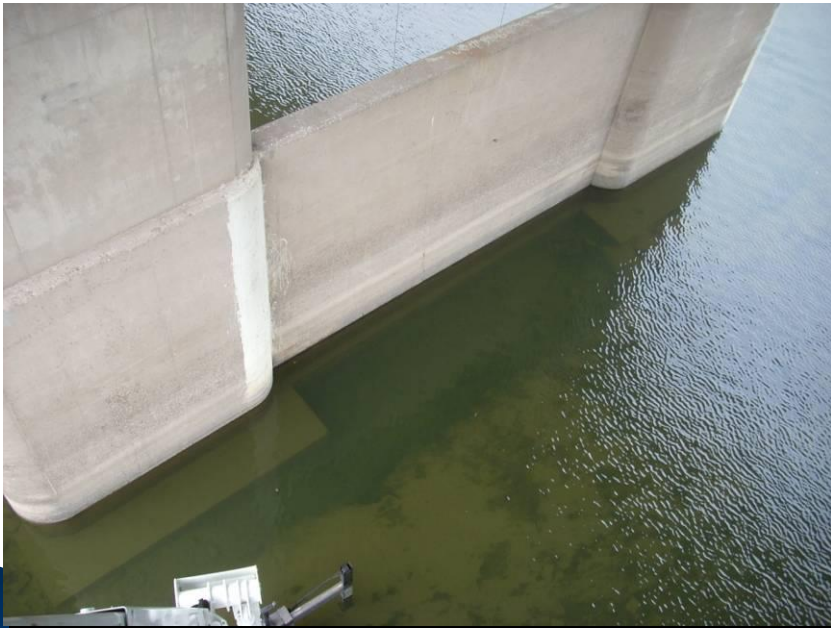
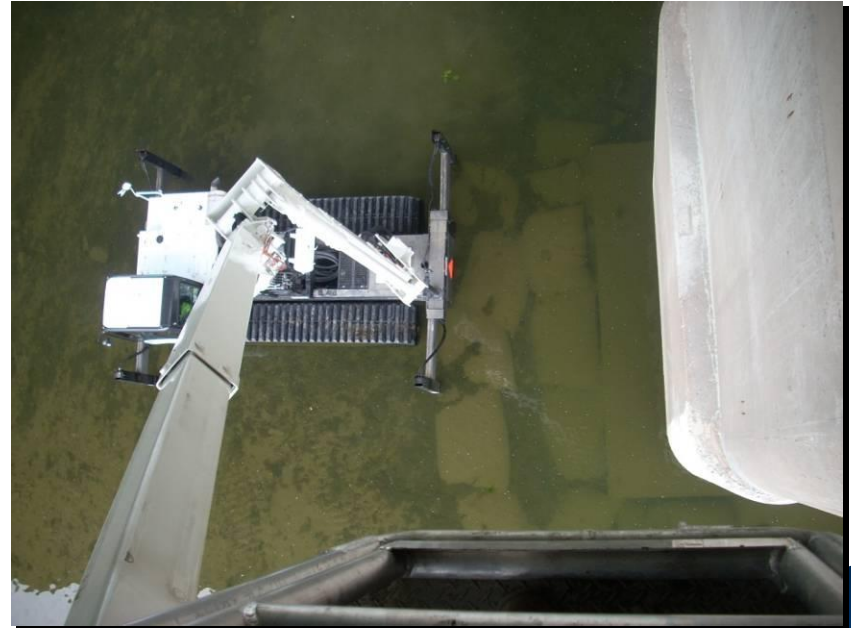
- Voids Around River Footings
- Piers 19, 20, 26, 27 and 38
- Repair – Install Intrusion Grout Bags

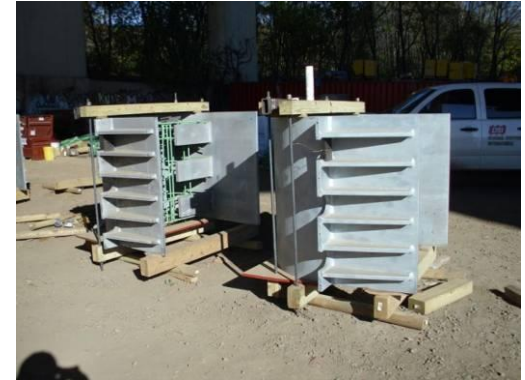
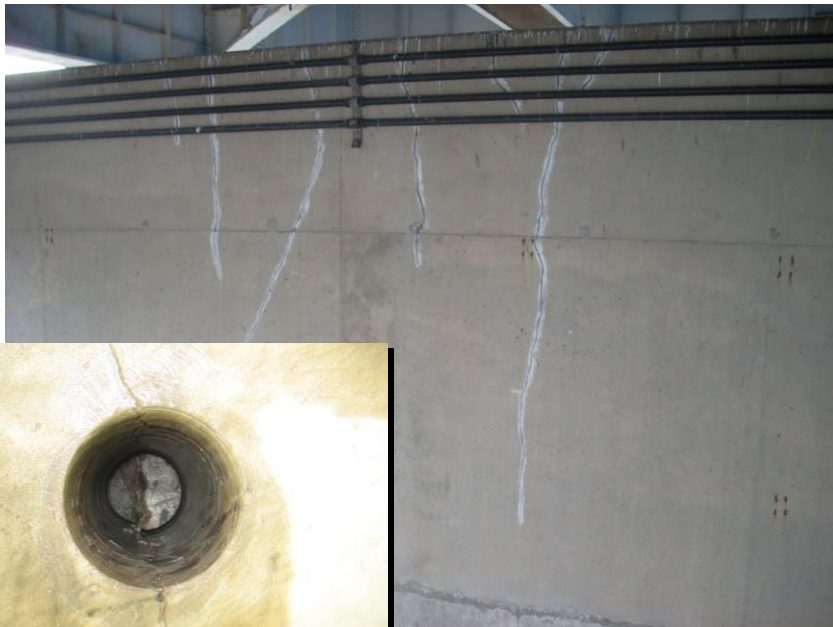
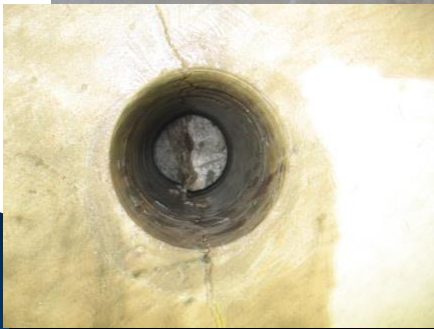
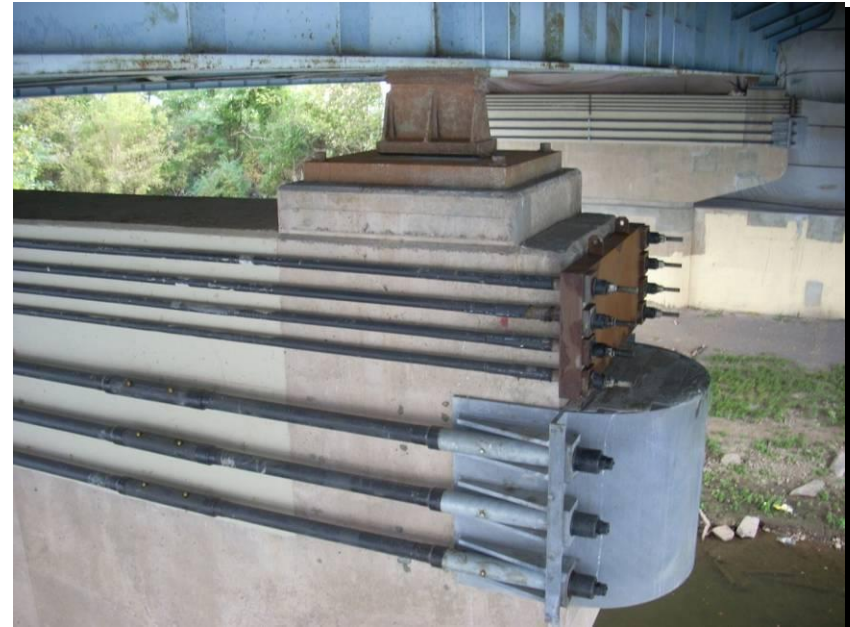
- Pier Cap Cracks
- Repair – Additional Post Tensioning
- Piers 8-41 Northbound and Southbound

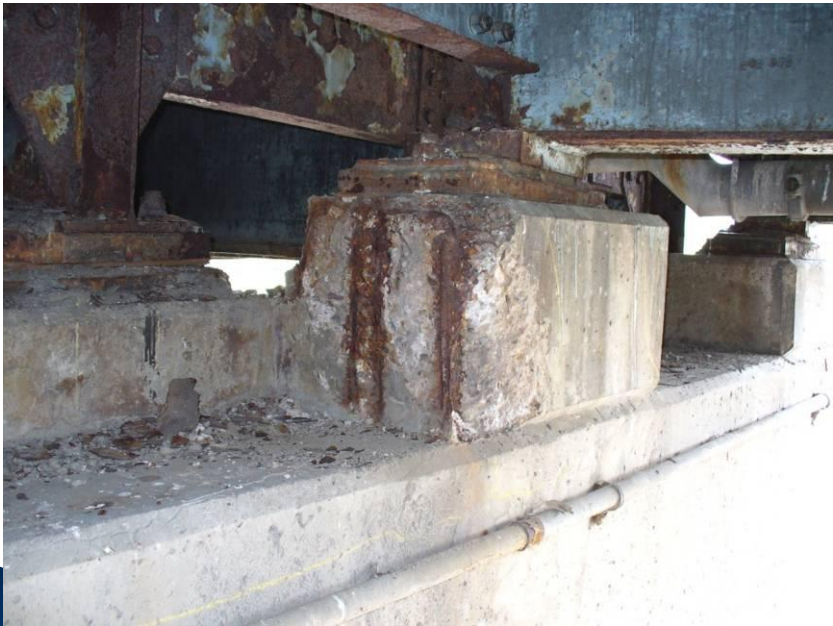
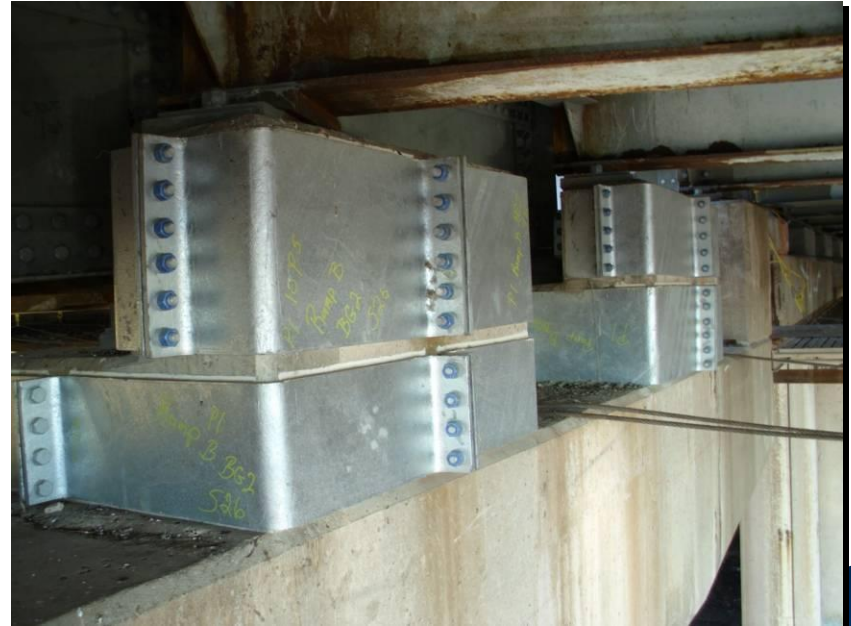
- Pedestal Spalls
- Repair – Install Fabricated Steel Retainers
- 118 Locations
