pennsylvania
DEPARTMENT OF TRANSPORTATION

GEORGE N. WADE BRIDGE REHABILITATION

I-81 Over the Susquehanna River,
Norfolk Southern Railroad,
and North Front Street

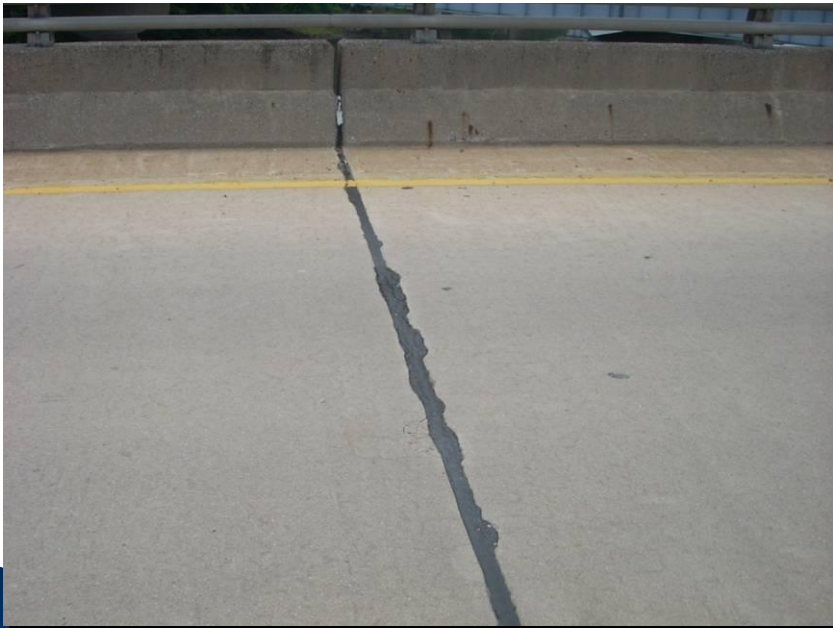
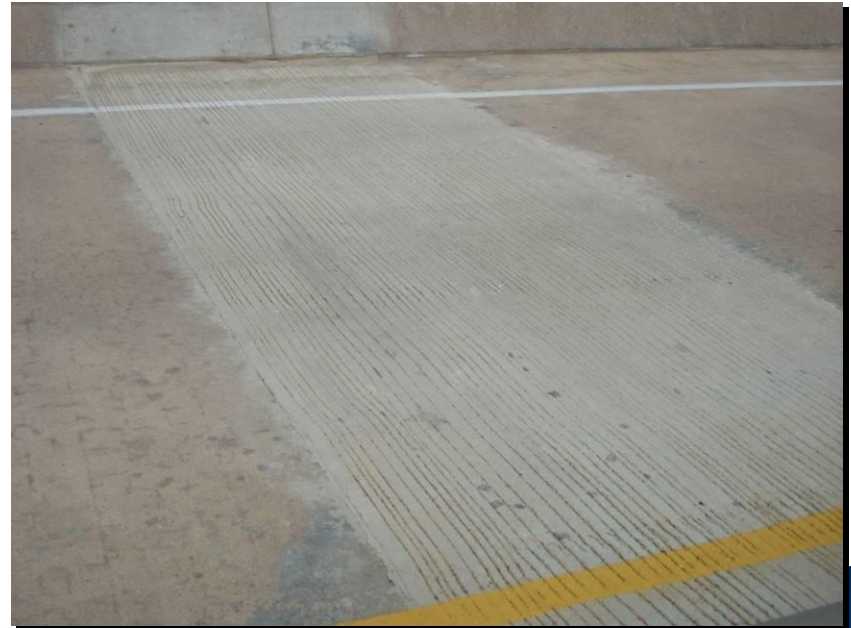
- Ramp A-A
- Leaking Open Joint Causing Heavy S/L on Steel Below
- Repair – Removed Joint

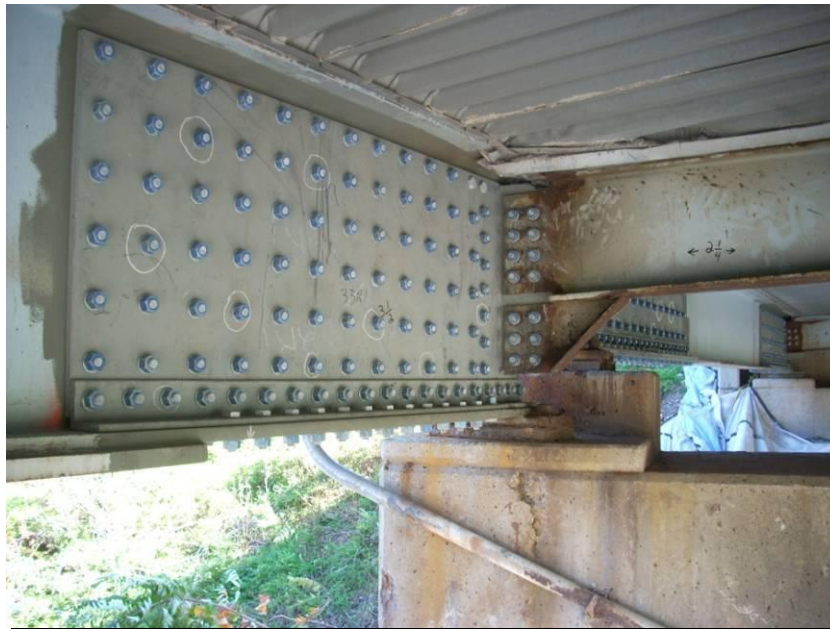
- Ramp C-C had most extensive repairs
- Beam End Section Loss
- Repair – Bolted Steel Plates
