Liberty Bridge Fire Event: Response Evaluation for Jacking Operations and Ratings

ABCD Susquehanna Chapter

Thomas Murphy, Ph.D., P.E.
Andrew Adams, P.E.
Nohemy Galindez, Ph.D., P.E.
Christopher Smith, P.E.

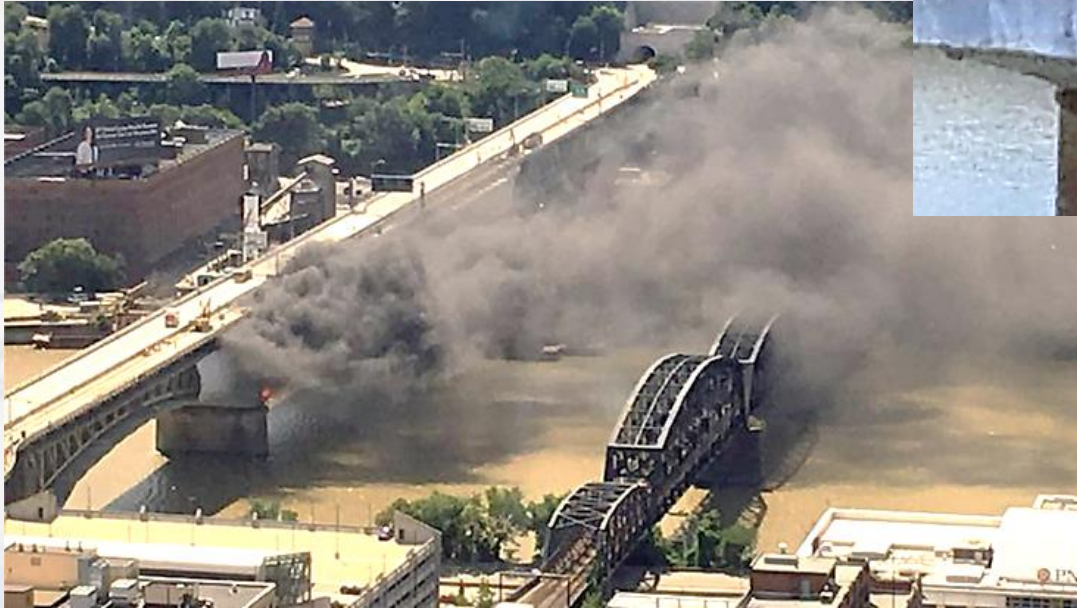
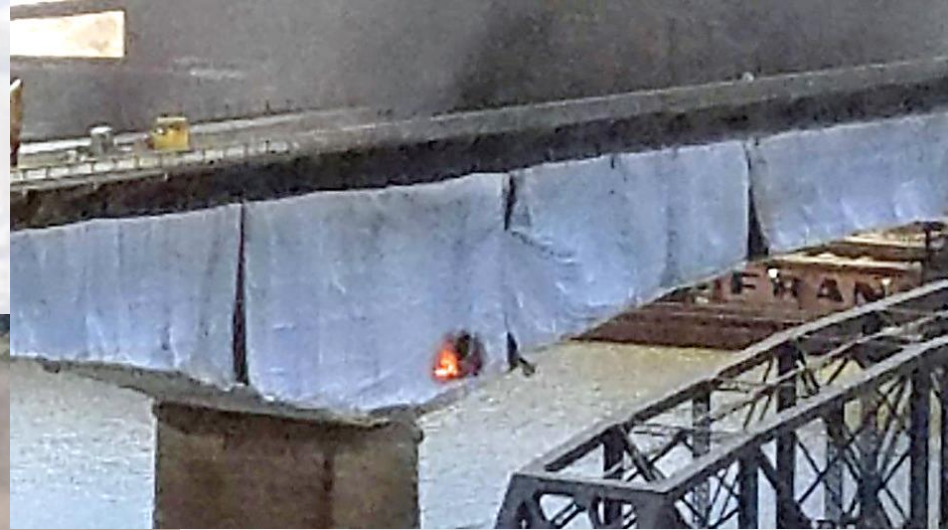
- Started Sept. 2, 2016, 1:00pm

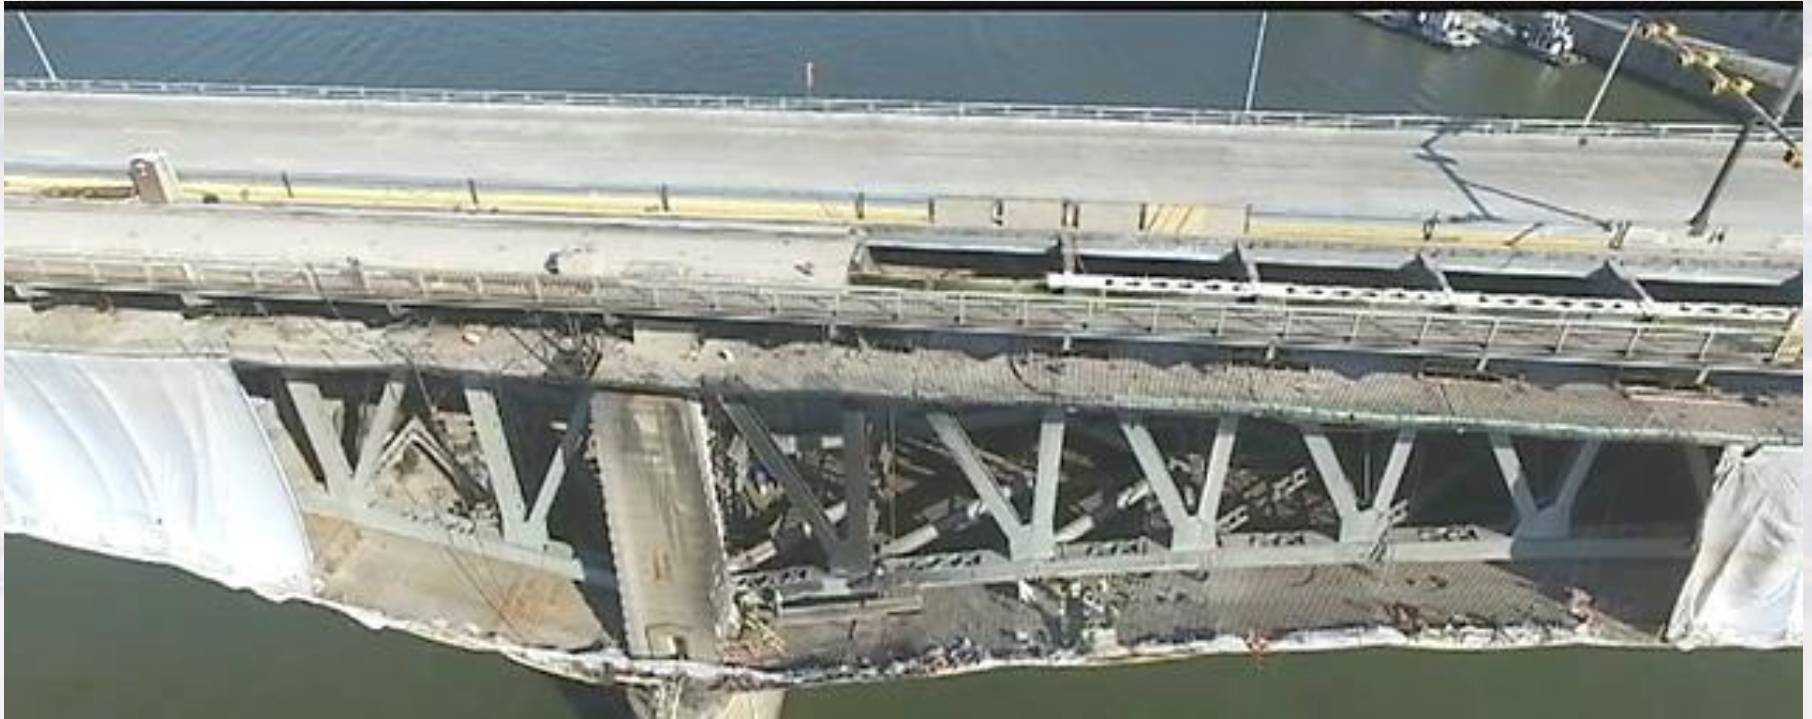
- ▶ Extinguished ~30 min. after arrival of City of Pittsburgh Fire Dep.

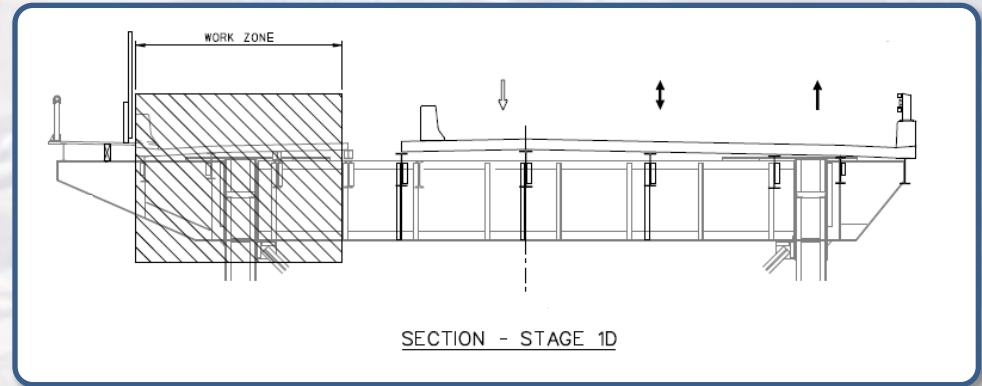
- Modeling of dead load
 - PP7-PP31 – Stage 1D
 - PP31-PP38 – New deck system
 - Results verified by comparison w/HDR model
- Modeling effect of fire damage on rest of truss
 - Apply temperature load to L31L32W to achieve desired displacement of L31W
- Variations to consider
 - Deck behavior – composite vs. non-composite action w/ truss
 - Pinned joints vs. fixed joints
 - Boundary conditions at expansion bearings and ends of cantilever span

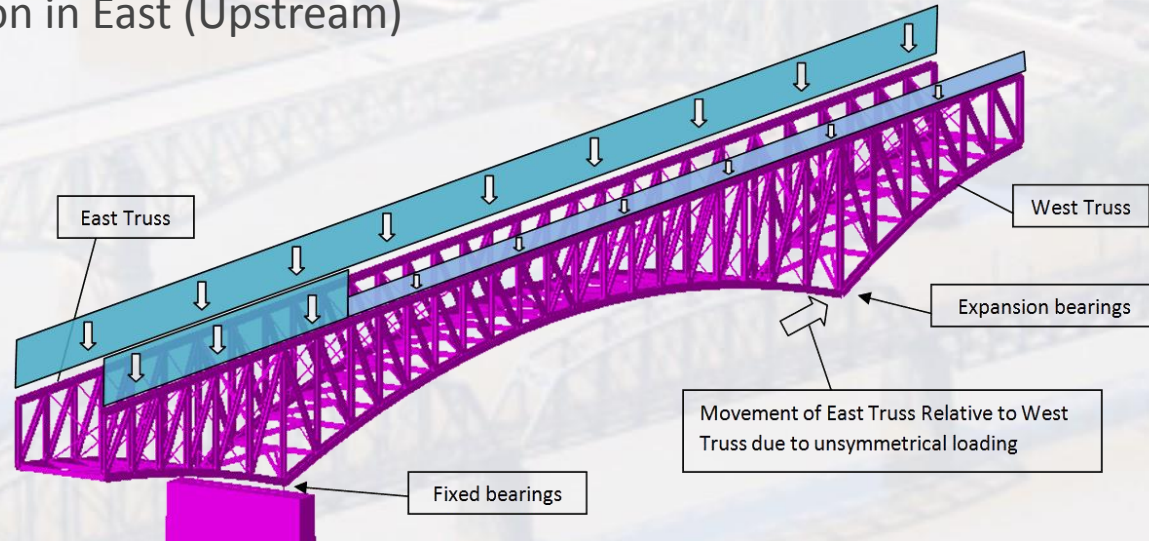
- 3D dead load effects
 - Unequal loading of truss lines causes loads in bottom lateral system and increased compression in East (Upstream) Truss

Member	2D Analysis DL (separate truss lines)	3D Analysis DL
L31L32 East	2353 k	2609 k
L31L32 West	2483 k	2003 k

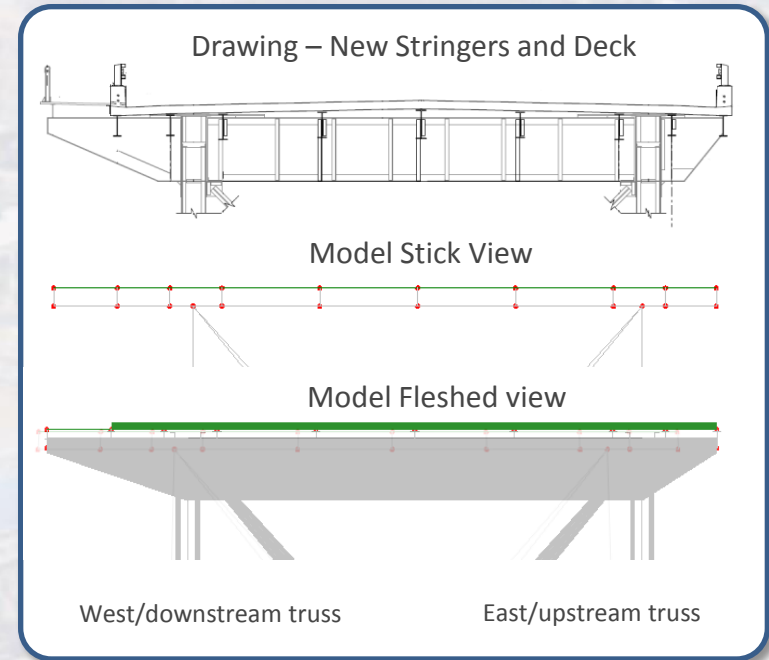
- Deck action significantly changes the behavior of the structure
 - Stiffness Comparison - Movement of L31N along L31L32N
 - w/deck stiffness, ~1100 k/in.
 - w/o deck stiffness, ~460 k/in.
 - Displaced Shape
 - w/ deck stiffness, much smaller lateral movements, more of a localized response
 - Lateral Bracing and Sway Bracing Forces
 - Structure much stiffer w/ deck active, larger forces developed
- So how did the actual structure behave?

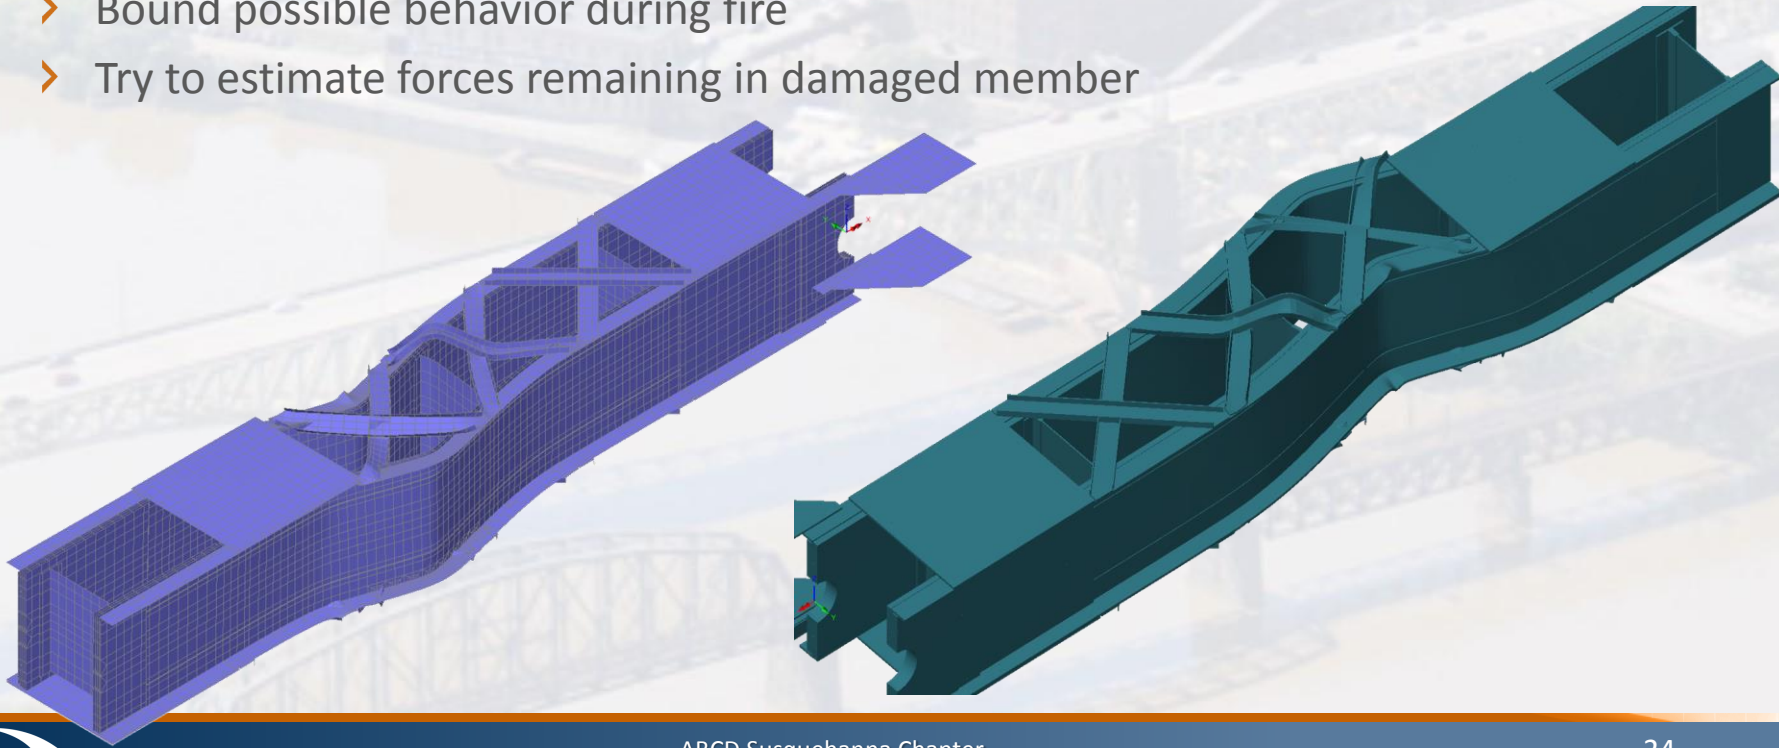
- Refined Local Analysis of Damaged Member
 - Bound possible behavior during fire
 - Try to estimate forces remaining in damaged member

- Plastic axial strains became a point of discussion
 - Plastic hinges forming under compression result in net axial compressive strains
 - In order to recover all the axial displacement, need to straighten member under significant tension loads
- Would jacking procedure accomplish complete axial recovery?
 - Conclusion (from Lehigh and MM work) – full recovery unlikely
- What effect would an incomplete recovery have on the ability of the structure to carry live loads?
 - Need to determine this and develop approach to rapidly update results based on actual response of bridge

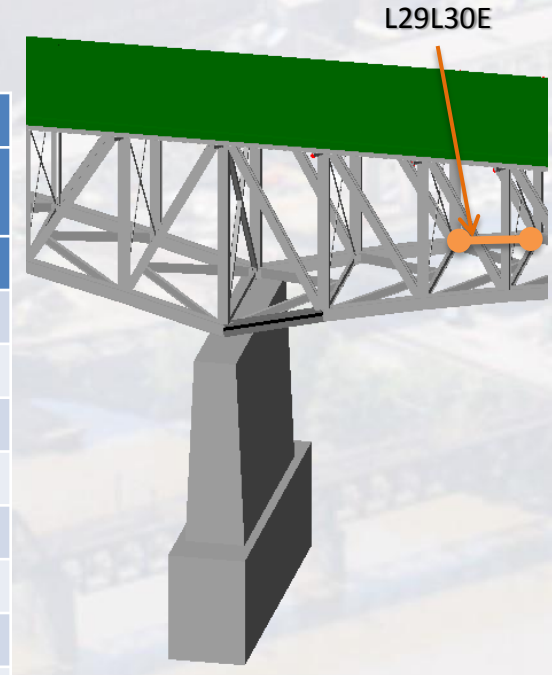
- Stage 1D: HS20 OR > 30 Tons
 - Critical Member – L29L30E (upstream)

Joint L31W Restored Displ.	HS20					
	Inventory		Operating		2015 Contract Rehab Steel*	Add'l Steel Req'd for 30Tons
in.	RF	Tons	RF	Tons	in. ²	in. ²
1.00	0.13	4.8	0.22	8.1	58	258
1.125	0.19	6.9	0.32	11.5		129
1.250	0.25	8.9	0.41	14.9		60
1.375	0.31	11.0	0.51	18.3		16
1.500	0.36	13.0	0.60	21.8		0
1.625	0.42	15.1	0.70	25.2		0
1.750	0.48	17.1	0.79	28.6		0
1.88	0.54	19.3	0.89	32.2		0

*Original design repair area for a minimum HS20 ORF of 1.5 in the final condition

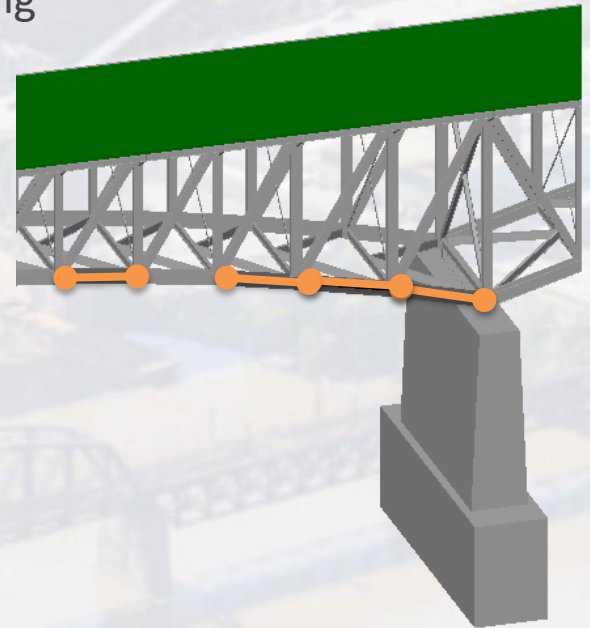
- Final Condition: HS20 ORF > 1.5
 - Four East LC members possibly require strengthening

Joint L31W Restored Displ.	Add'l Retrofit Steel Area			
	L27L28	L29L30*	L30L31	L31L32
in.	in. ²	in. ²	in. ²	in. ²
1.00	8	137	41	1
1.125	5	91	19	0
1.250	1	57	1	0
1.375	0	31	0	0
1.500	0	10	0	0
1.625	0	0	0	0
1.750	0	0	0	0
1.88	0	0	0	0

*3D effect relieved from strengthening plates if installed during Stage 1D

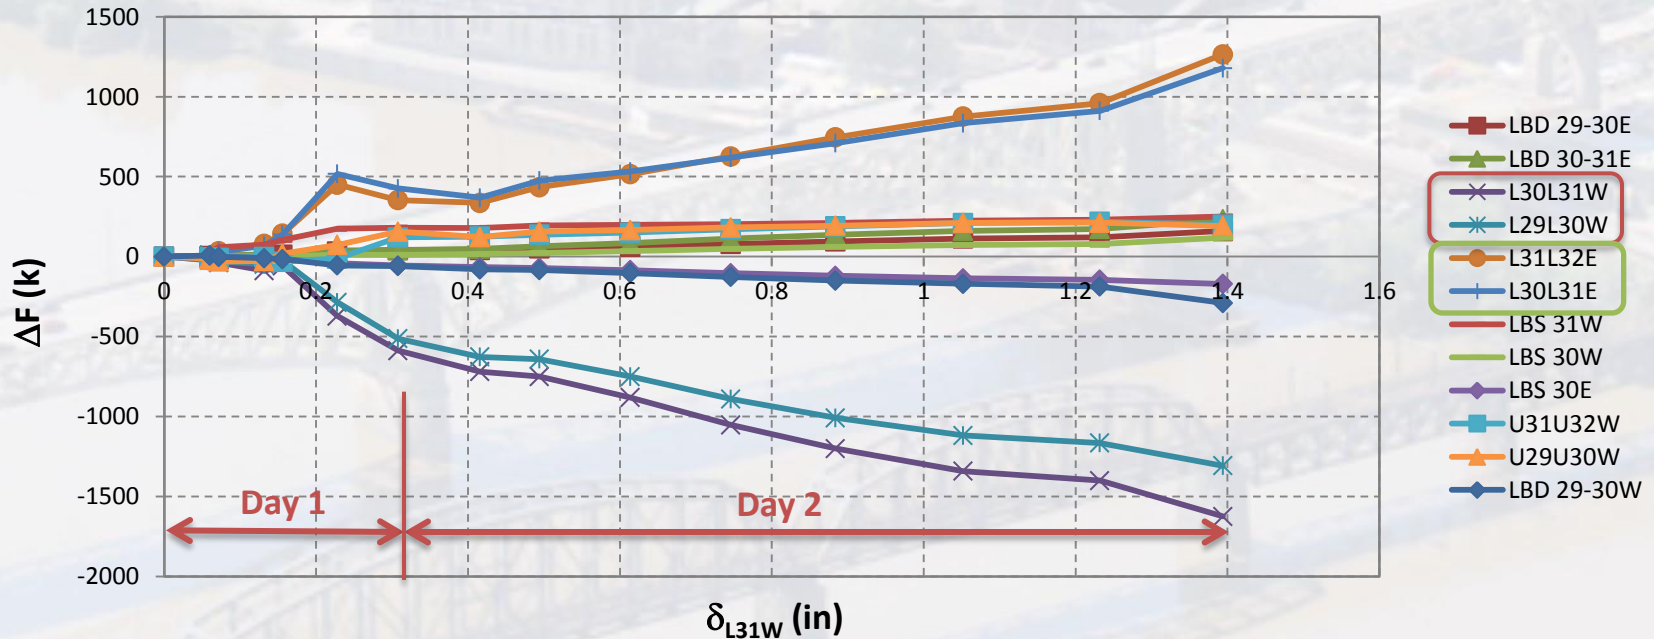
Collected Data

- Processed strain gage data (Restoring Forces) vs L31W Restoring Displacement

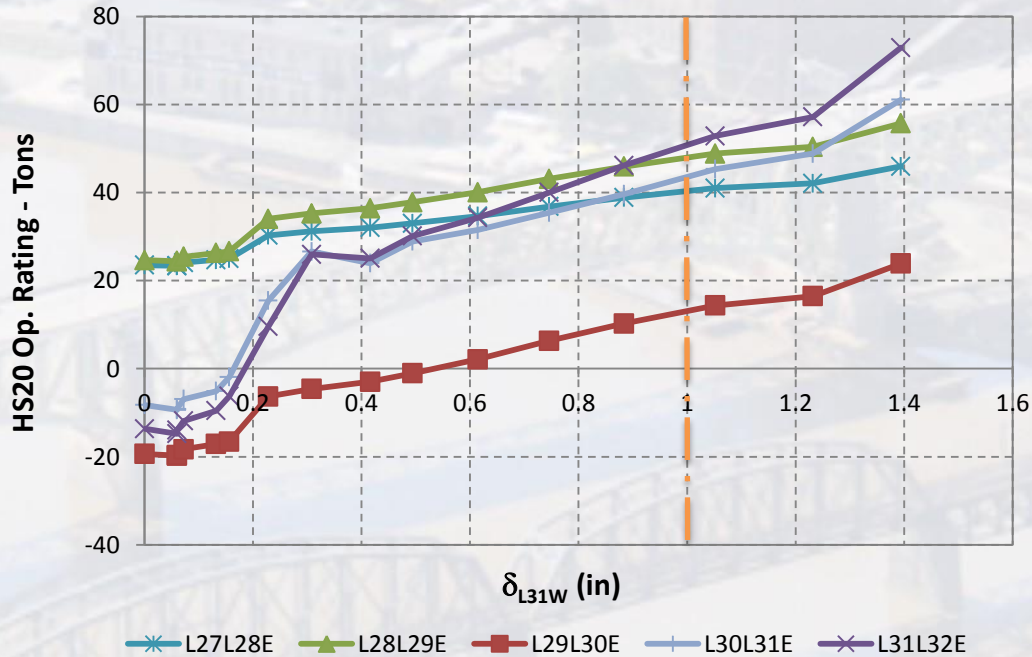
Real-time Ratings (During Jacking)

- Critical components = East (upstream) truss lower chord members

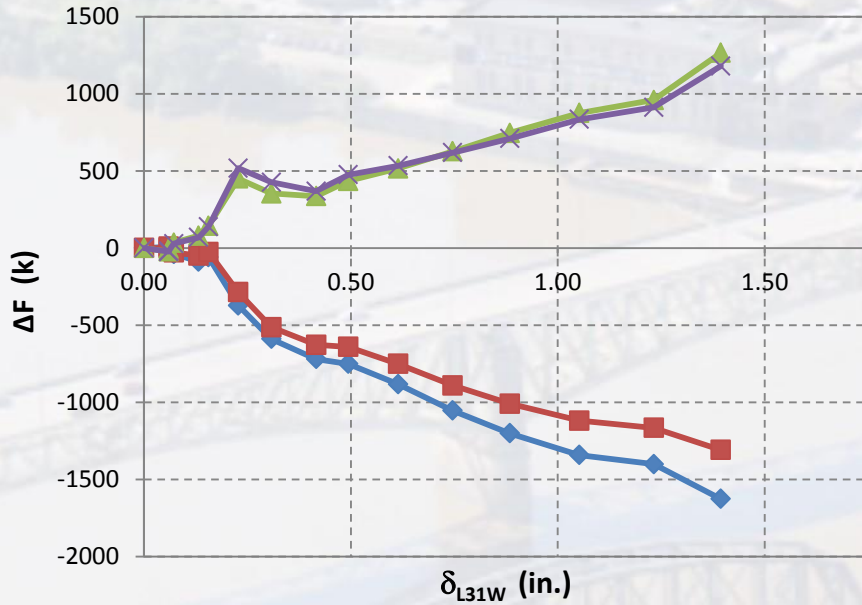
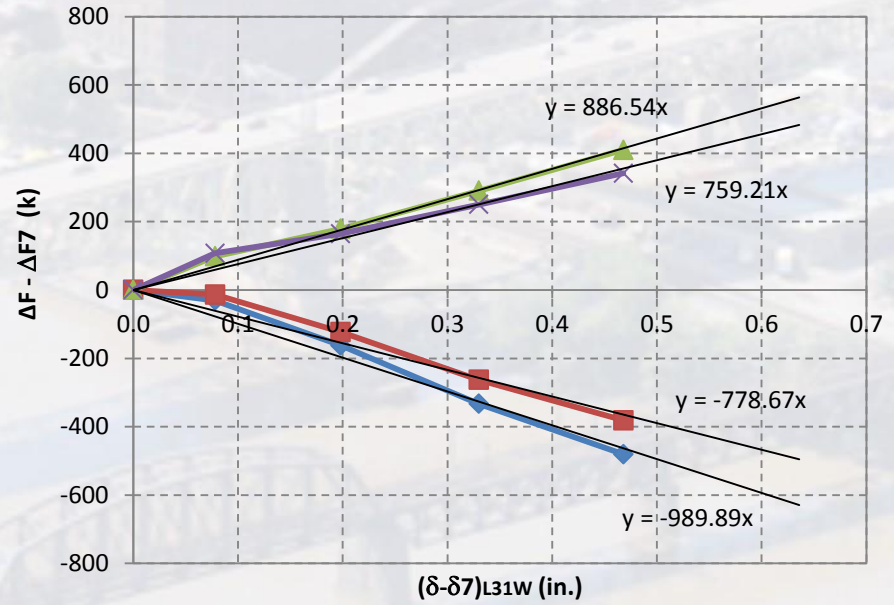
Refined Stiffness Calcs

➤ Refined post-processing after jacking:

$$K_{mod} = \bar{\alpha}K_o, \quad \bar{\alpha} \approx 1.015$$

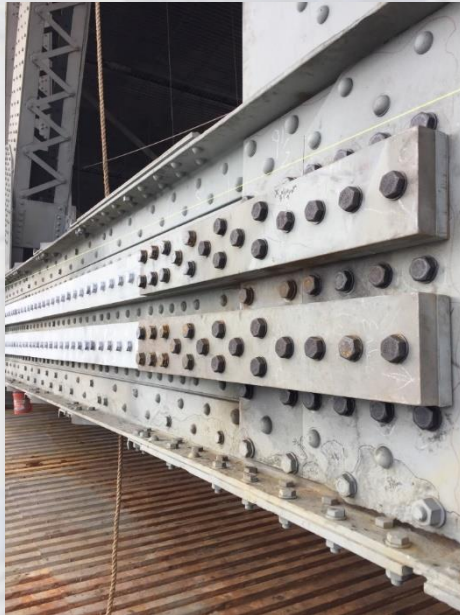
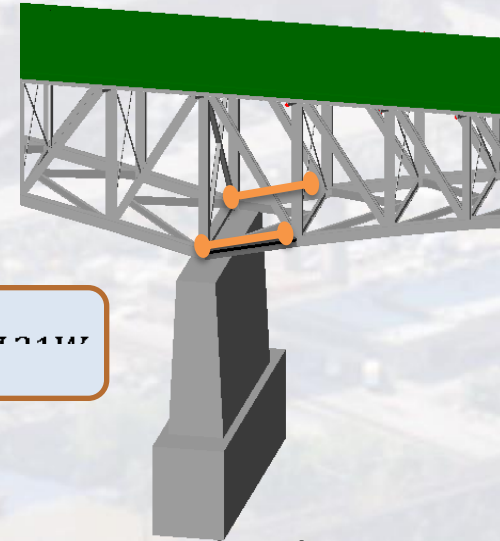
Post-jacking Work

- 30 Ton Weight Limit Restored on 9/29/16
 - 98 in² of steel added to L29L30E

$$\Delta L \approx 3/8" \approx 1.88 - \delta_{L31L32}$$

- Jacking Removal on 3/18/17
- Final differential length between east and west L31L32 members measured on 4/25/17

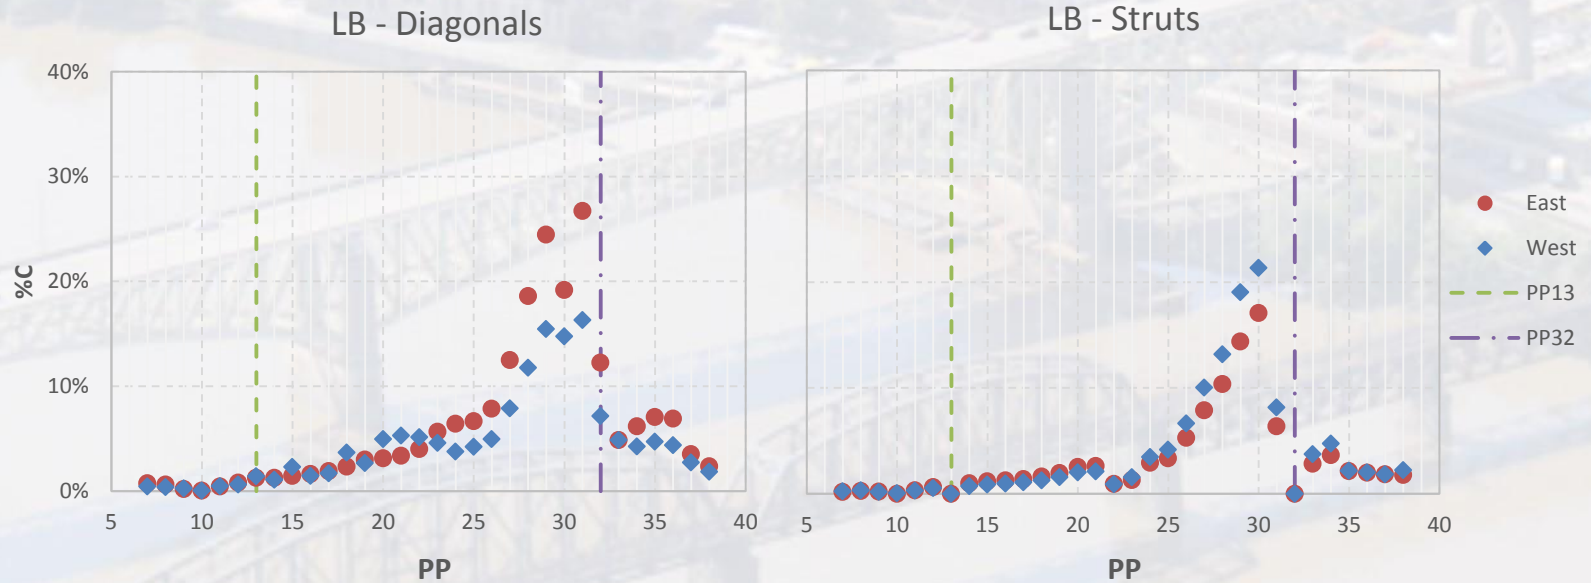
Bottom Lateral Bracing Assessment

- Remaining effects of the fire load shift expressed as a percentage of their capacity

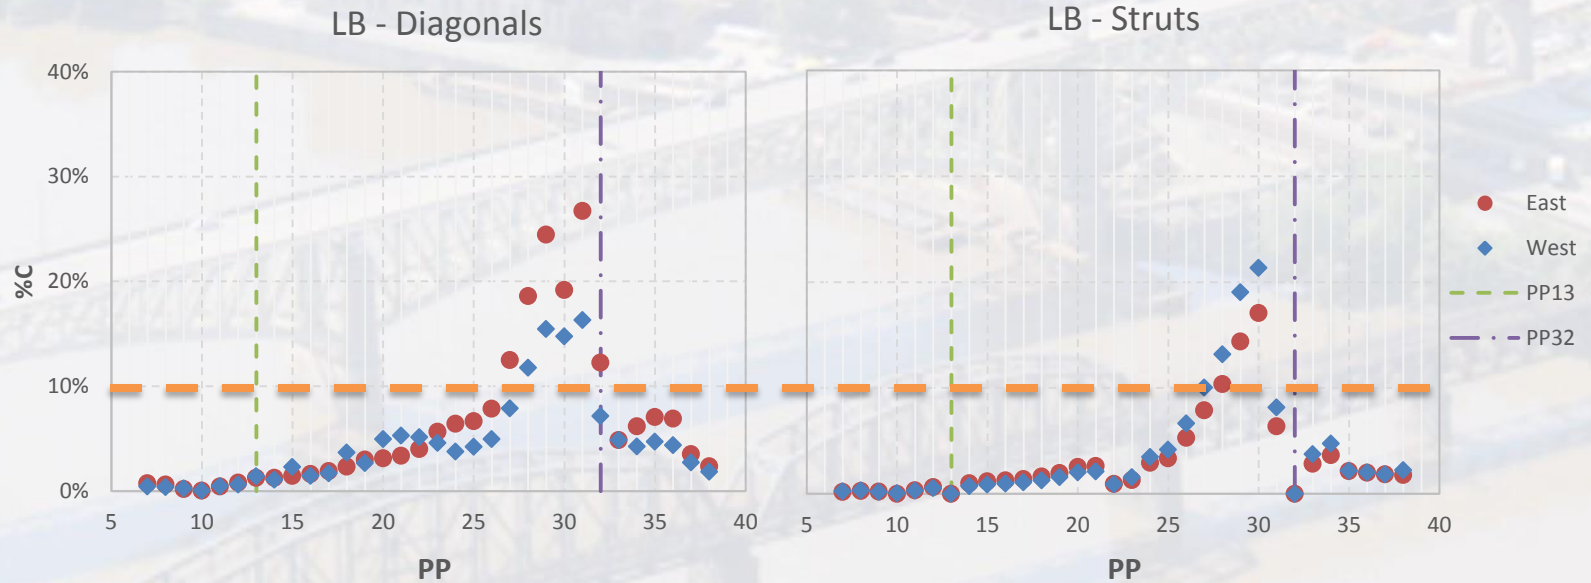
Bottom Lateral Bracing Assessment

- Remaining effects of the fire load shift expressed as a percentage of their capacity

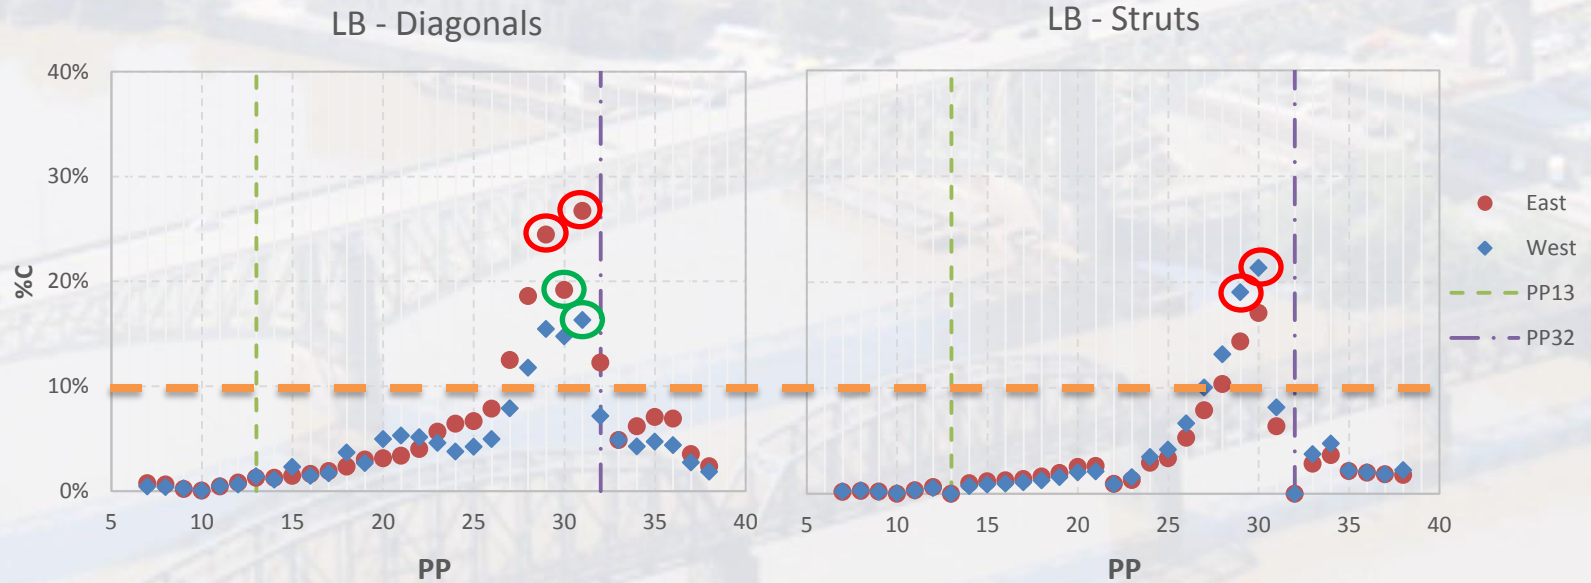
Bottom Lateral Bracing Assessment

- Remaining effects of the fire load shift expressed as a percentage of their capacity

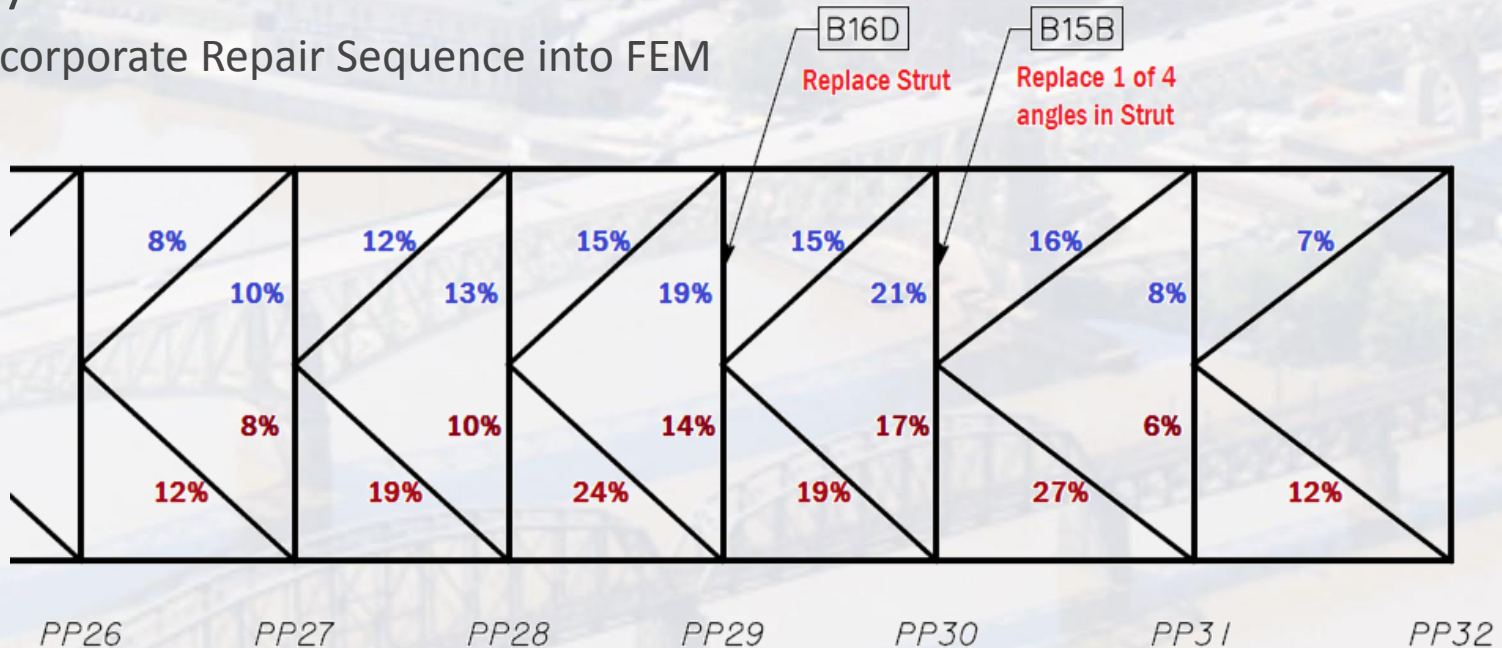
Bottom Lateral Bracing Assessment

- HDR (2015 Rehab. Engineer of Record): Effects of Upcoming Repairs on BLB system
 - Incorporate Repair Sequence into FEM

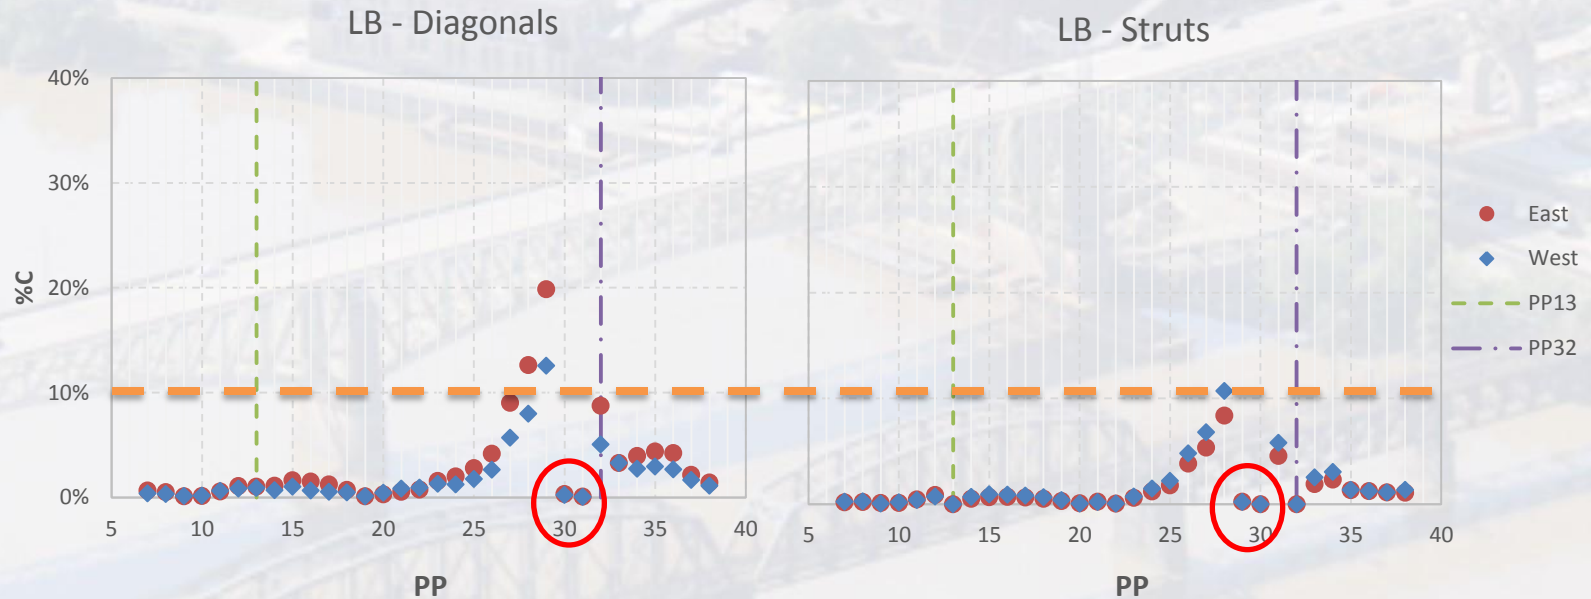
Bottom Lateral Bracing Assessment

Original Repair Sequence: Remaining Effects

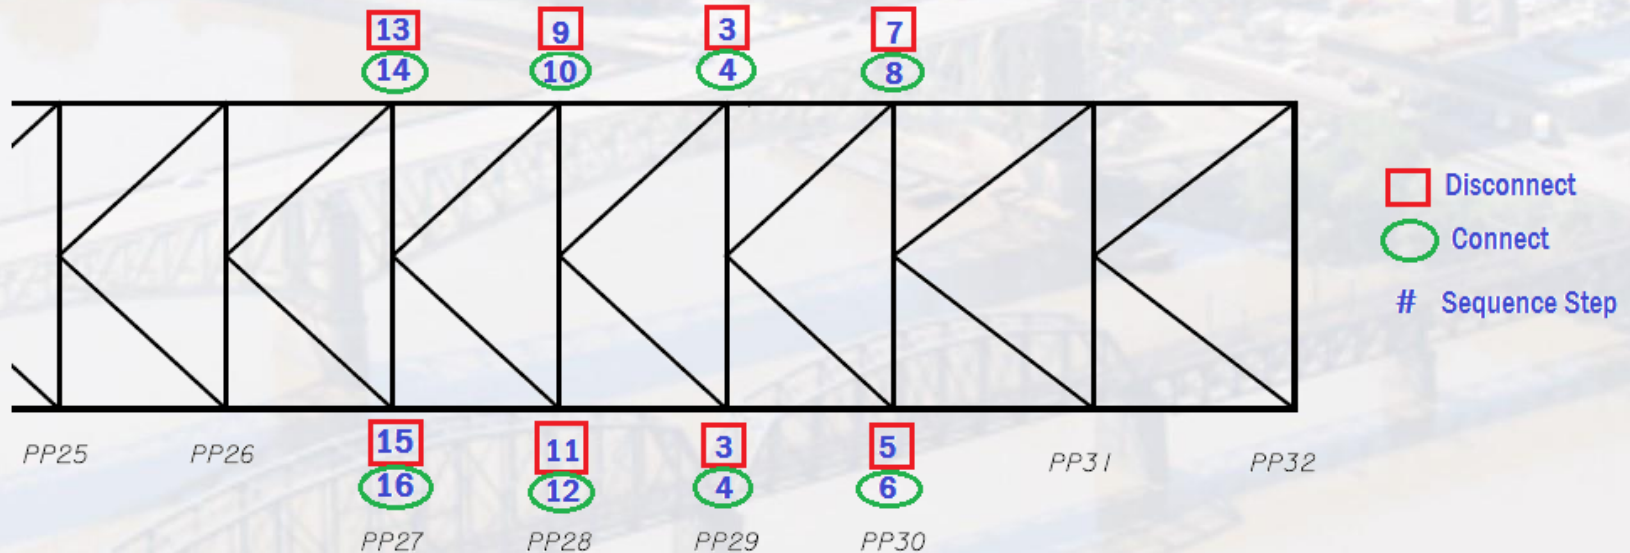
Bottom Lateral Bracing Assessment

Proposed Repair Sequence:

1. End of Stage 1D
2. Full Width Deck

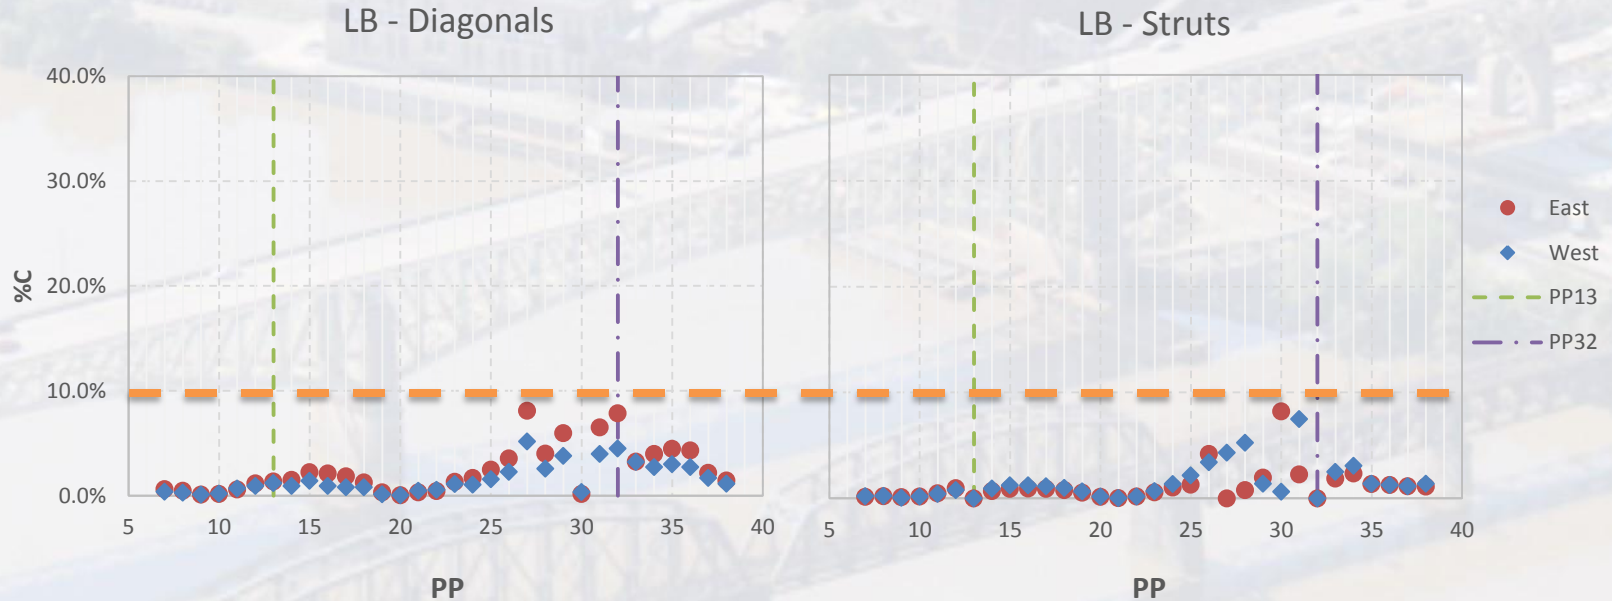
Bottom Lateral Bracing Assessment

➤ Proposed Repair Sequence: Remaining Effects

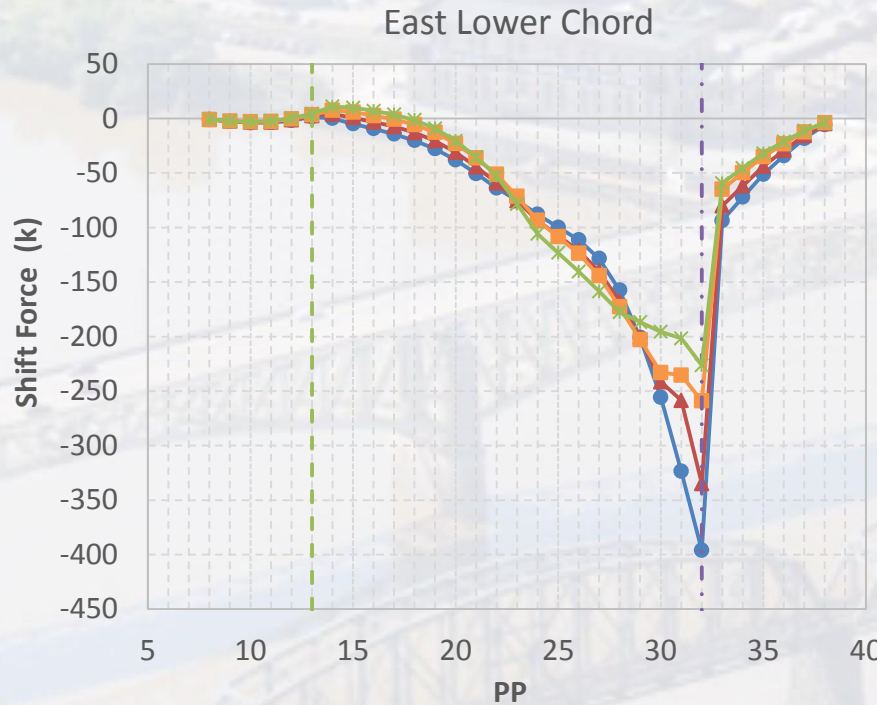
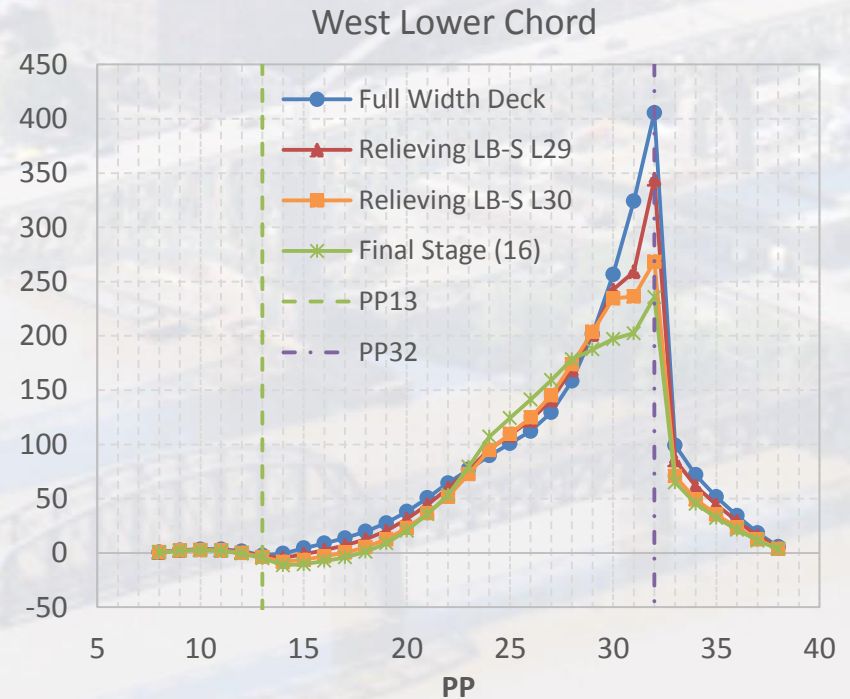
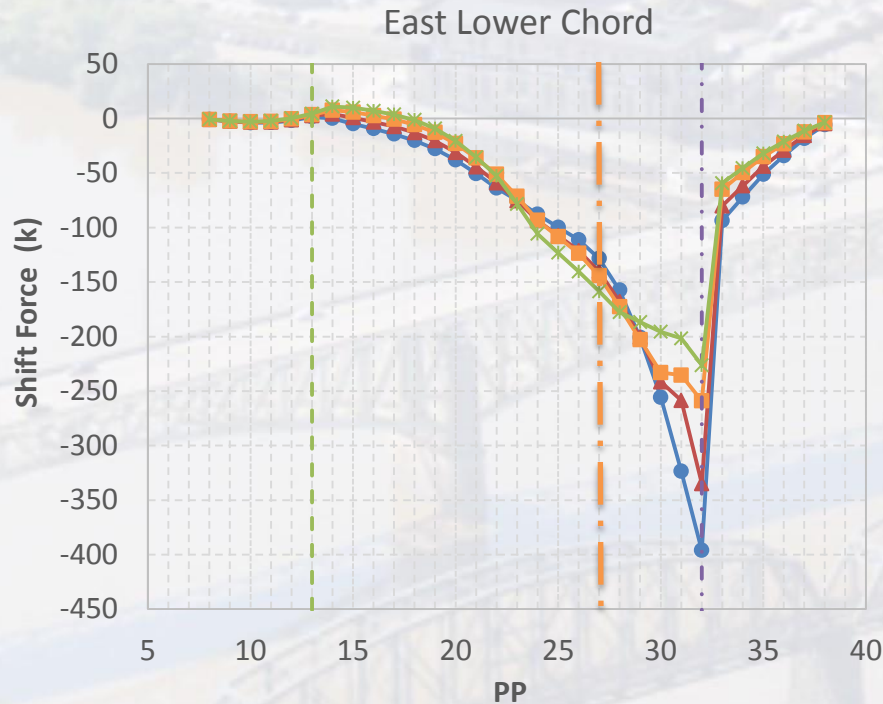
Bottom Lateral Bracing Assessment

Proposed Repair Sequence: Effects on Truss Members

➤ East Truss Members: HS20 ORF > 1.5

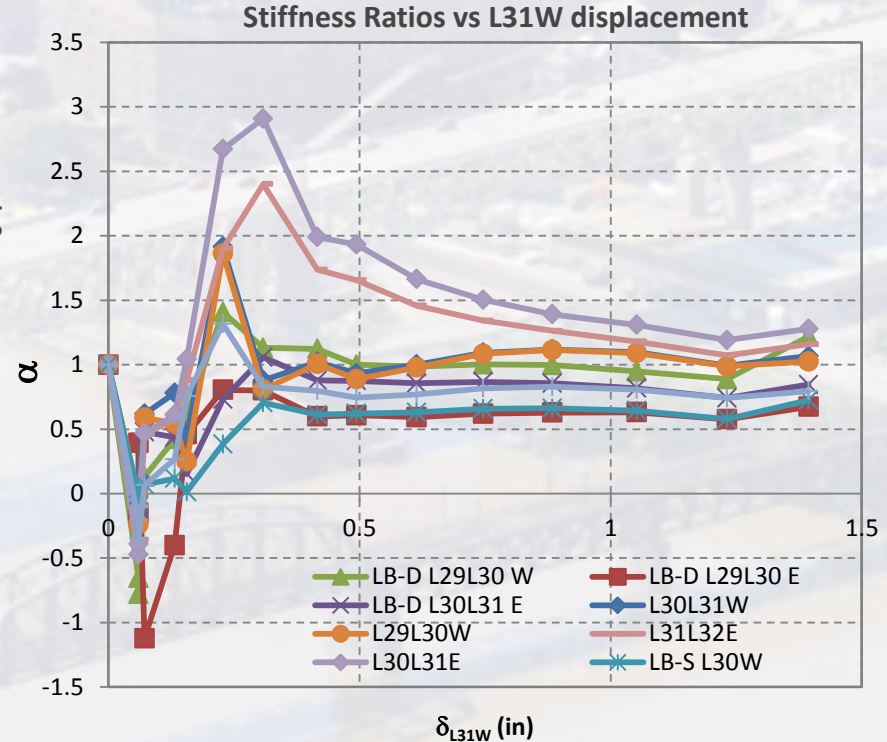
Issues Encountered

- Initial large deviations in stiffness
- Initial engagement between the jacking frame and the bridge, stabilization of instrumentation

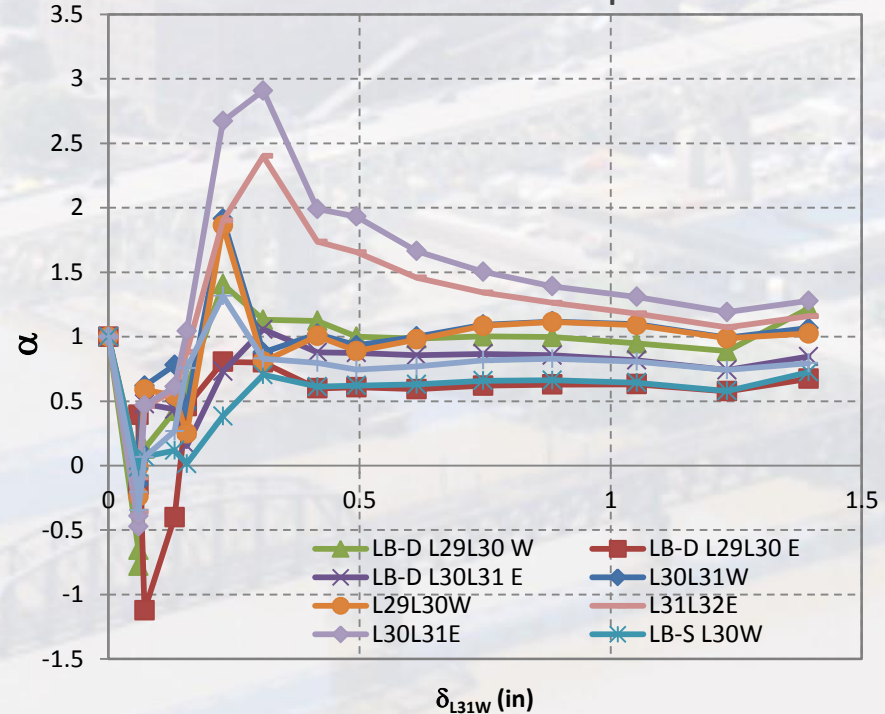
Stiffness Ratios vs L31W displacement

➤ Initial large deviations in stiffness

➤ Temperature effects

- Day 1 (9/23/16) – Sunny - measured steel temperatures

- Day 2 (9/24/16) – Overcast - measured steel temperatures relatively constant ~67°F

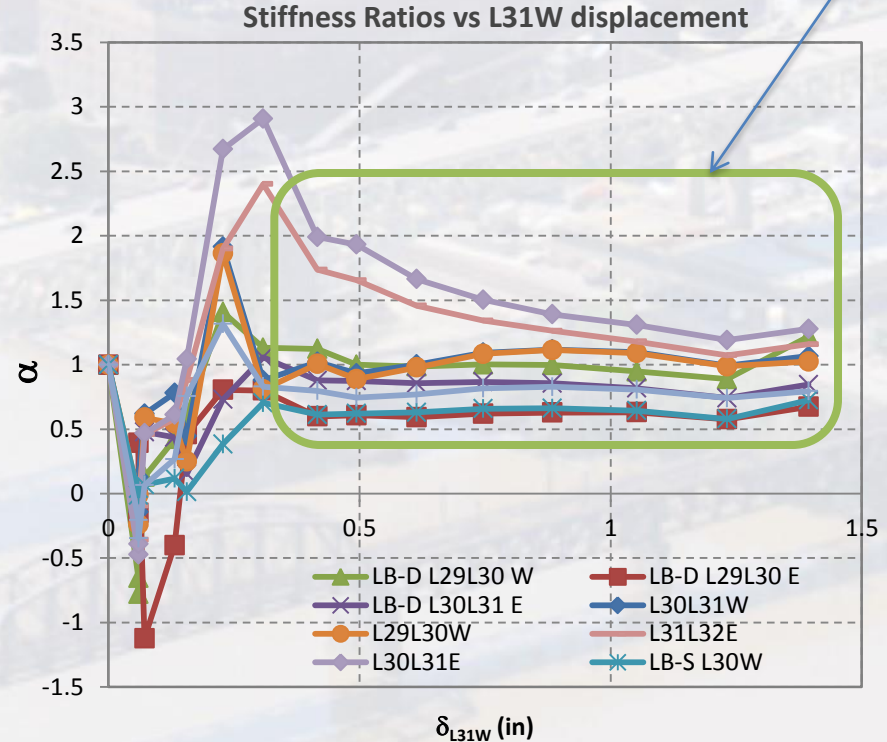
Issues Encountered

Day 2 data used in calculation of Stiffness Ratios, α , for final post-processing of data

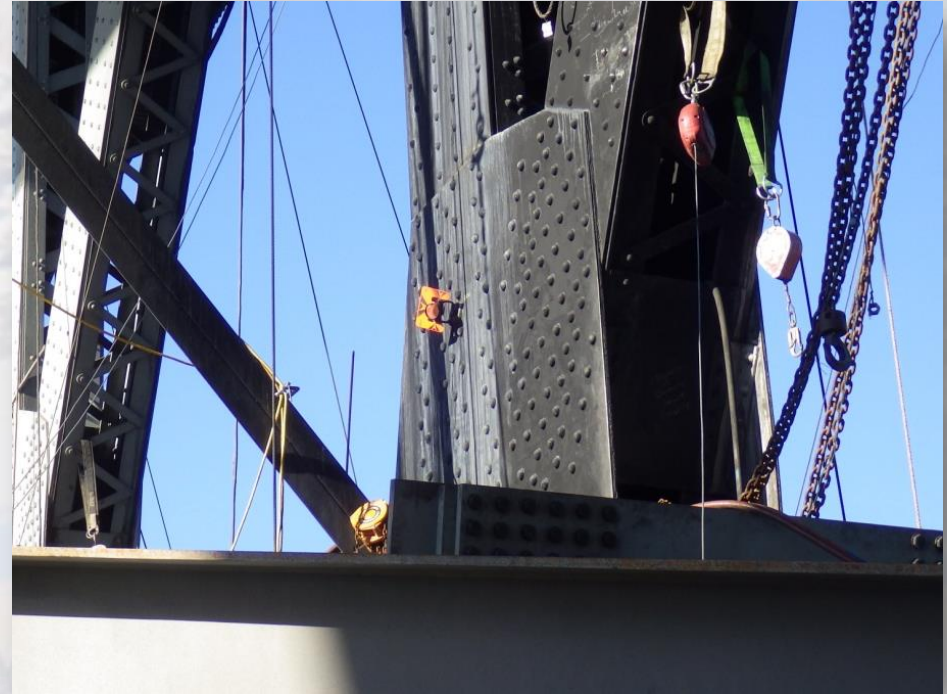
Issues Encountered

- Measurement of L31-L32W panel length
 - Value is critical to determining stiffnesses to compare w/FEA
 - Started using survey data from targets on inboard side
 - Rotation of joint due to lateral jacking influenced and caused inaccuracy of these values
 - Updated methodology to use survey measurements of targets on inboard and outboard side

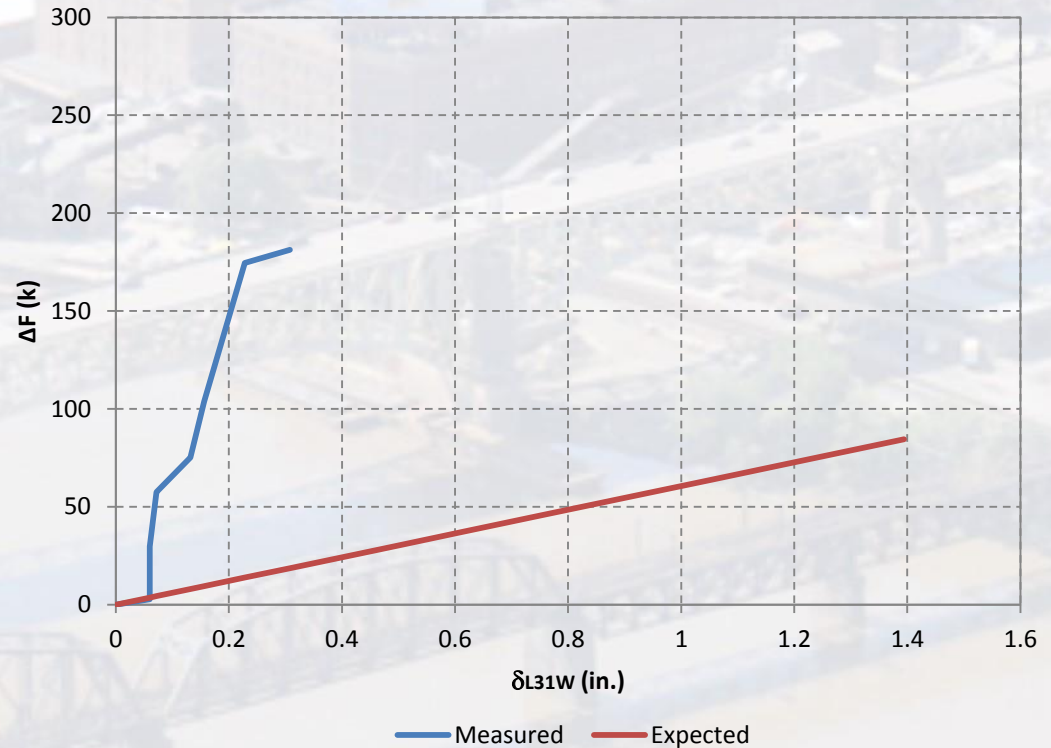
Issues Encountered

➤ L31W Strut

- DL in post-fire condition \approx 120 k (compression)
- Capacity \approx 320 k (tension)
- Measured vs. expected shift forces (+ = tension added)
