Liberty Bridge Fire Event: Response Evaluation for Jacking Operations and Ratings

ABCD Susquehanna Chapter

Thomas Murphy, Ph.D., P.E.
Andrew Adams, P.E.
Nohemy Galindez, Ph.D., P.E.
Christopher Smith, P.E.

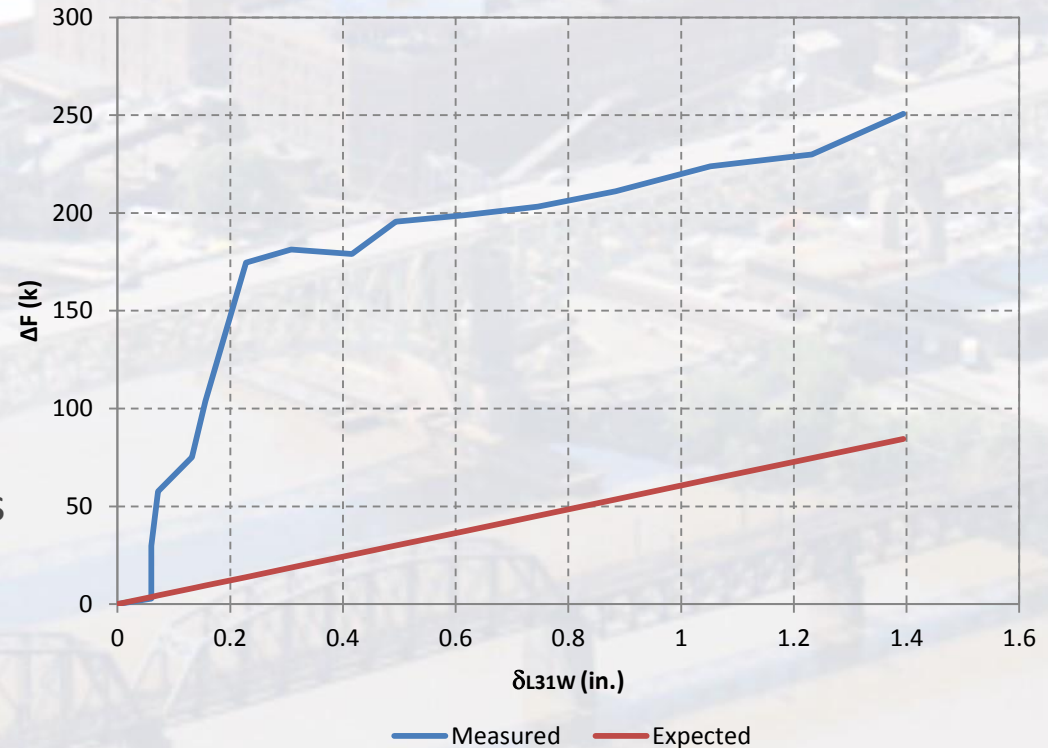
Issues Encountered

➤ L31W Strut

- Large initial forces due to lateral jacking near L31W
- Jacking team informed to stop increasing lateral jack force
- Once lateral jacking force was backed off, stiffness closely matched expected
